HYDRO GRAND HOTEL

10 THE BAY HILL, TIMARU

HERITAGE ASSESSMENT

Report Prepared by
SMART ALLIANCES LTD
for
TIMARU DISTRICT COUNCIL

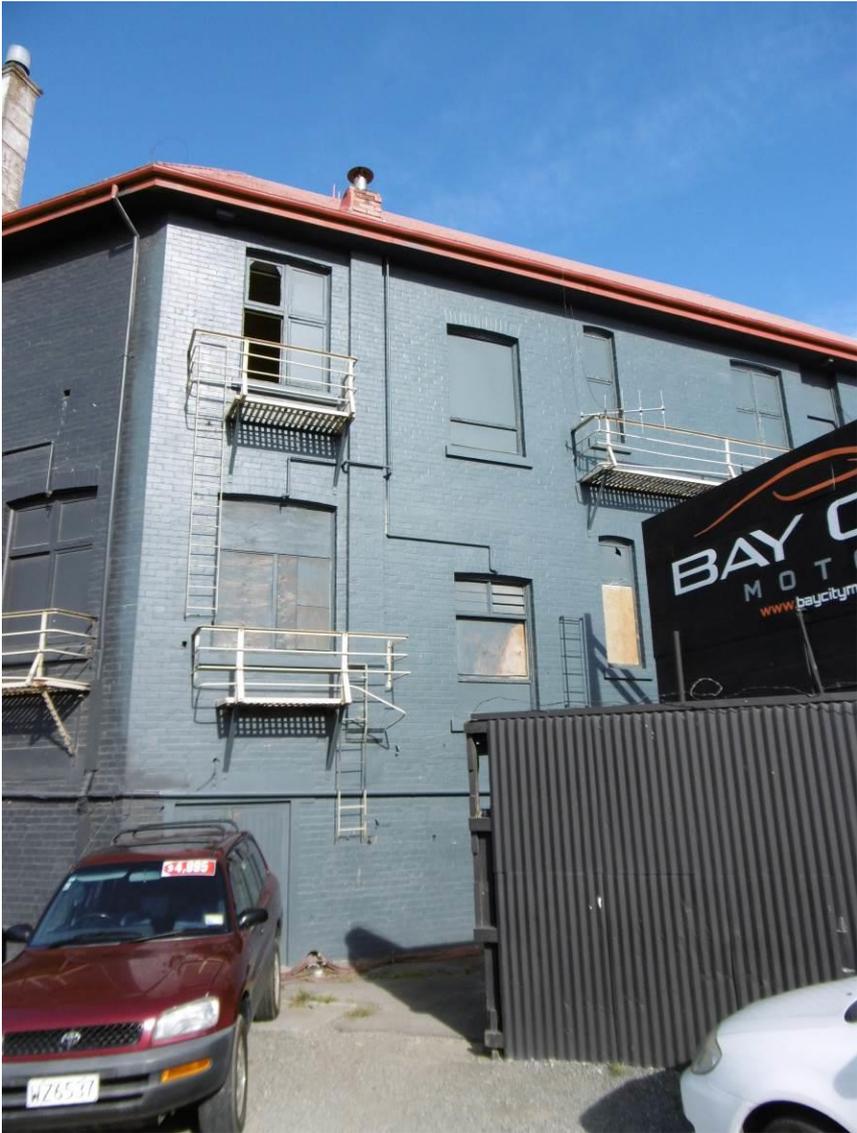
WEST ELEVATION SHOWING PAINTED OUT WINDOWS

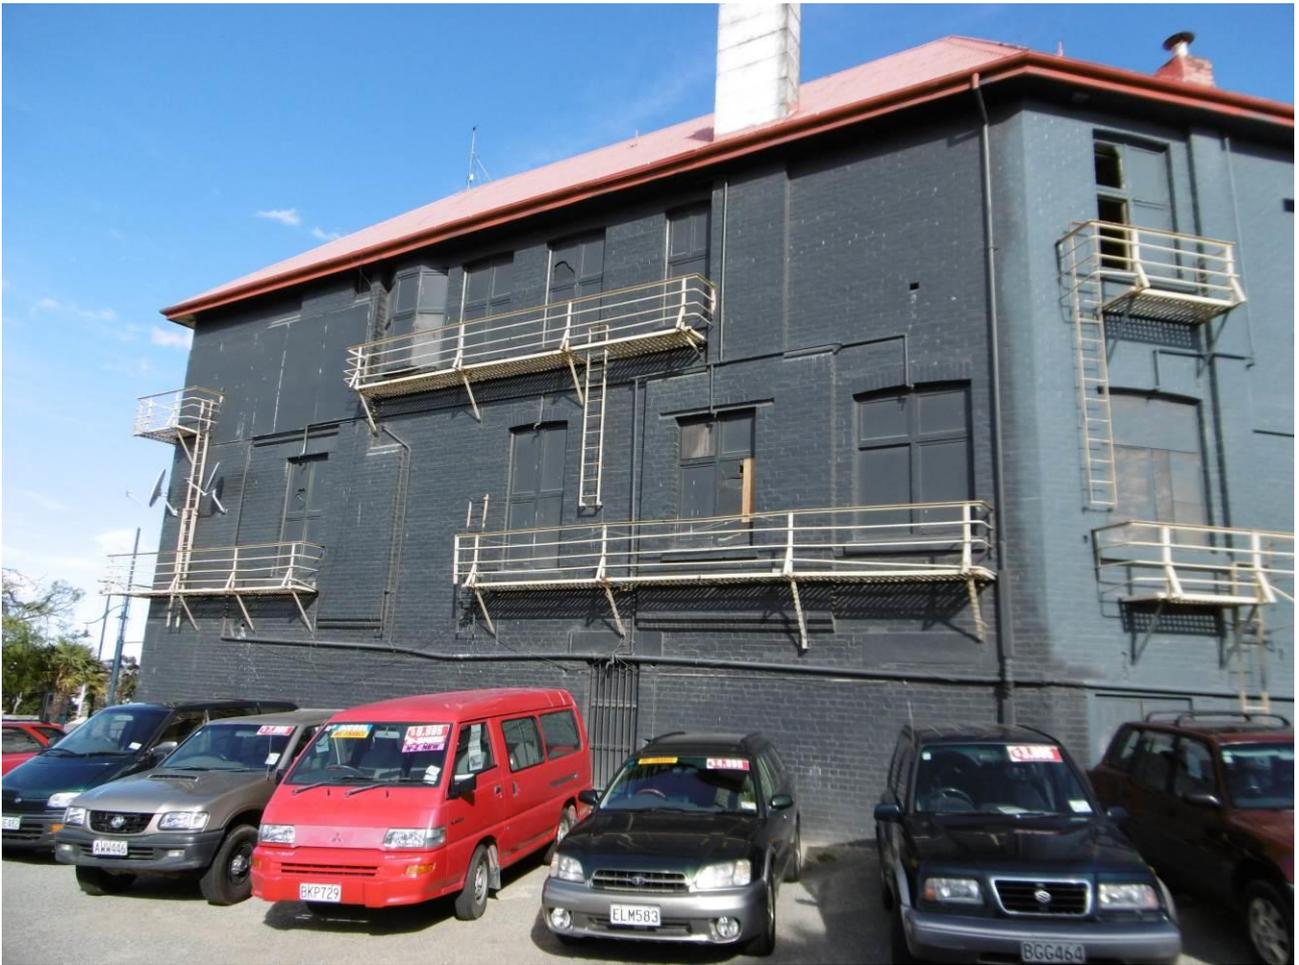
NORTH ELEVATION WITH WINDOWS ALSO PAINTED OUT

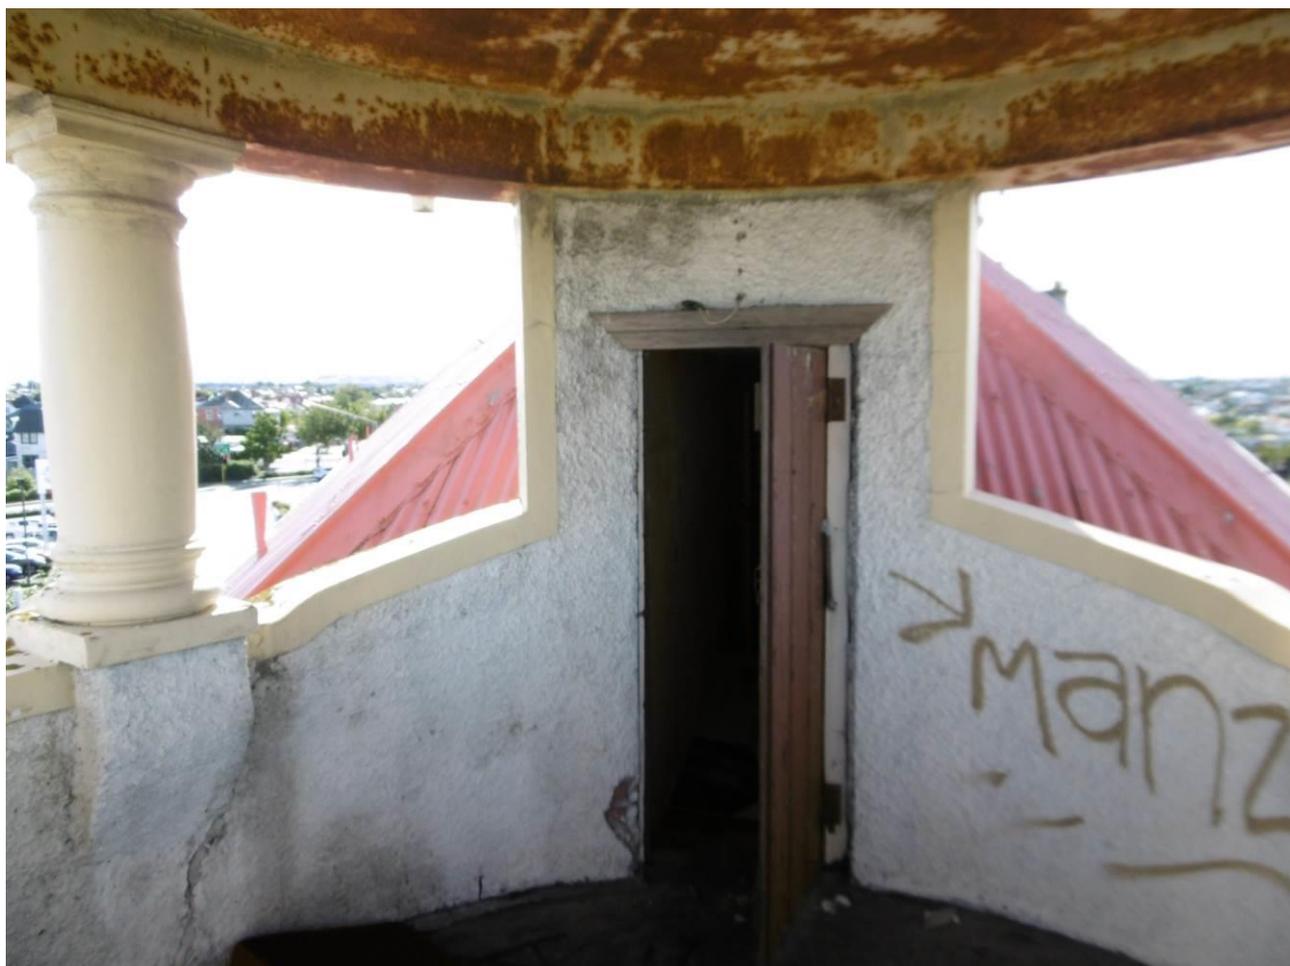
INSIDE OF THE CAPOLLA LOOKOUT, LOOKING NORTH WEST. NOTE THE LARGE CRACK IN THE STRUCTURE BELOW THE COLLUMN.

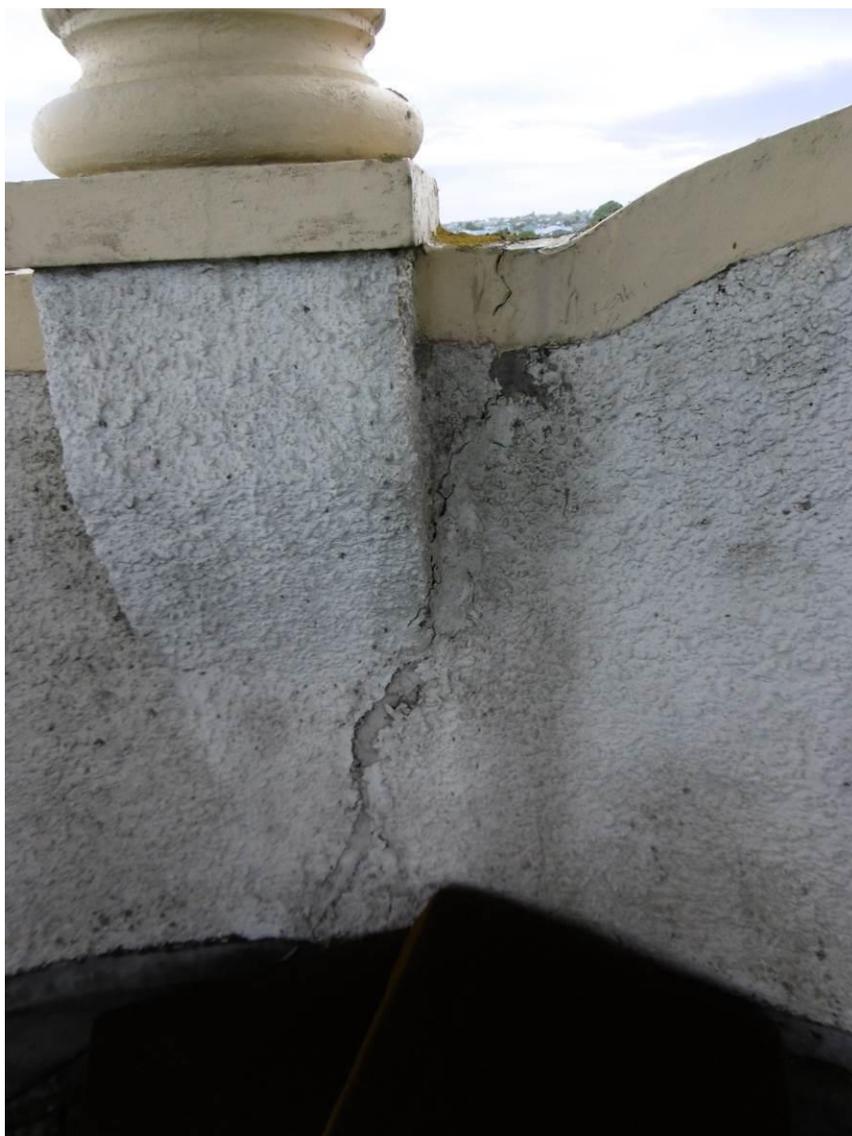
DETAIL OF CRACK IN CAPOLLA STRUCTURE

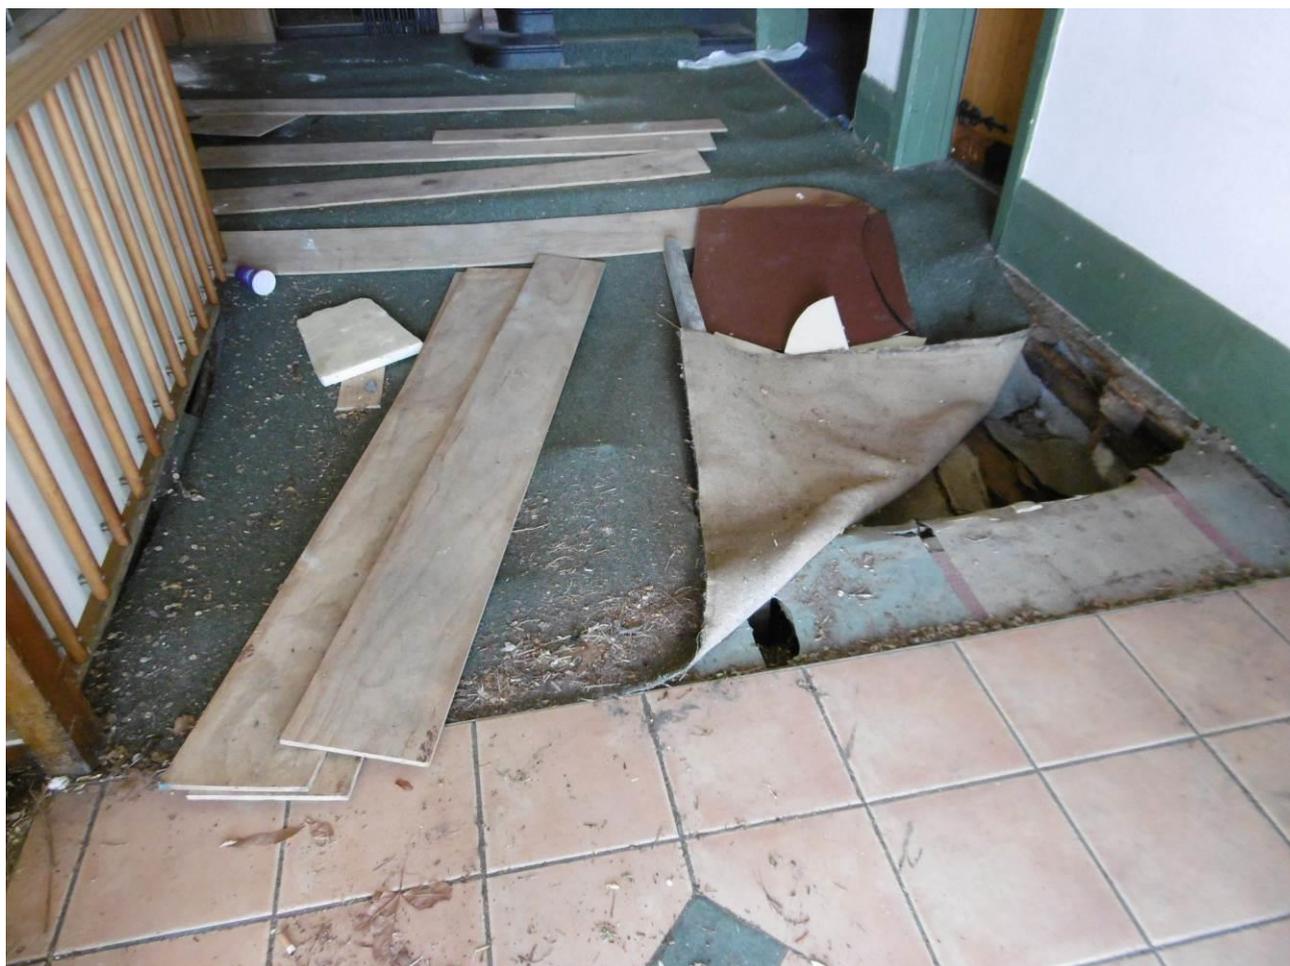
Internally, the floors are of timber frame with T&G floor boards on all three levels. The ground floor is badly rotted in several areas to the point of total collapse as is the lower intermediate stair landings between the ground and first floors and first and second floors. All these areas would be considered to be in dangerous condition under the terms of section 121(1) and 123 of the Building Act.

THE FLOOR IS VERY ROTTEN IN THE ENTRY AREA AND HAS TOTALLY COLLAPSED

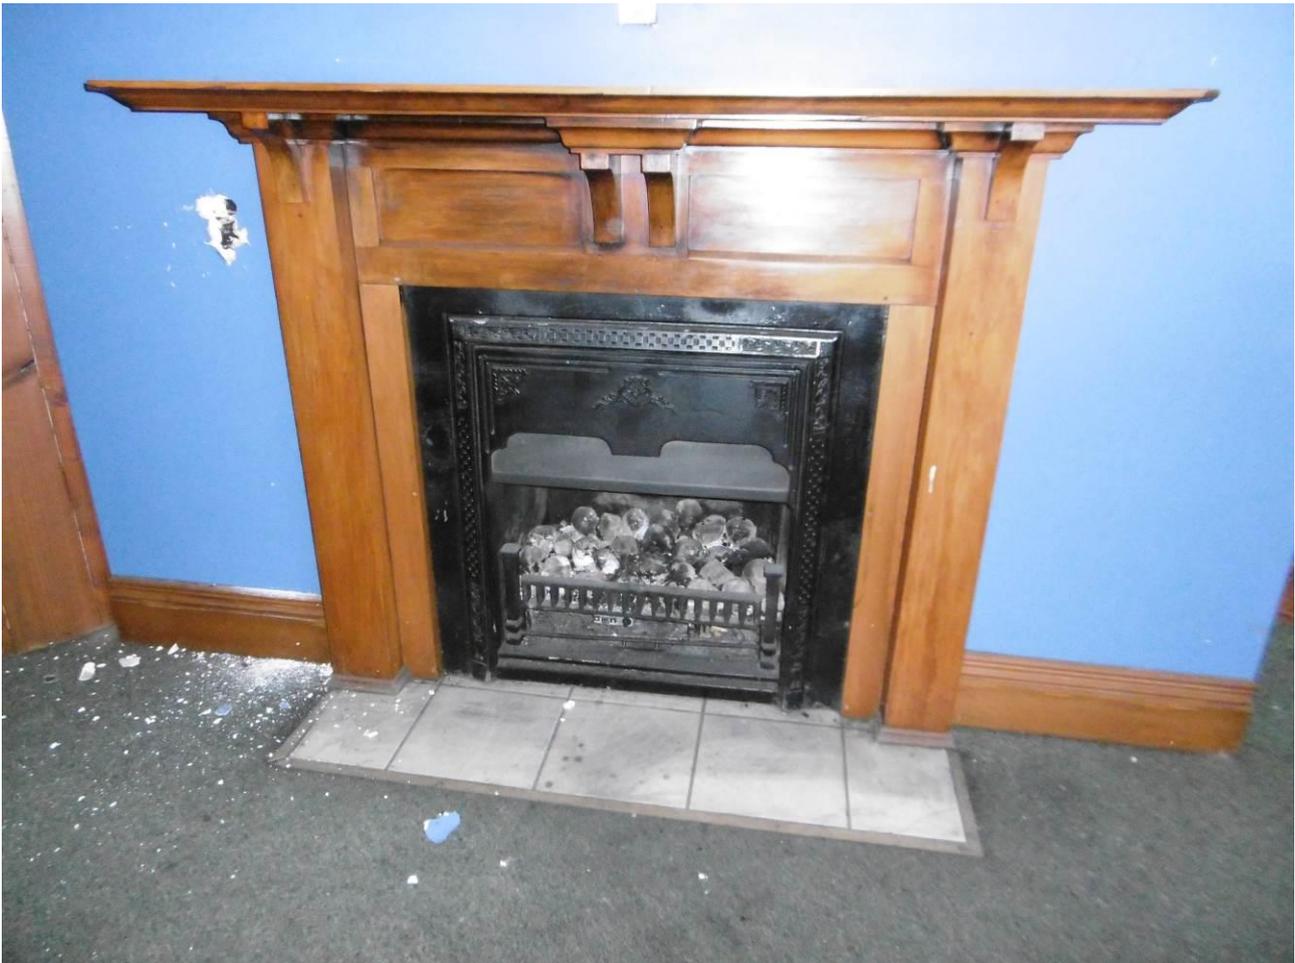
THIS FIRE AND SURROUND IS NOT BELIEVED TO BE ORIGINAL FABRIC TO THE BUILDING, AS THE FIRE IS GAS POWERED AND THE TRIM DOES NOT MATCH THE REST OF THE ORIGINAL FABRIC.

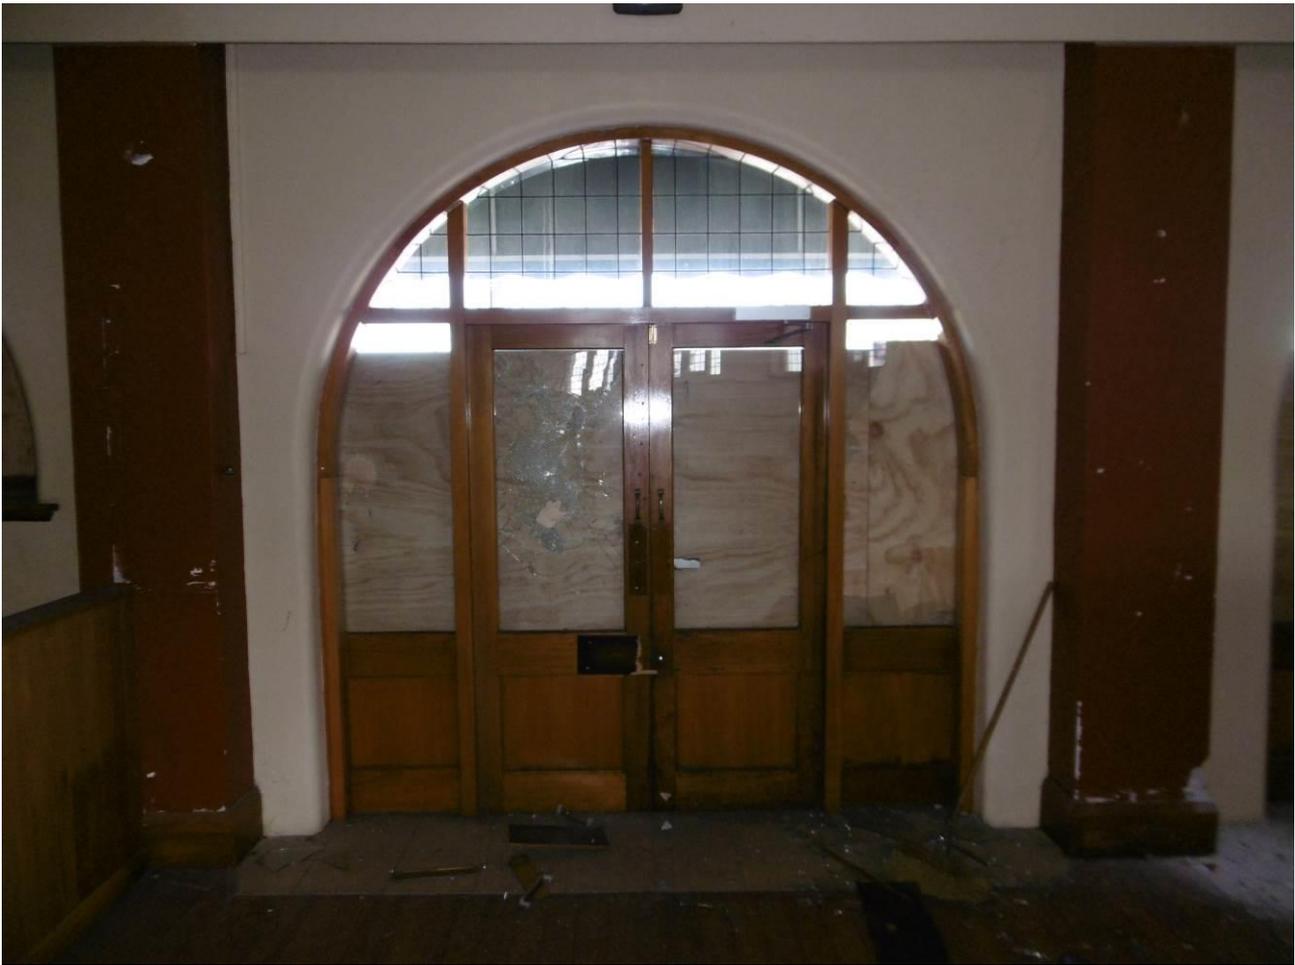
THE CURVED TOP ENTRY DOOR TO THE RESTAURANT, THIS DOOR IS A LATER ADDITION AS THERE WERE NO DOORS HERE IN THE 1914 CHANGES.

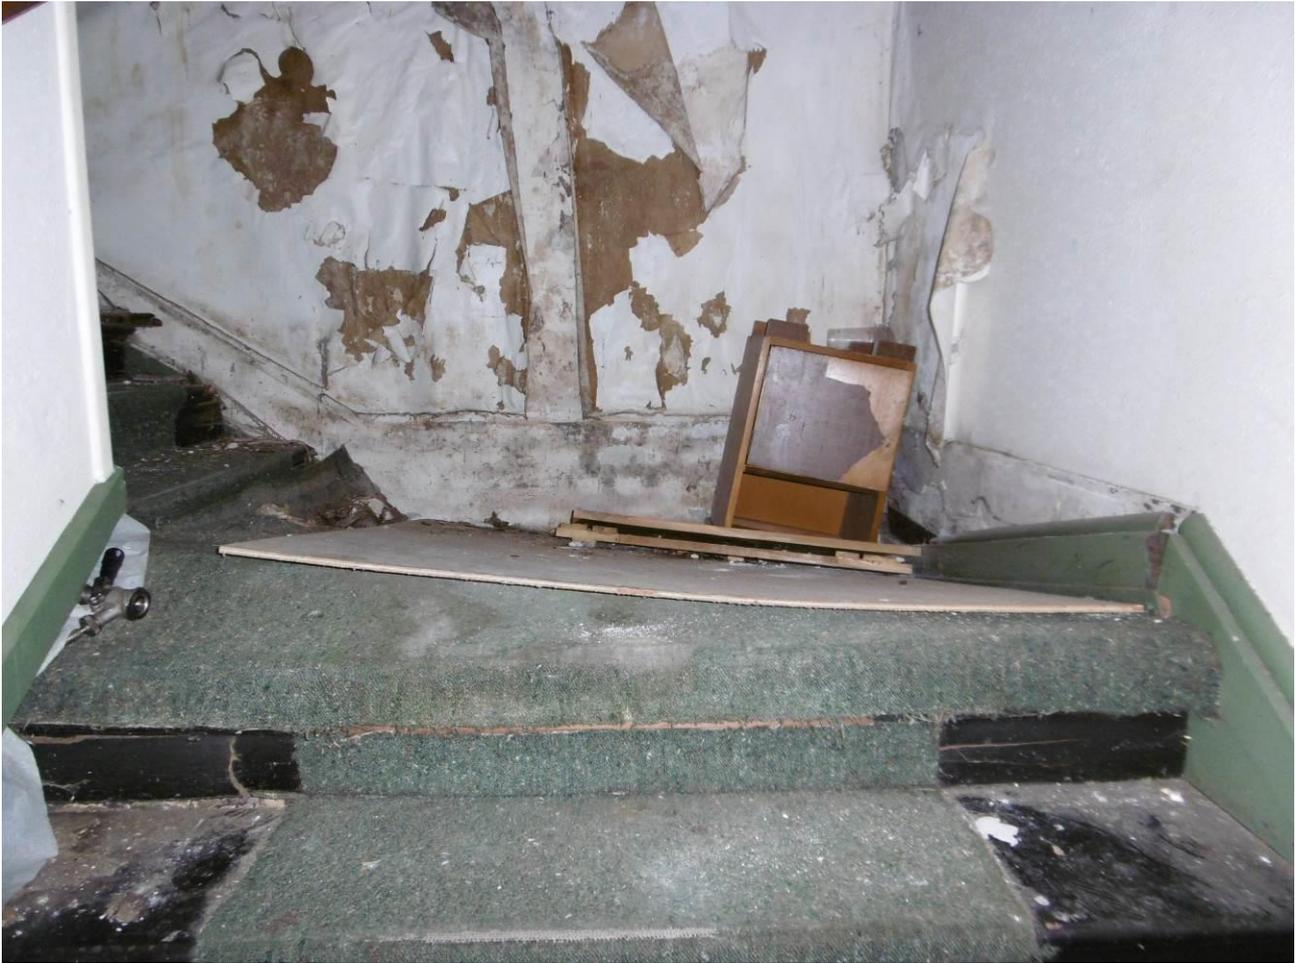
ROTTED AND COLLAPSED FIRST LANDING ON MAIN STAIR. THE WALL LINE INDICATES WHERE THE LANDING SKIRTING USED TO BE LOCATED.

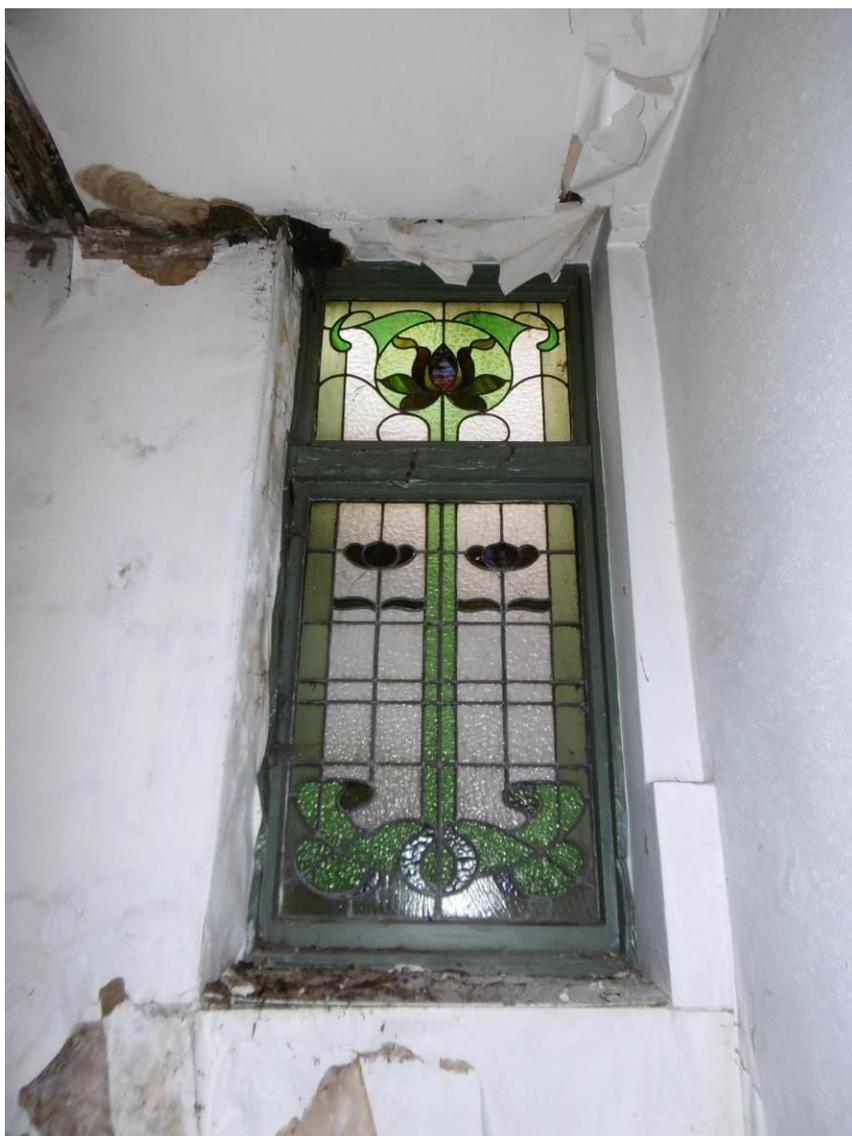
THE VERY DECORATIVELY COLOURED STAINED GLASS WINDOWS WHICH OCCUR AT THE LOWER LANDINGS OF EACH LEVEL OF THE BUILDING SHOULD BE REMOVED TO PROTECT FROM DAMAGE.

- Representative items should include:
 - The two coloured/stained glass windows from the stairwell
 - The bottom timber newel post from the main stair
 - At least one concertina steel lift door and frame (to be displayed against a blank wall).

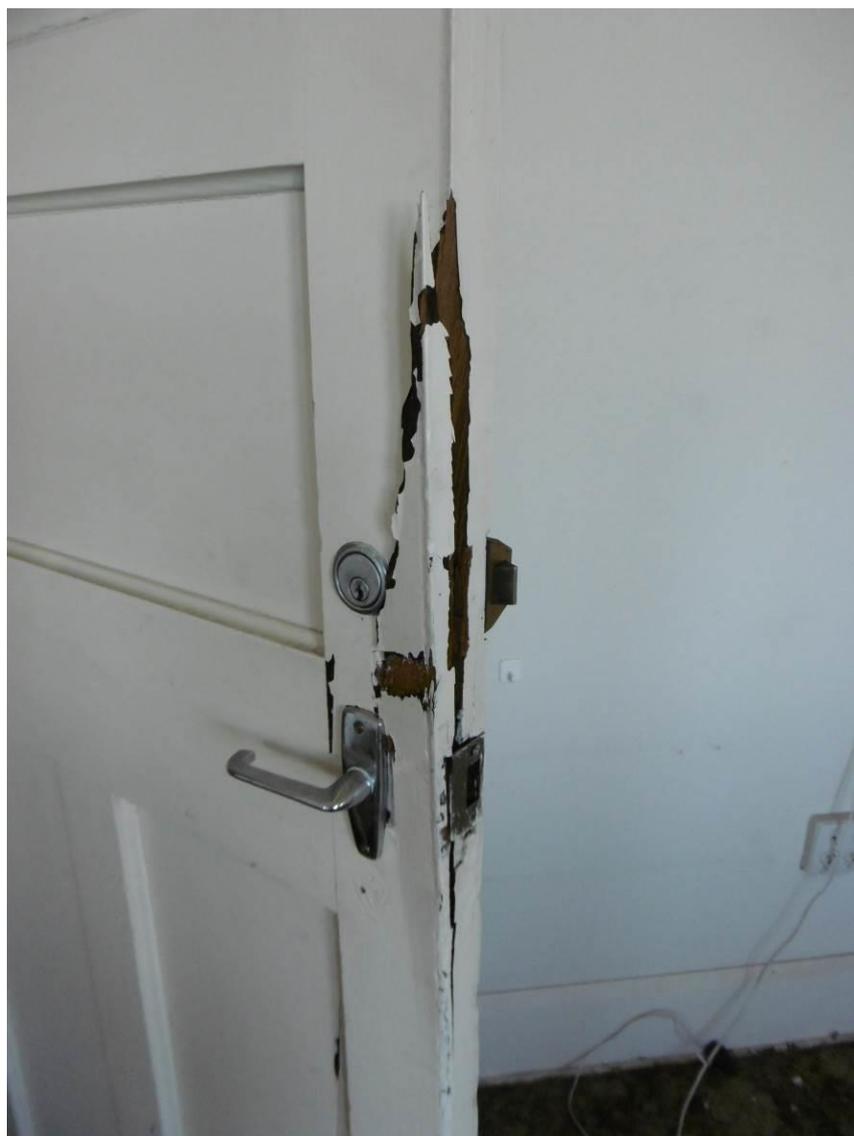
A VANDALISED BEDROOM DOOR, ONE OF MANY THROUGHOUT THE BUILDING

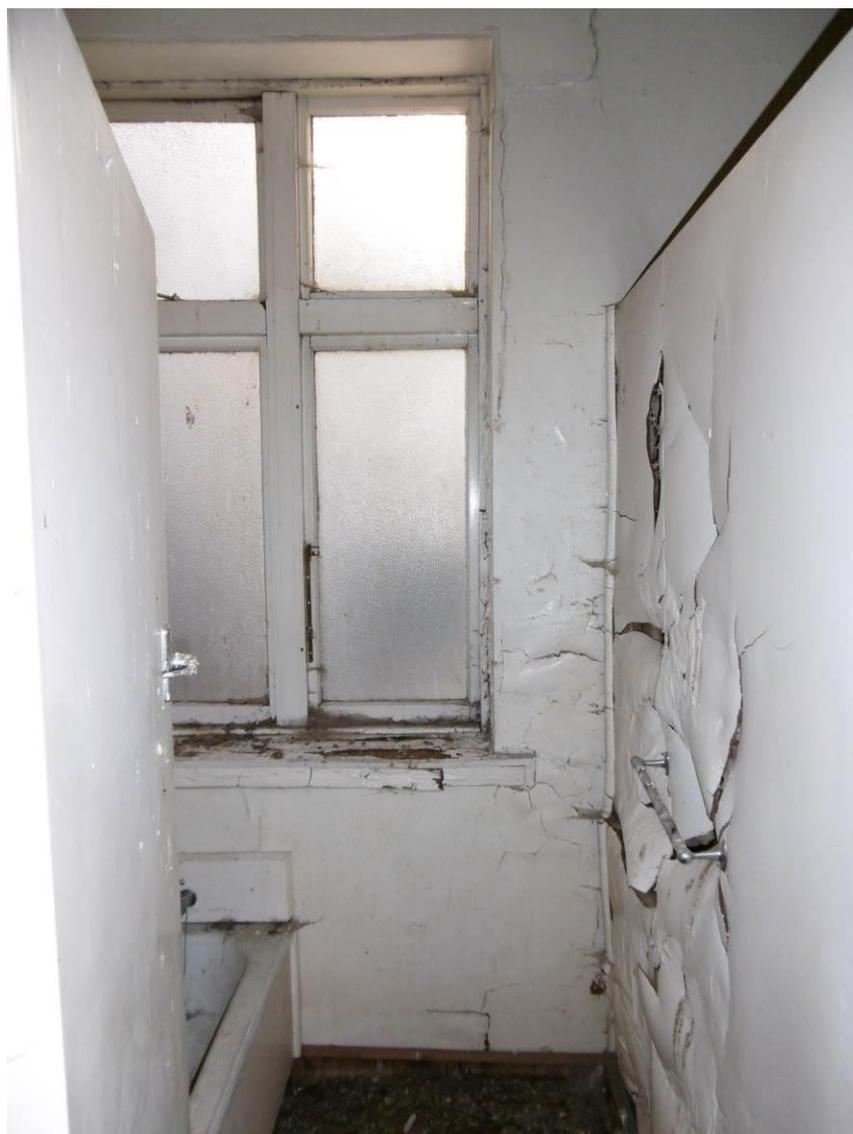
COMMUNAL BATHROOM FIRST FLOOR, WITH SEVERE WATER DAMAGE TO LININGS

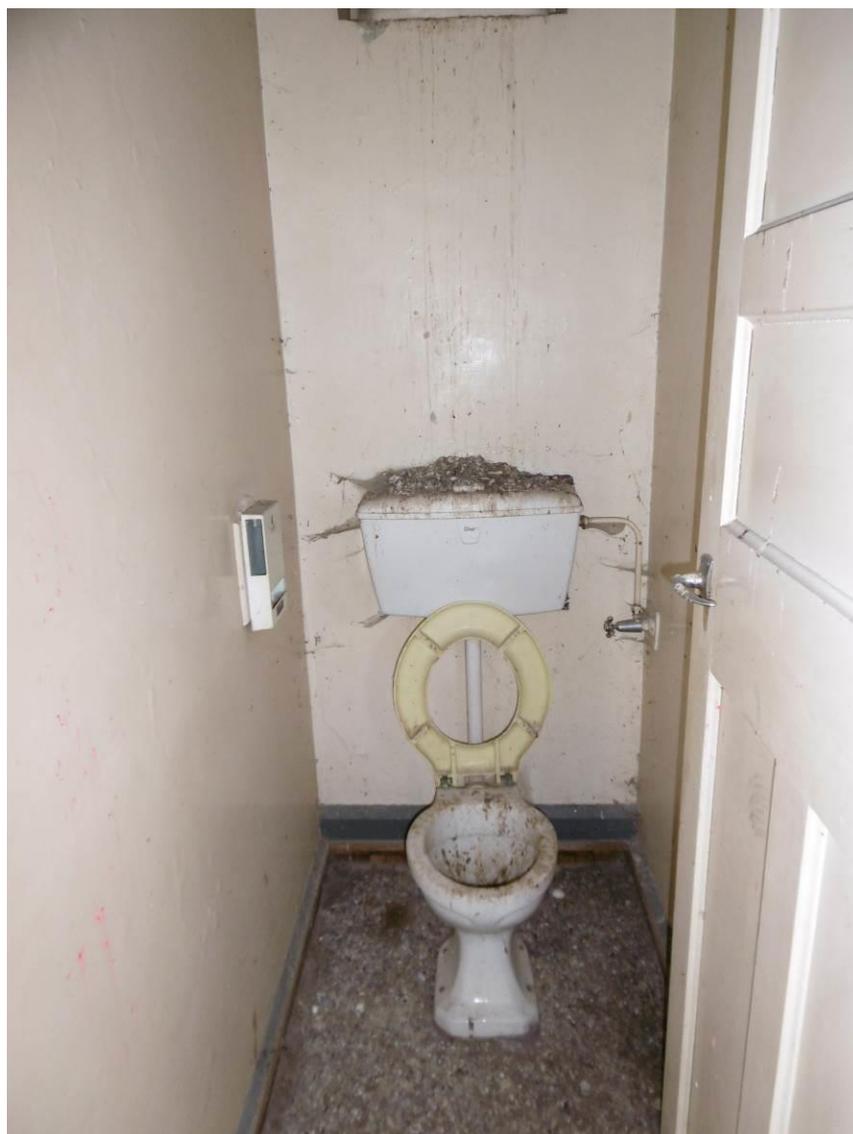
The general disrepair, moisture penetration, considerable deposits of pigeon droppings and dead animals throughout the interior, would constitute an unsanitary building, injurious to public health, under section 123 of the NZBA.

COMMUNAL TOILET WITH BIRD DROPPINGS ON ALL SURFACES

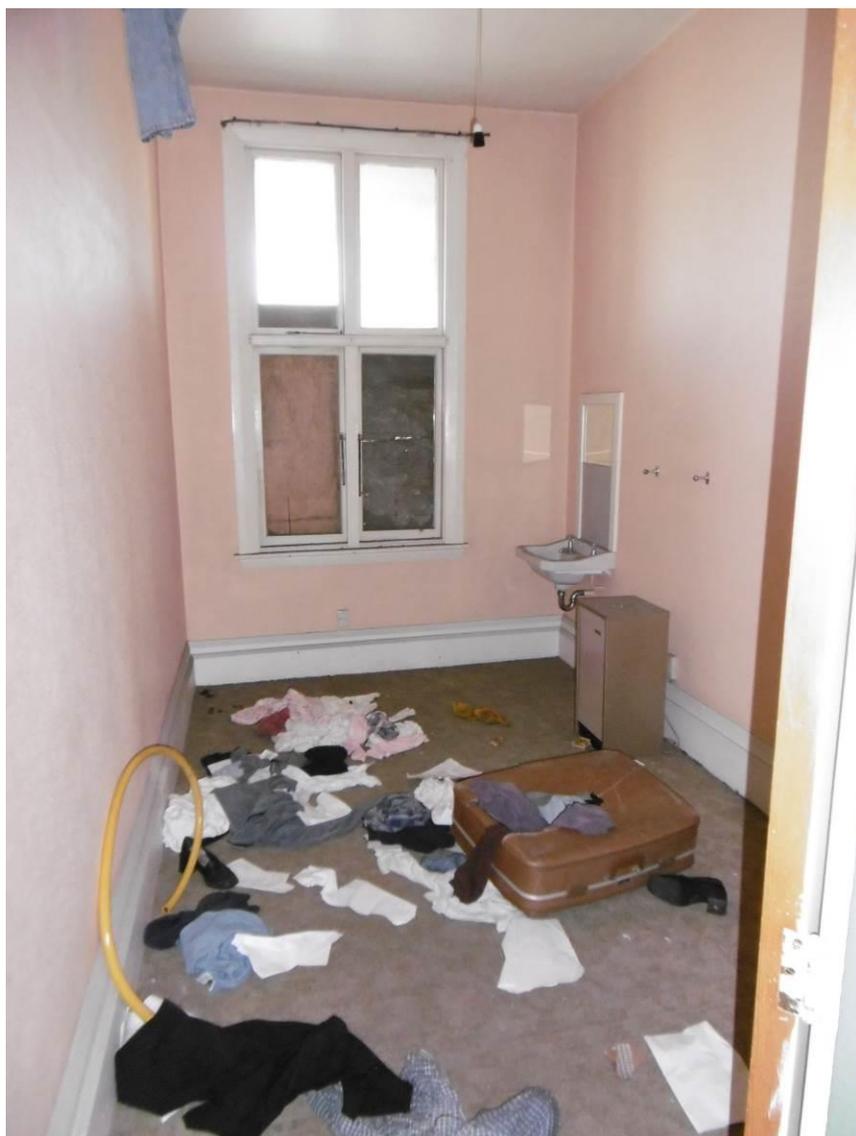
BEDROOM WHERE PEOPLE HAVE BEEN LIVING ROUGH WITHIN THE BUILDING

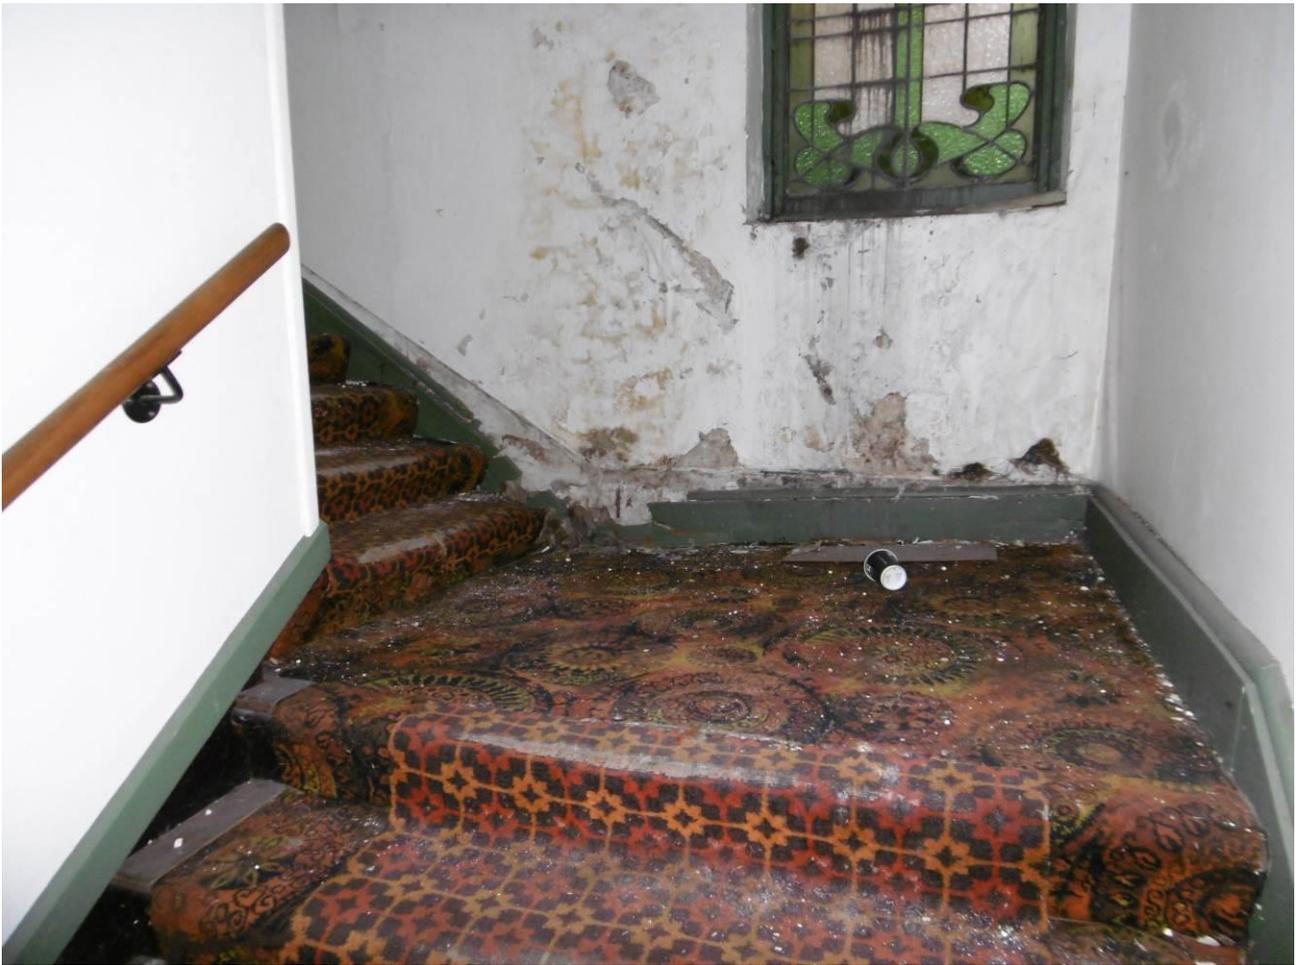
STAIRWELL TO UPPER FLOOR. THE LANDING HERE HAS ALSO COLLAPSED DUE TO ROT.

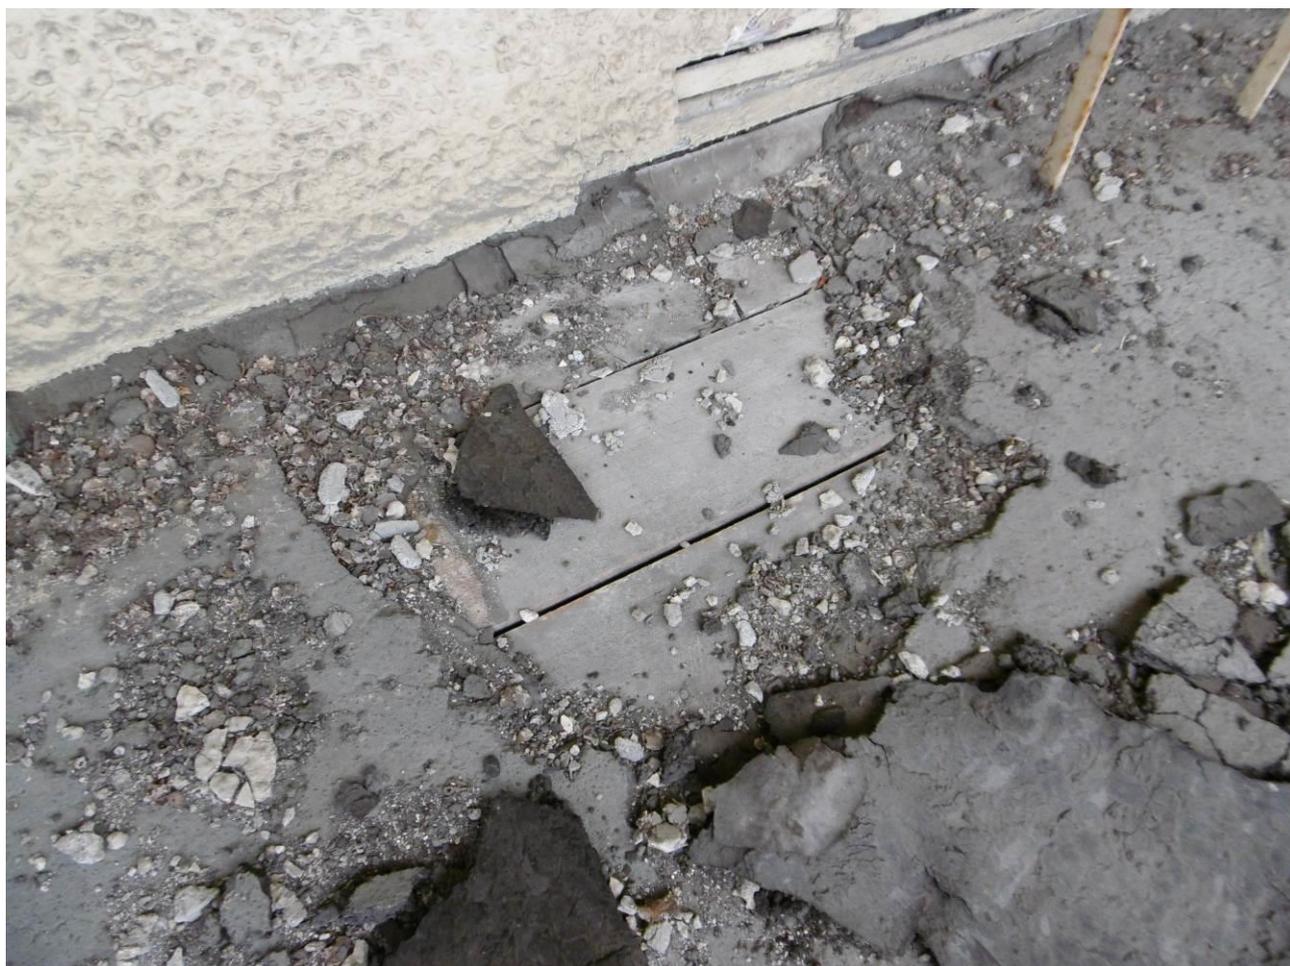
ASPHALT WATERPROOFING WHICH HAS DISINTERGRATED ON THE FIRST FLOOR BALCONY
