PRELIMINARY SITE INVESTIGATION

Hydro Hotel, Timaru

Report Number: 1540086-002-Rev0-PSI

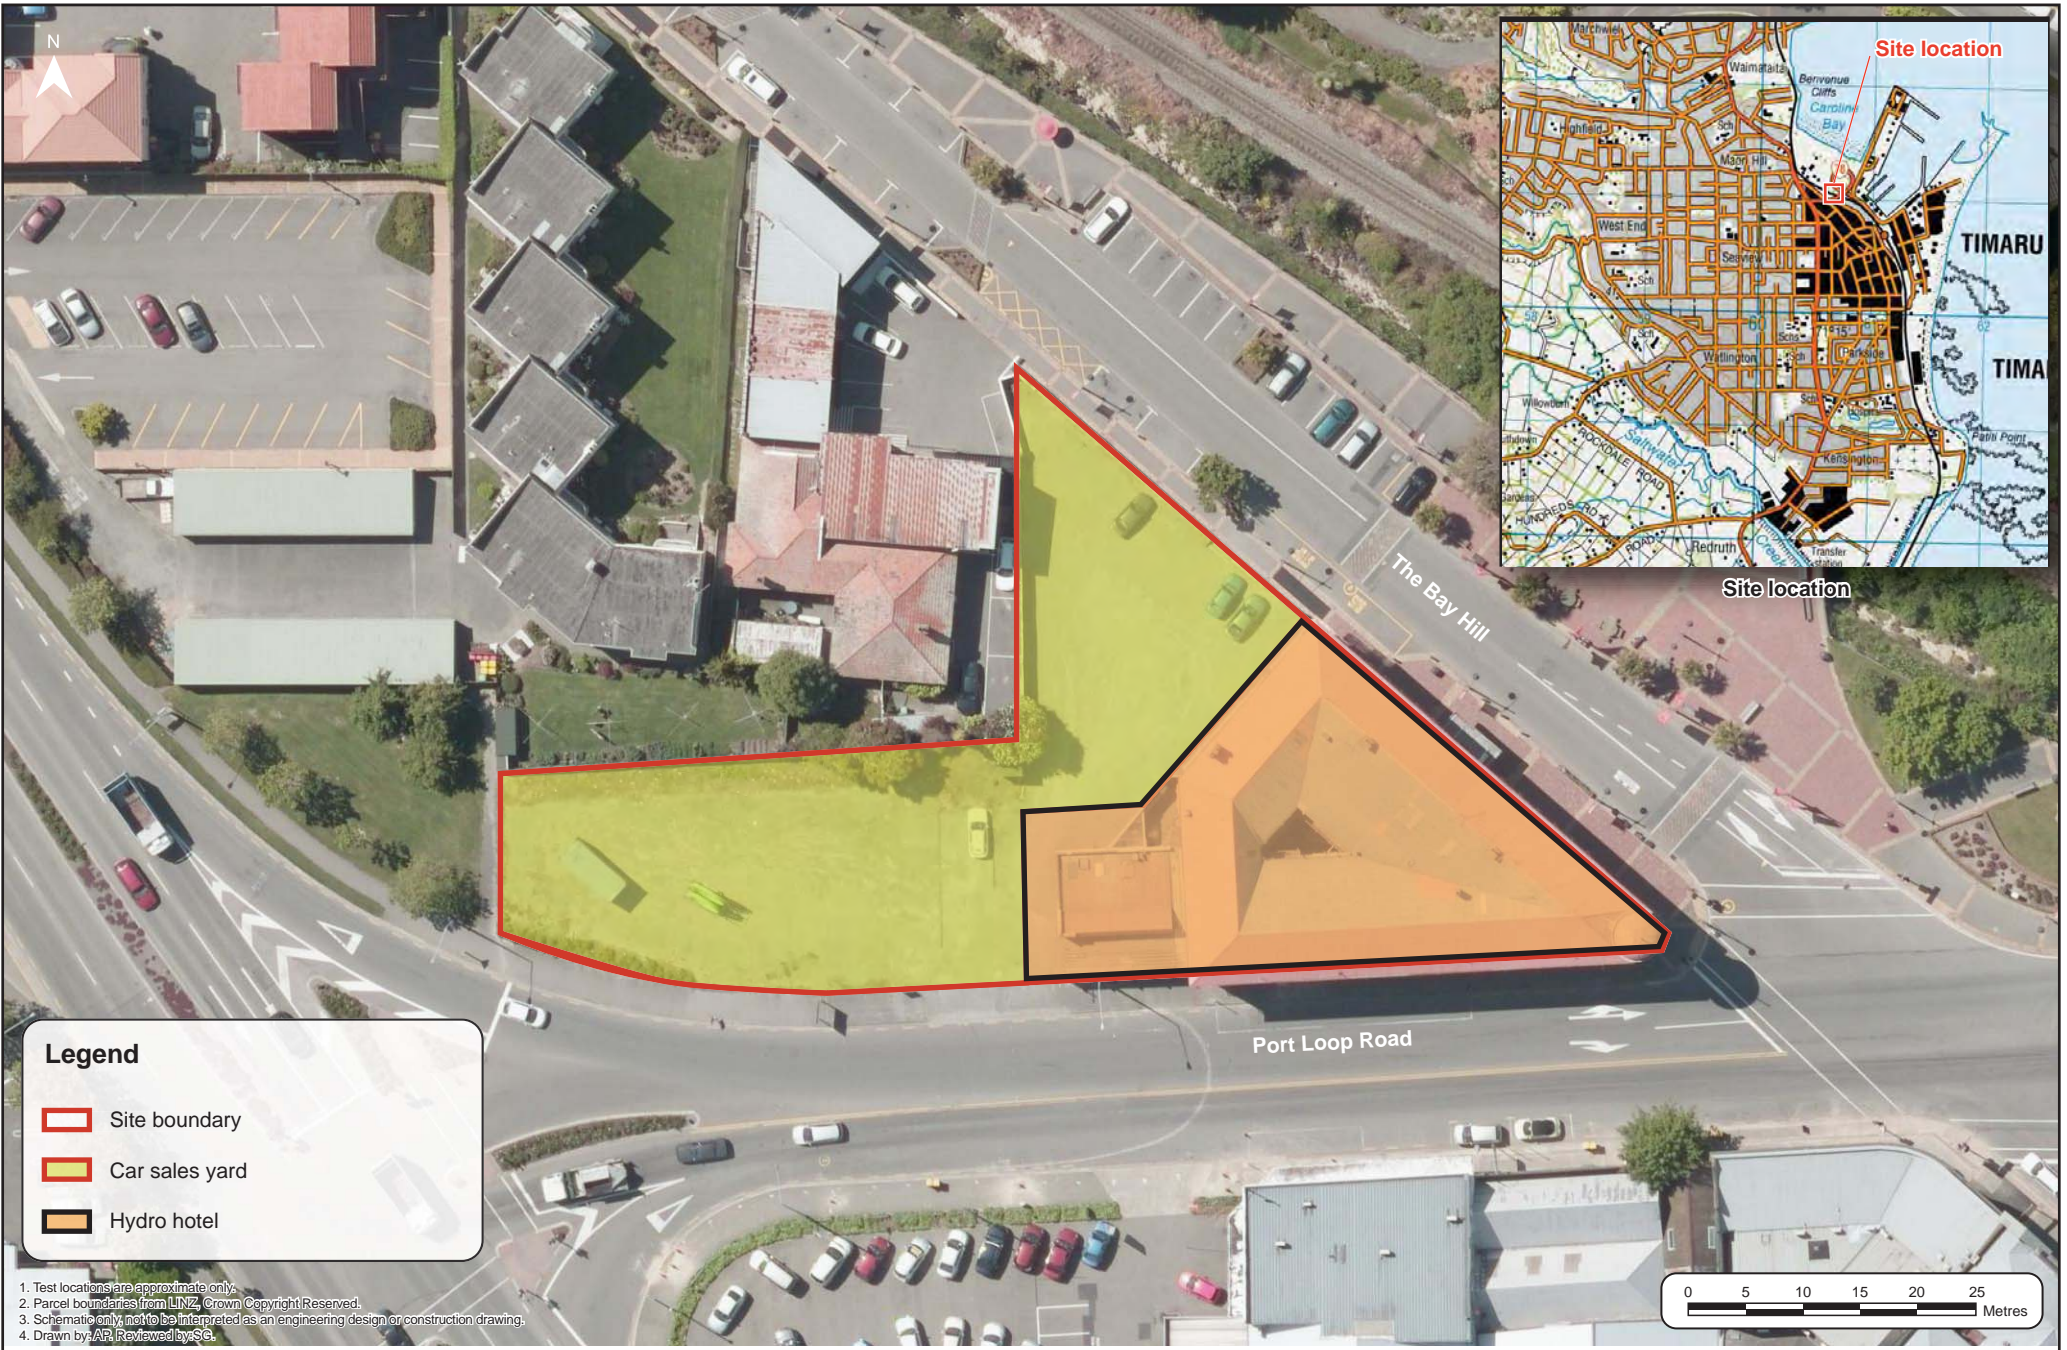
The site is located across at 10 and 16-26 The Bay Hill, Timaru, Canterbury (see Figure 1). The area of interest is approximately 2,600m² and consists of 4 Lots (Lot 3 DP 11427, Lot 2 DP 3530, Part Lot 3 DP 3530, and Part Lot 1 DP 3530).

The site lies at the intersection of The Bay Hill and Sefton Street East and is occupied by the derelict Hydro Hotel and a used car sales yard. The area surrounding the site is under mixed commercial and residential use; bars, cafes and apartments to the west; Caroline Bay Park and beach to the north and east; and car dealers and servicing to the south.

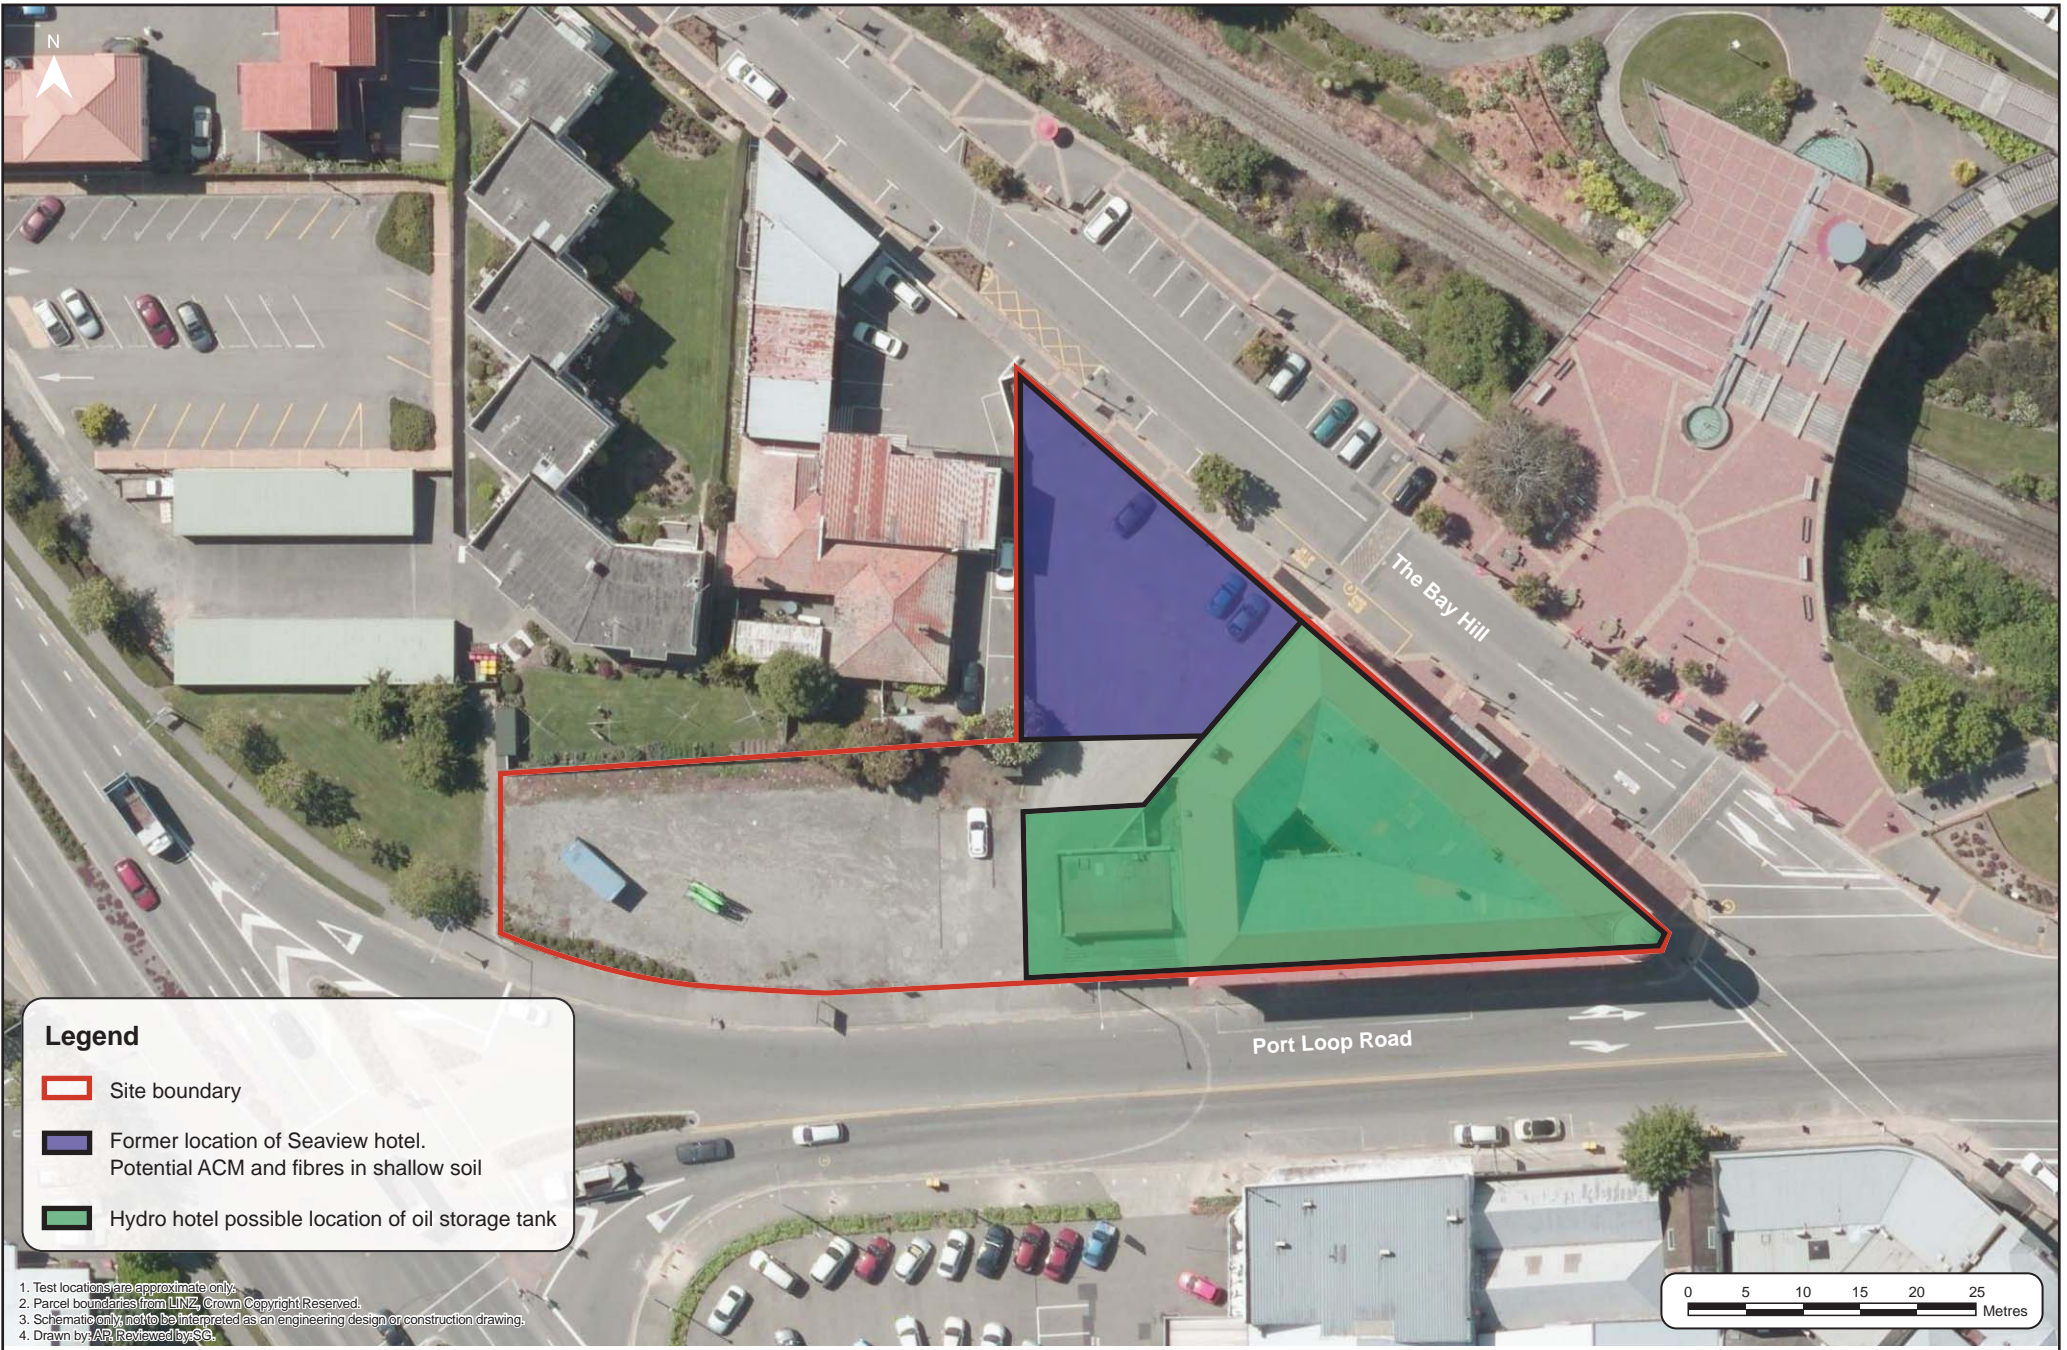
Based on a review of the information obtained from the TDC files, CRC resources, historical aerial photographs and the site walkover, a conceptual site model was developed for the site, see Figure 2 and Table 3.

Source	Contaminants of Concern	Pathway	Receptor
Soils in the footprint of the former Seaview Hotel	Asbestos (fibres from uncontrolled demolition).	Inhalation	Site workers
Soils impacted with leaks/spills from diesel/oil storage tank	Petroleum hydrocarbons	Ingestion and dermal contact	Site workers

- Soil samples are collected during the geotechnical investigations and assessed (visually) for the presence of ACM. If ACM is not observed then there is no cause to suspect that asbestos fibres would be present in site soils.
- During the survey of the Hydro Hotel, the likely presence or absence of the storage tank is confirmed. This would be achieved via detailed inspection of the annex area and any other areas considered to be a likely location for a storage tank. If necessary, the inspection could be complemented by use of Ground Penetrating Radar.

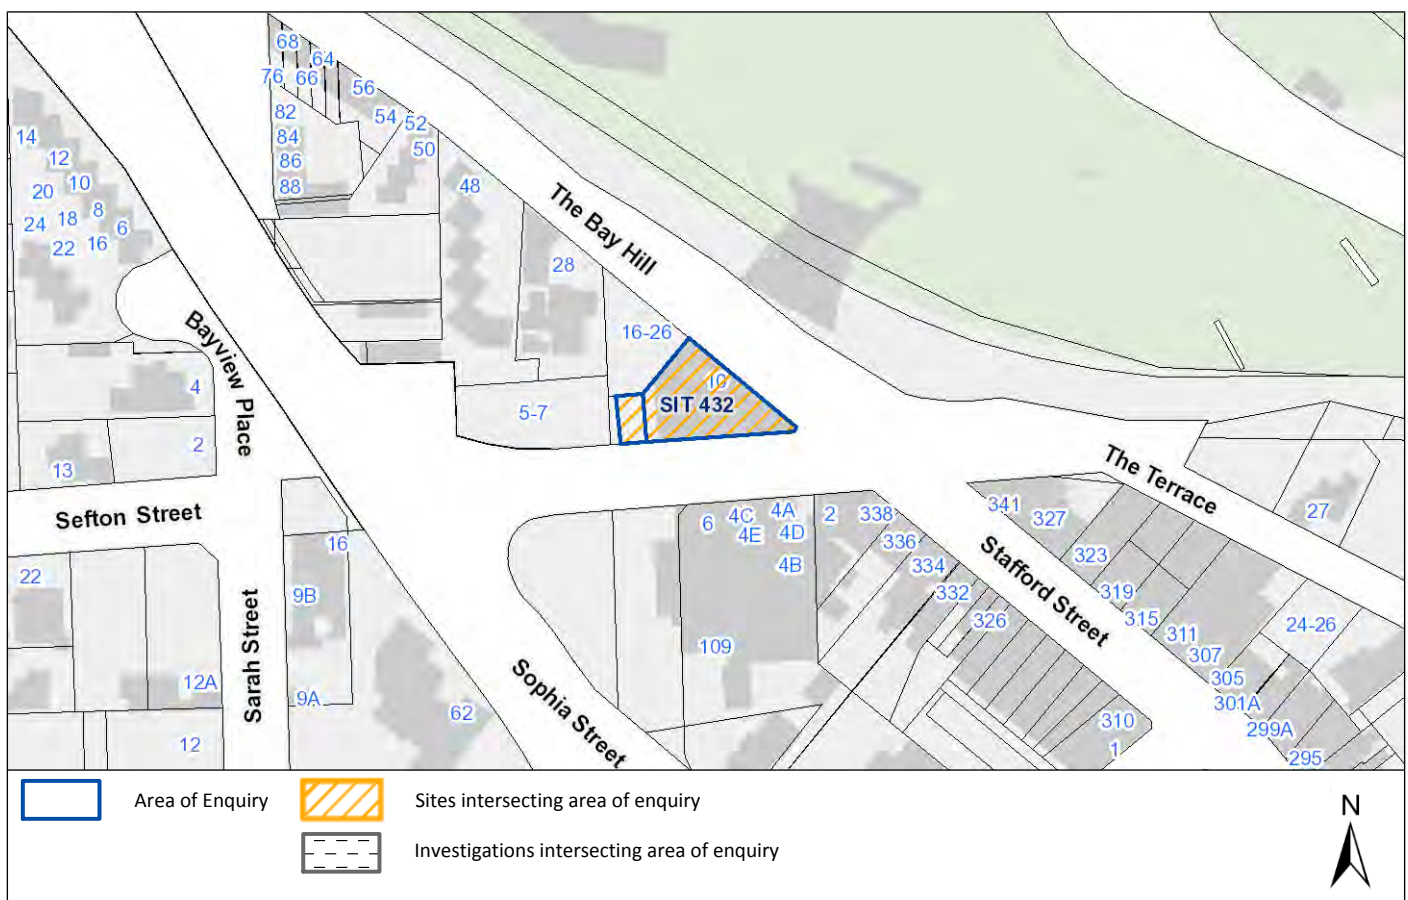
Date:	23 September 2015	
Land Parcels:	Part Lot 2 DP 3530	Valuation No(s): 2495042000
	Part Lot 3 DP 3530	Valuation No(s): 2495042000

The information presented in this map is specific to the property you have selected. Information on nearby properties may not be shown on this map, even if the property is visible.
