Approved Public Health Risk Management Plan

Timaru Drinking Water Supply

Timaru District Council

Public Health Risk Management Plan for the Timaru Drinking Water Supply

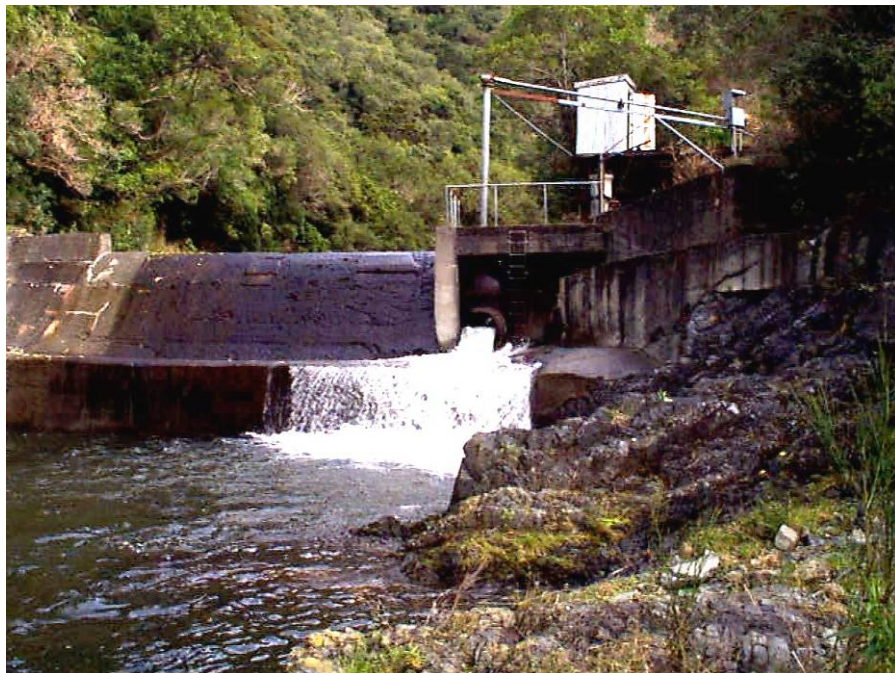
The intake consists of a 7m weir with a 25mm fixed screen on the true left (north) bank, then 18mm removable screen directly behind. There is a 750mm scour valve through the weir to drop the water level for maintenance. These screens are serviced as necessary by the operators, usually after a reduction in flow. These visits may be 6-8 weeks apart.

Intake weir with scour valve open

The weir was damaged in the 1986 floods and required reinstatement. The flood was assessed as a 100 year event. The weir was secured to the bedrock and is less likely to fail. The weir was inspected by a structural engineer in 2010.

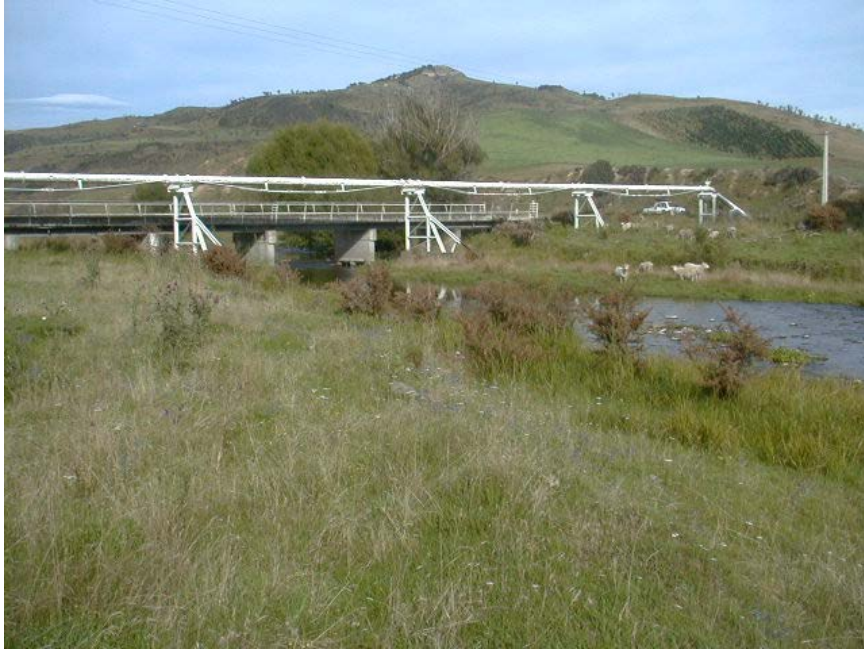
Several river crossings are above ground with the remainder of the pipeline buried.

Pareora Pipeline - Pipe Bridge

In 1986 a major flood (a 100 year event) occurred extensively damaging the top section of pipeline. The first several kilometers is AC pipe installed in 1986. This is now less vulnerable to flooding. However the Timaru District Council has the plant to set up emergency pumping directly into the pipeline if a similar event occurs.

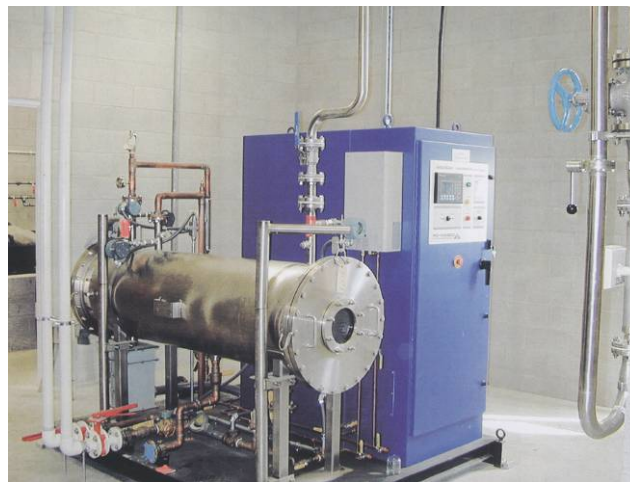
Two ozone generators convert the oxygen to an ozone oxygen mix. The design allowed for full redundancy, however both generators are now required to meet the Ct when the water is cold.

Ozone Generator

The ozone generator is serviced by the supplier under a maintenance contract every 3 months.

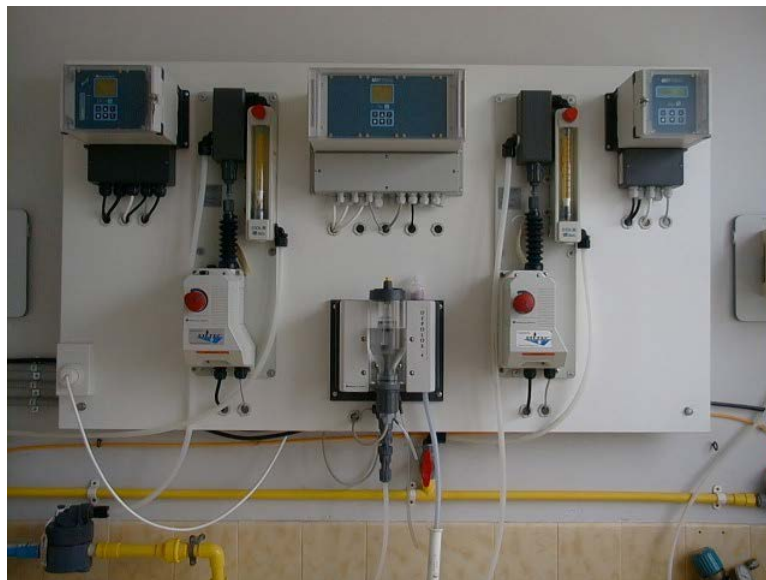
The water is dosed at $1\text{g}/\text{m}^3$ with chlorine gas and pumped to the Treated Water Reservoir for storage. The chlorine is purchased in 920kg drums,

Chlorination Equipment
