# Active Signs Trial

## Report

October 2005

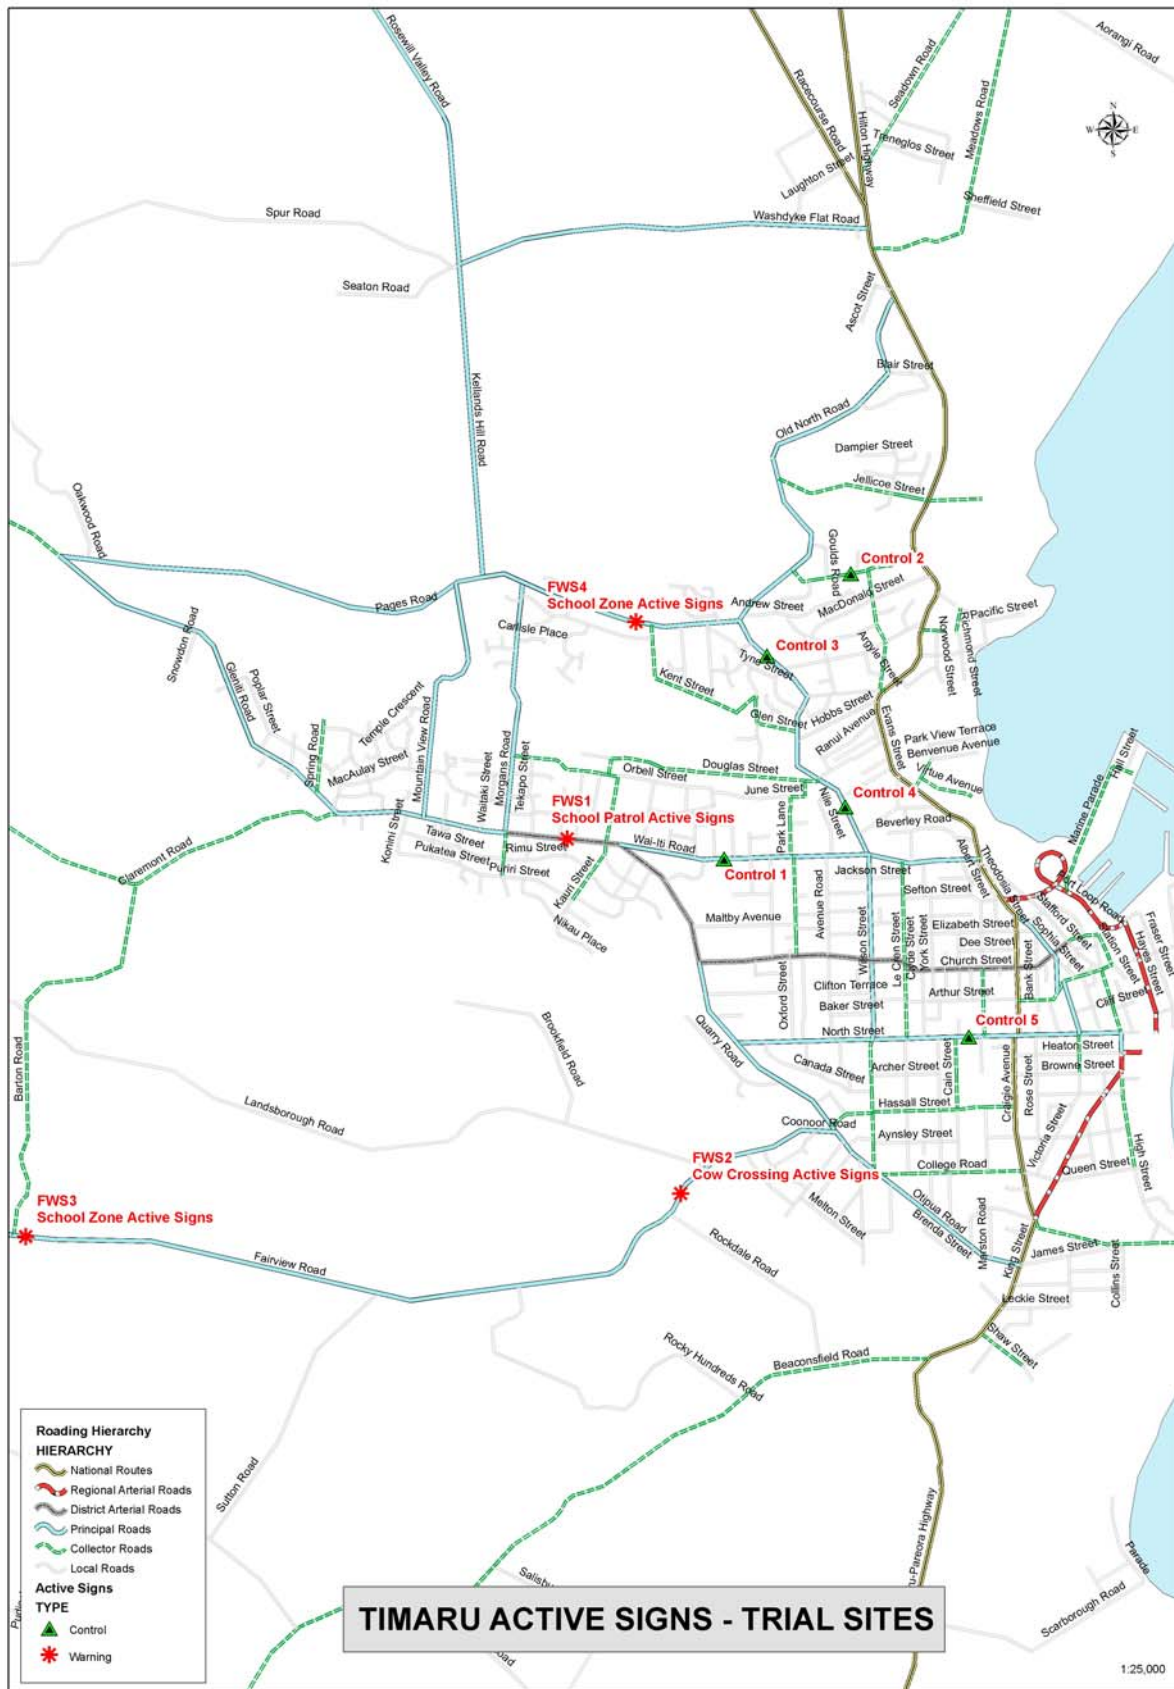
## **Pole Signs Installation**

All pole sign sites were installed using cable-less control and powered by solar panel. The batteries have 15 days life (based on normal usage).

All signs have a small light on the back of the sign to confirm that the signals are on or off. The signs also have a time-out facility that switches the signs off after an hour.

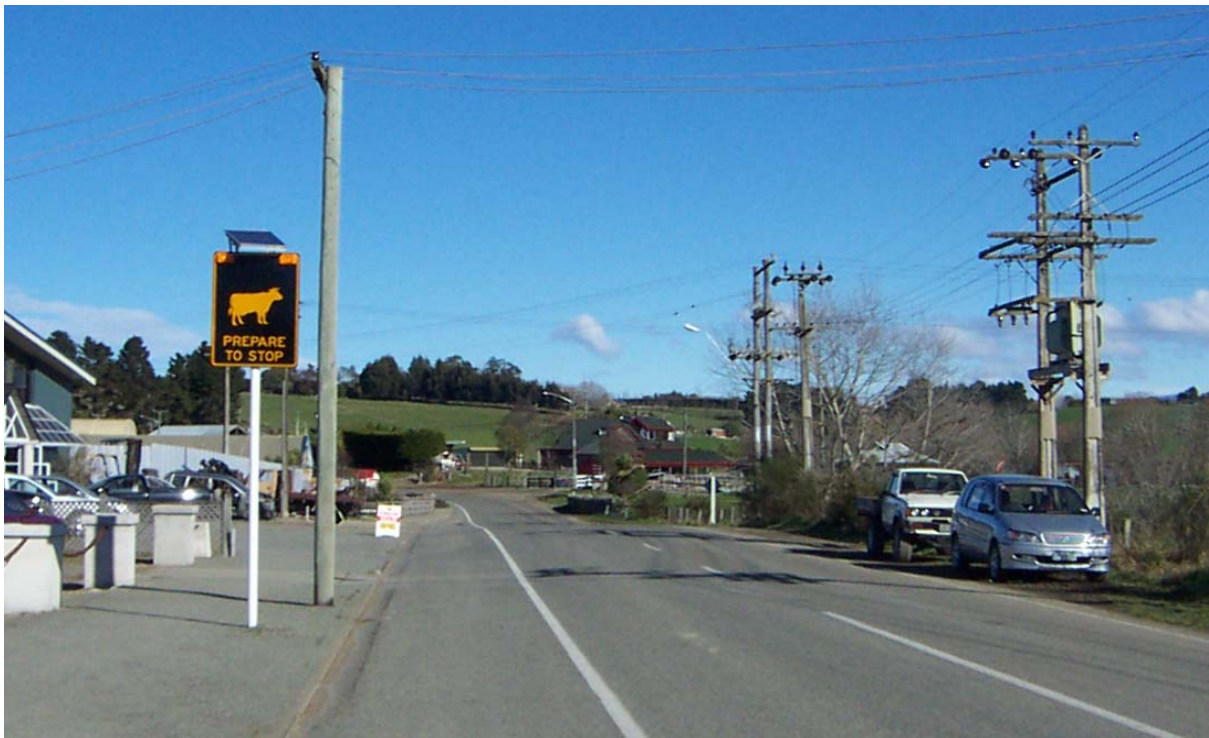
*Cow Crossing Coonoor Road*

Coonoor Road carries a traffic volume of 1425 vehicles per day and the crossing is in a 50km/hr speed limit zone with curves on both approaches. The active signs are located approximately 65m back from the crossing. Prior to the installation the farmer used a rotating beacon on a swing out pole and there were no pre-warning signs installed.

The signs are remotely activated by a switch located on the outside of the cow-shed building beside the road. A hand-held remote control was not required at this site.

The signs have been running successfully since their installation and the Council has received positive responses from the farmer and from road users. All signs have proven to be particularly visible in fog conditions.

The cost of the installation was \$7054 exclusive of GST.

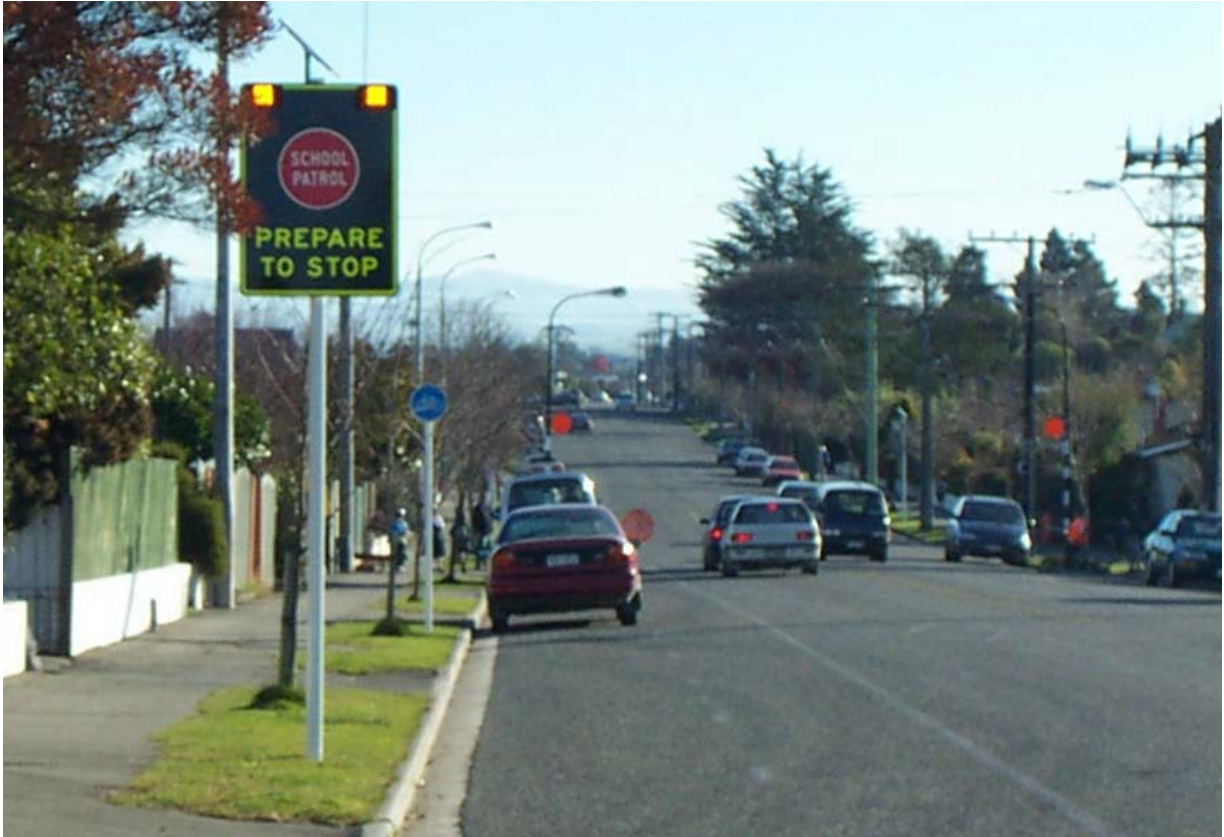
*School Patrol – Wai-iti Road*

The school patrol signs have been located 70m back from the zebra pedestrian crossing on Wai-iti Road. Wai-iti Road carries 11800 vehicles per day and is in a 50km/hr zone. Prior to the installation the site had flucal fold-open 'children crossing' signs.

The signs are turned on and off by means of a hand-held remote control.

The site is on a straight stretch of typical urban arterial road with trees in the grass berms. The road lies east-west and can be subjected to low sun for westbound traffic in winter in the afternoon. Cowls were installed to improve the conspicuity of the signals.

Comment received from the school is that the signs are very effective compared to the fold-out 'school crossing' type and in fog conditions.

The signs cost \$8688 a pair. Installation cost approximately \$600.

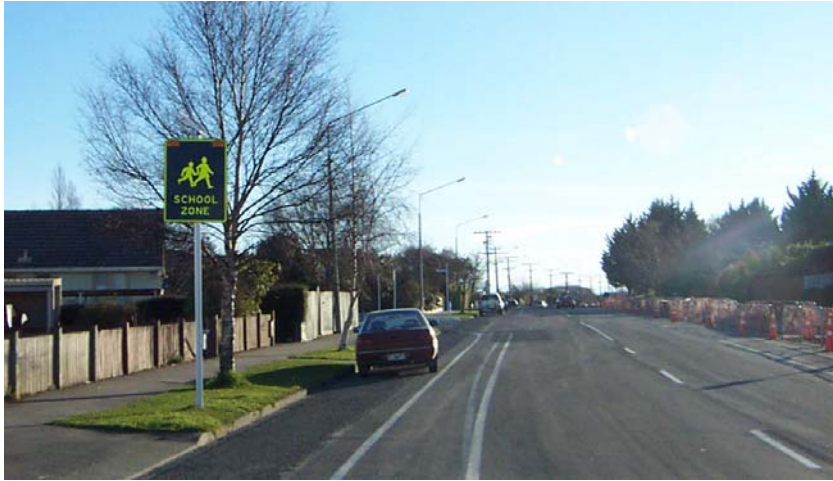
*School Zone – Pages Road*

Pages Road at Mountain View High School. This site is on an urban (50km/hr) arterial road carrying 3000 vehicles per day. There is a bend on the westbound approach to the school frontage and there is no pedestrian crossing at the school.

The signs are pre-programmed to flash in the morning and afternoon on each school day. Site 1 operates between 8:25am and 8:55am and between 3:25pm and 3:50pm. Site 2 operates between 8:30am and 9:00am and between 3:00pm and 3:20pm.

There is a manual over-ride remote control to turn the signals on or off if necessary.

Initially there were a few problems with the electronics, however these have been resolved. It is important that the times be programmed locally by a suitably experienced technician. Also, allow for daylight saving in the programming.

Regular checks on operation have been carried out including performance of the electronics. The signs cost \$8688 a pair. Installation cost approximately \$600 per site.

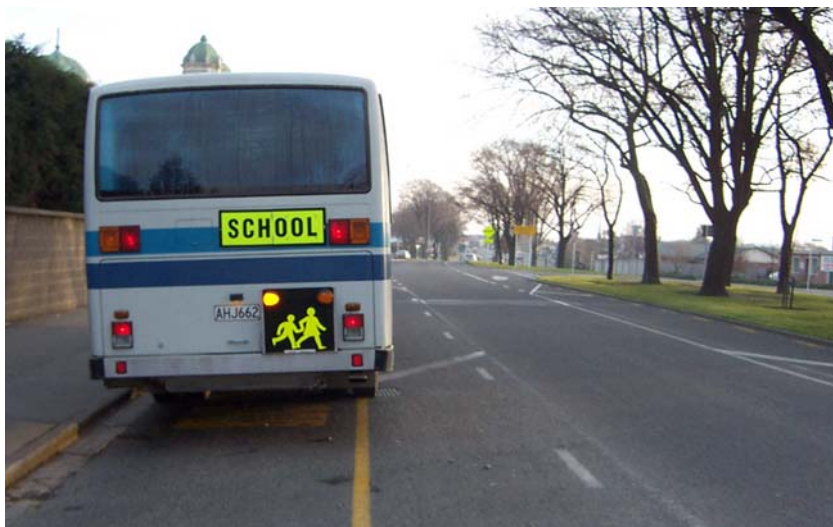
*School Bus Stopped*

Two school buses were fitted with the signs front and rear as shown. The ‘school’ signs were displayed alongside in some cases. The police commented that the flashing signs needed to be higher on the bus to be more effective.

The driver activates the signals when there is a need to slow traffic as the bus stops. Drivers noticed an improvement in traffic behaviour responding to the flashing signs. One driver advised that, on occasions, when the bus is leaving a stop, cars slow and let the bus in and this has improved over the period of the trial.

Metrocount classifier tubes were set out across the road and the bus was positioned on the side of the road over the counter.

Posted Limit	100		70		50	
	Mean	85%ile	Mean	85%ile	Mean	85%ile
<b>'School' Signs</b>	81	100	67	75	46	52
<b>New signs</b>	65	90	61	72	40	49
<b>Speed Reduction</b>	-16	-10	-6	-3	-6	-3

The speeds generally are surprisingly high with very little compliance with the 20km/hr limit as required by law. It is possible that, at the two 100km/hr zone sites, slowing to 20km/hr in such a traffic stream could be a dangerous exercise in itself as following vehicles may attempt to overtake.
