AGENDA

Infrastructure Committee Meeting Tuesday, 12 March 2024

Timaru District Council

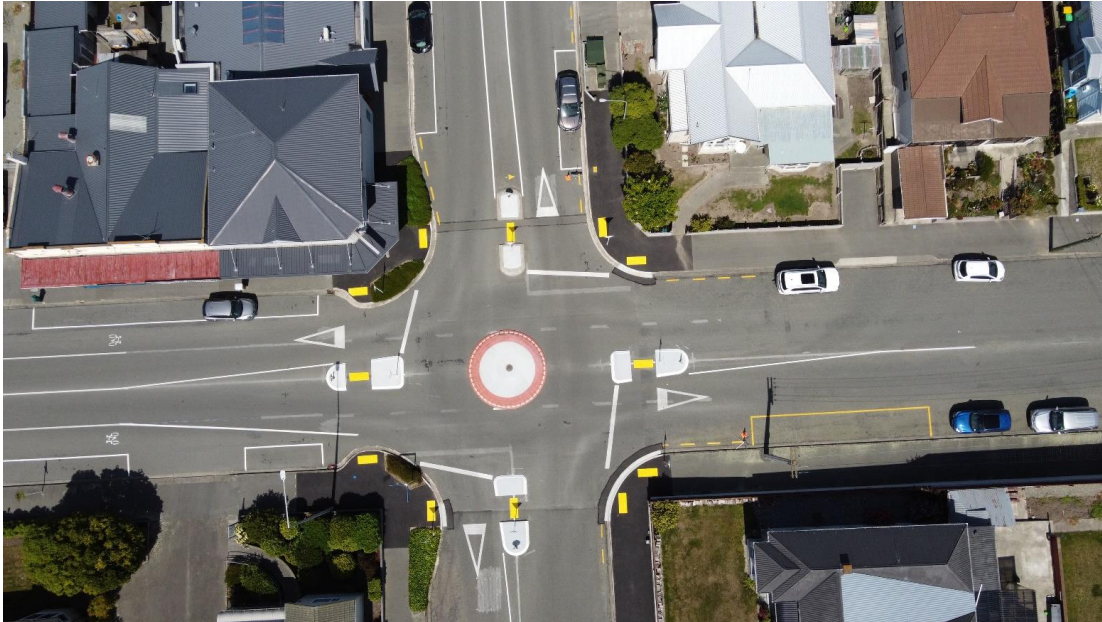
Hassall and Harper Street Roundabout

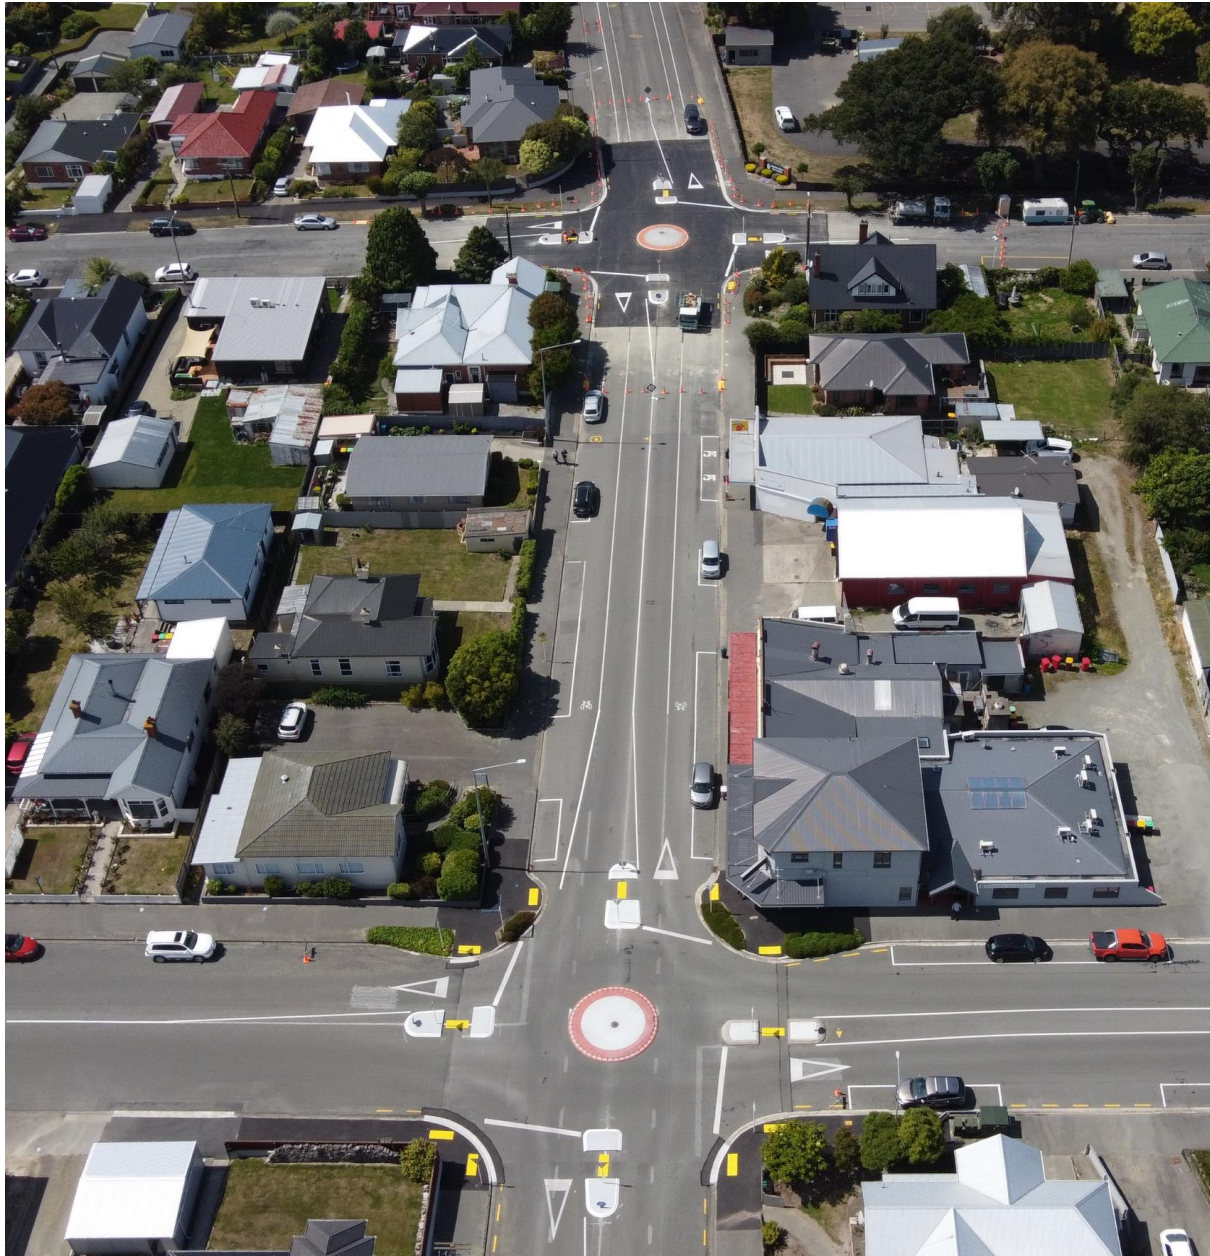
Route Improvement Hassall Street

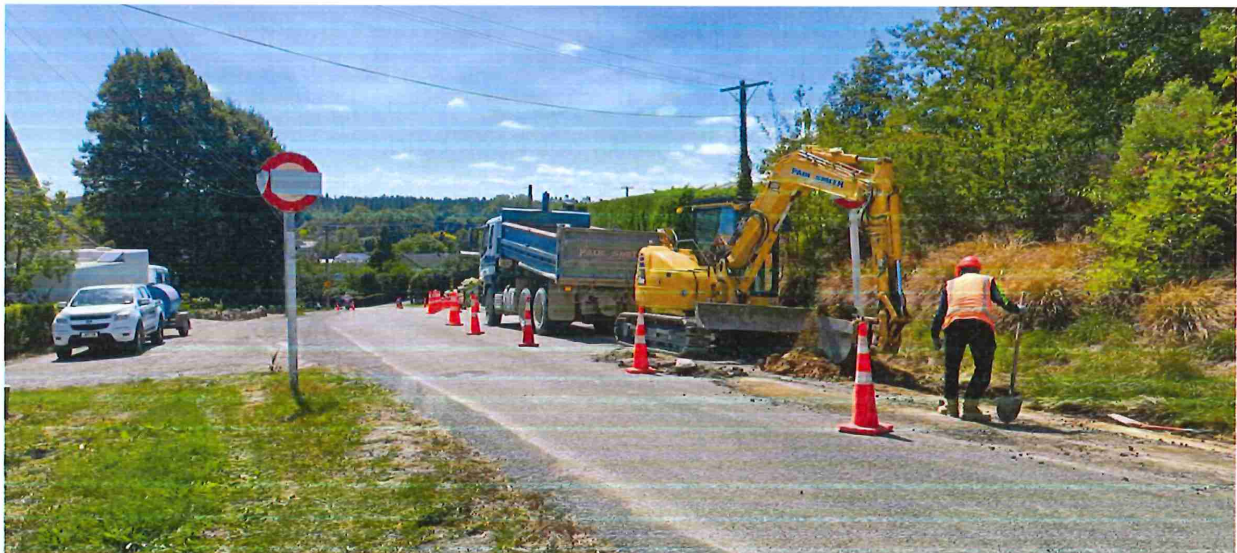
Construction in Progress – Manse Road, February 2024

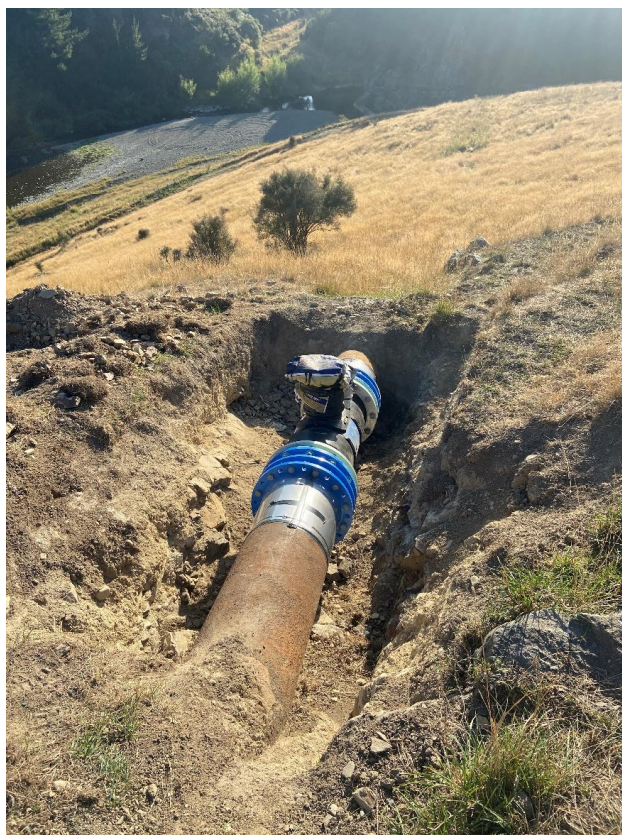
Contract 2469– Pareora Pipeline Renewal Section 2

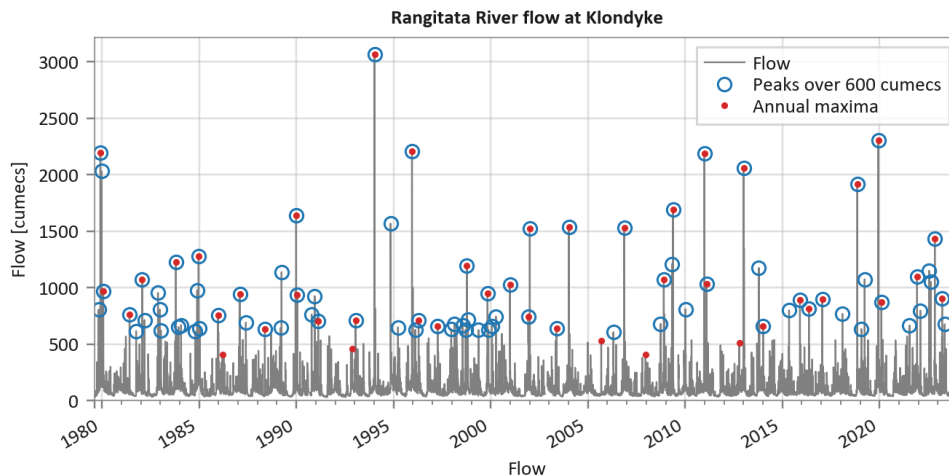
An overview of historical flow records dating back to 1980 is shown below in Figure 1. Annual maxima flow peaks and flow peaks over 600 cumecs are indicated by dots and circles respectively. It should be noted that one cumec is equal to one cubic meter of water flowing past a point in one second (m³/s).

Figure 1: Historical flows with indicated annual maxima flow and flow peaks over 600 cumecs

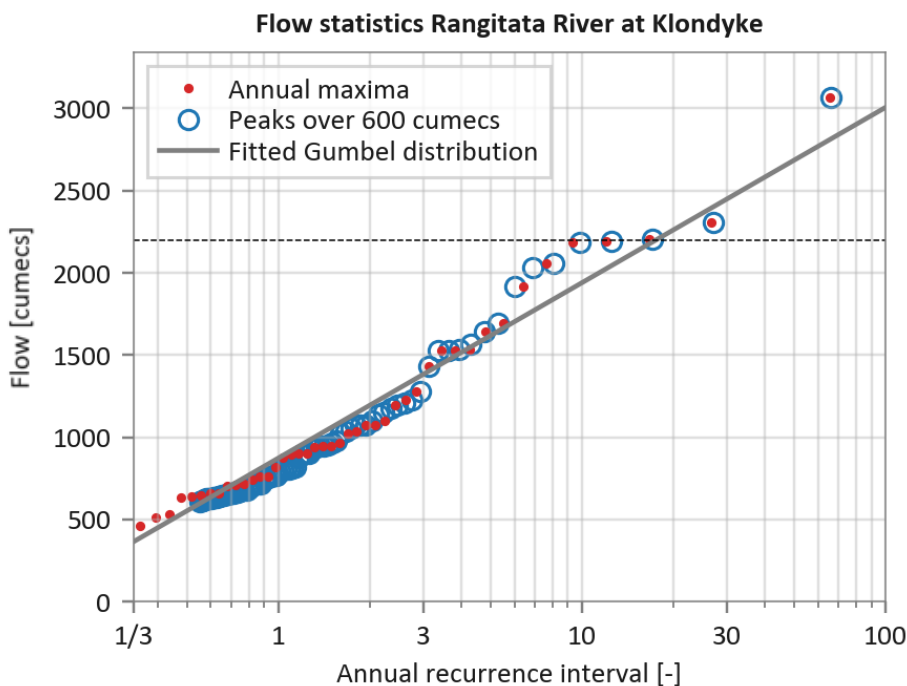
The annual maxima flow peaks and flow peaks over 600 cumecs can be used to fit a discharge and annual recurrence interval distribution graph. Figure 2 below shows both sets of flow statistics empirically plotted with a fitted Gumbel extreme value distribution to derive exceedance frequencies of the plotted events.

Figure 2: Empirical Flow Statistics and Fitted Gumbel Distribution

Table 2 below presents flow statistics with corresponding recurrence intervals that have been derived from the distribution shown in Figure 2. The first column gives the annual recurrence interval (ARI), which is the average time in between flood events that exceed the given flow. The annual exceedance

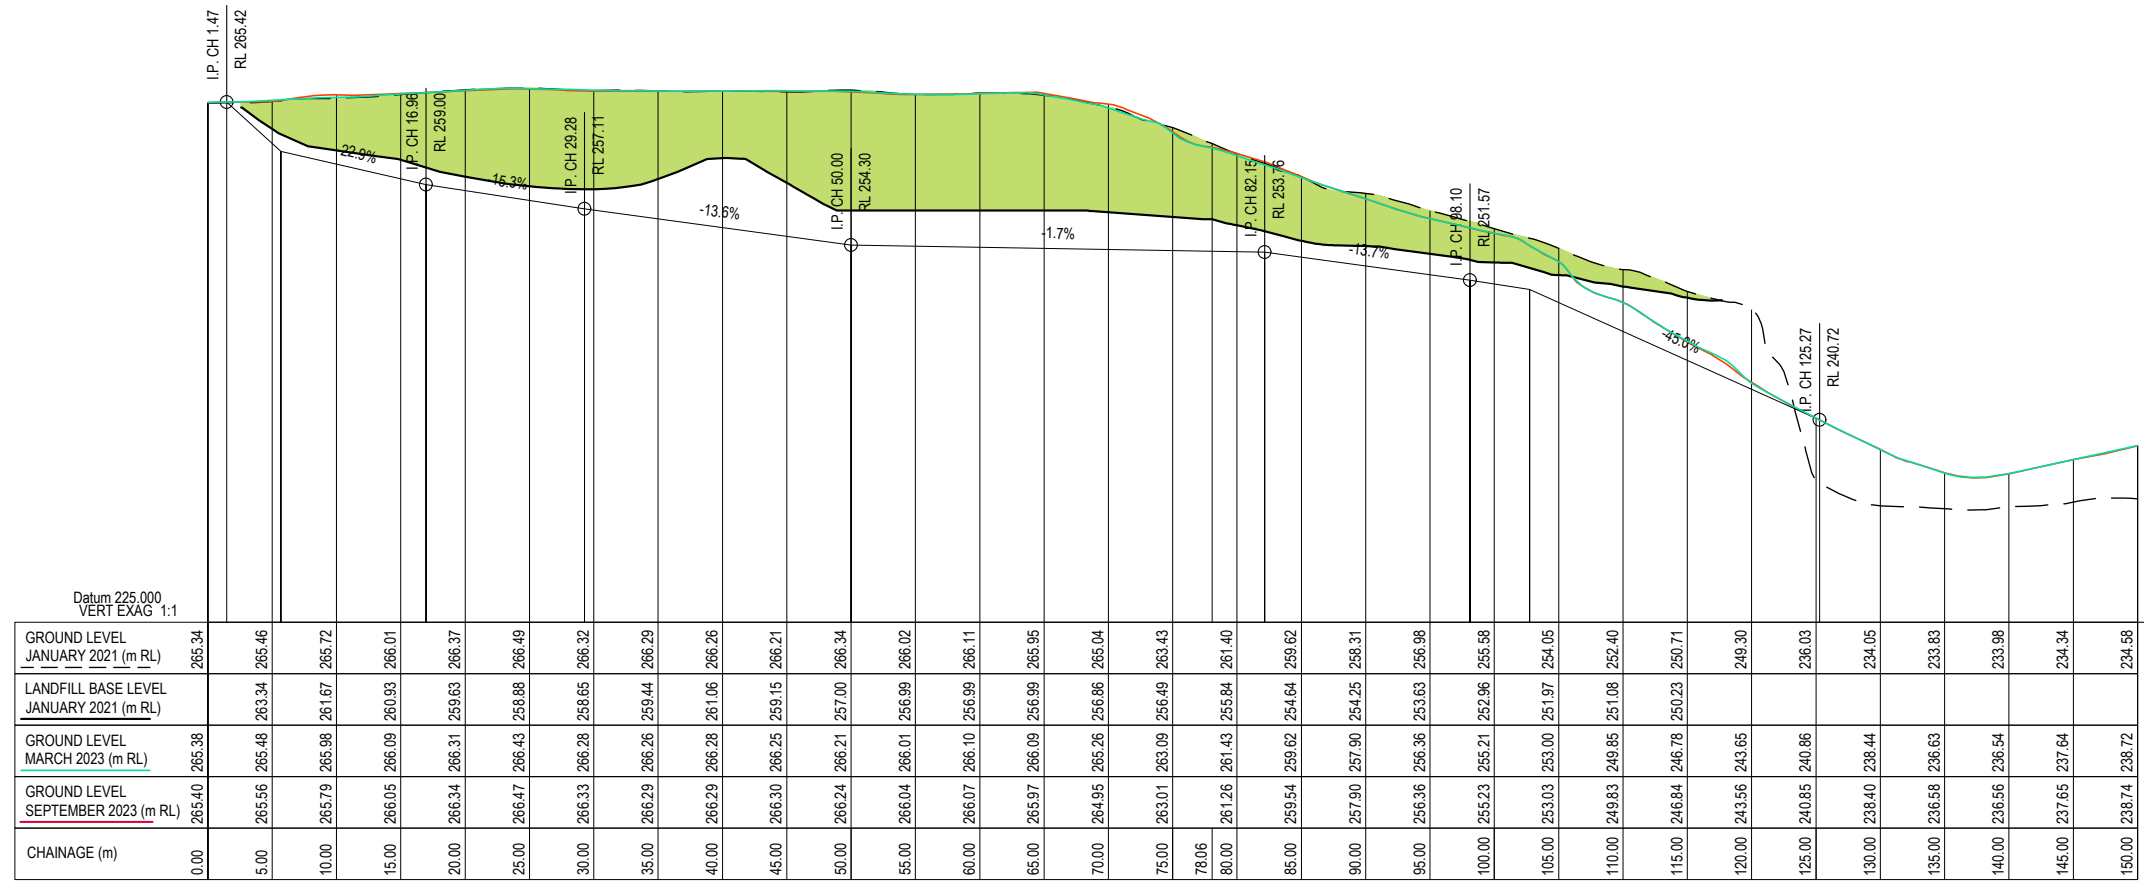
SECTION A
SCALE 1:500

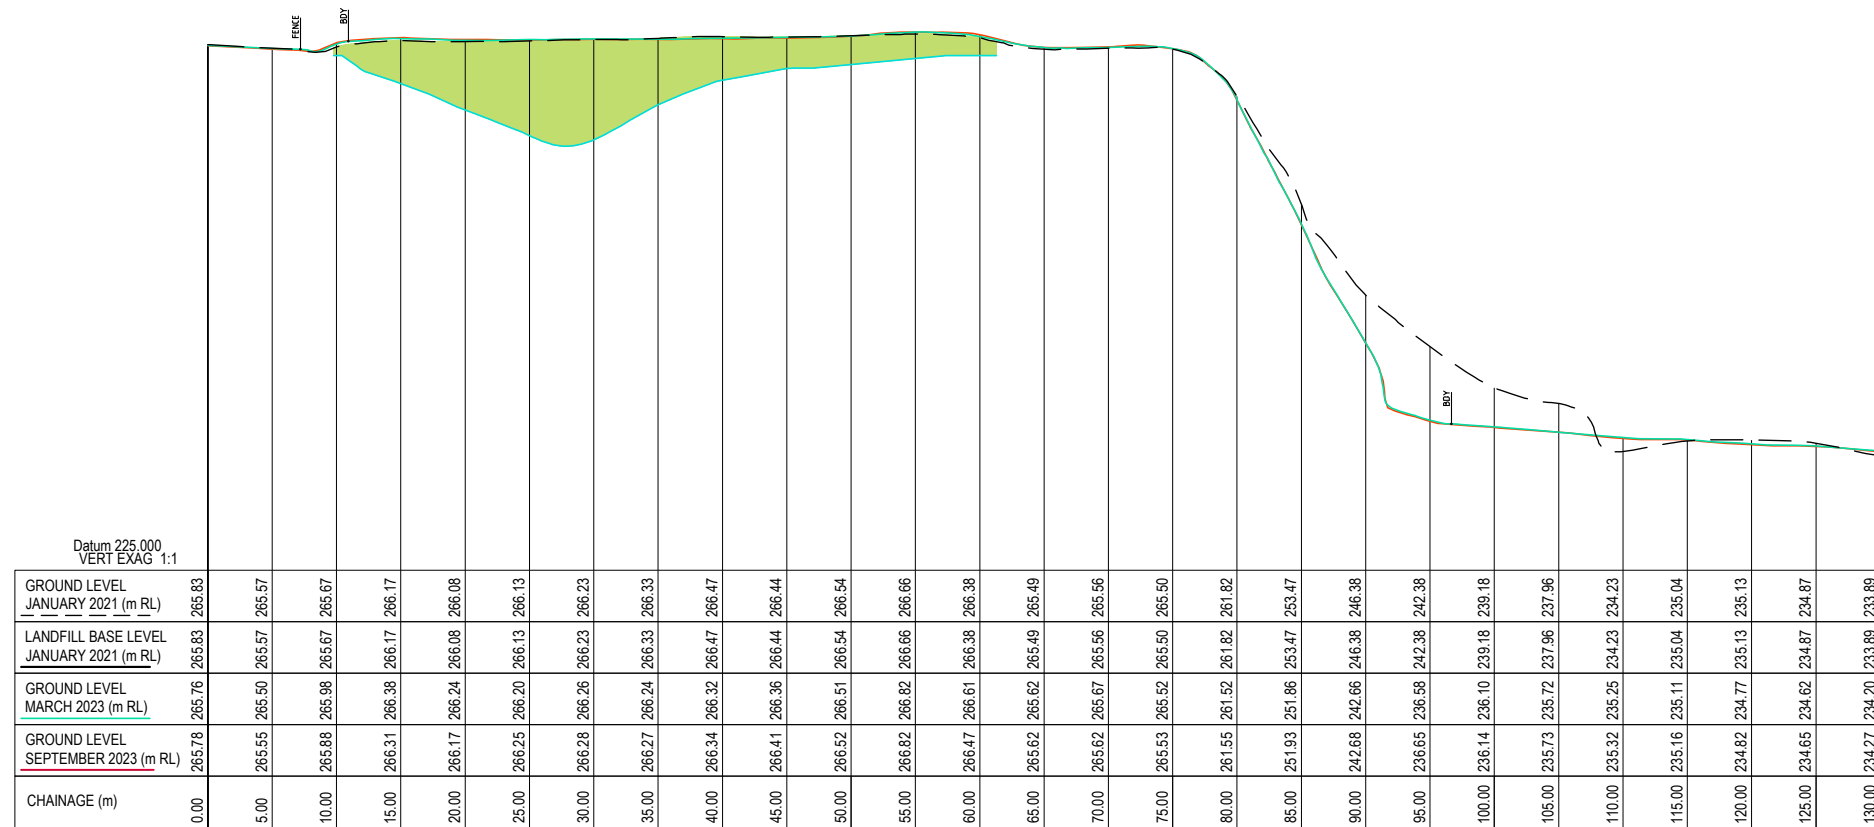
SECTION D
SCALE 1:500

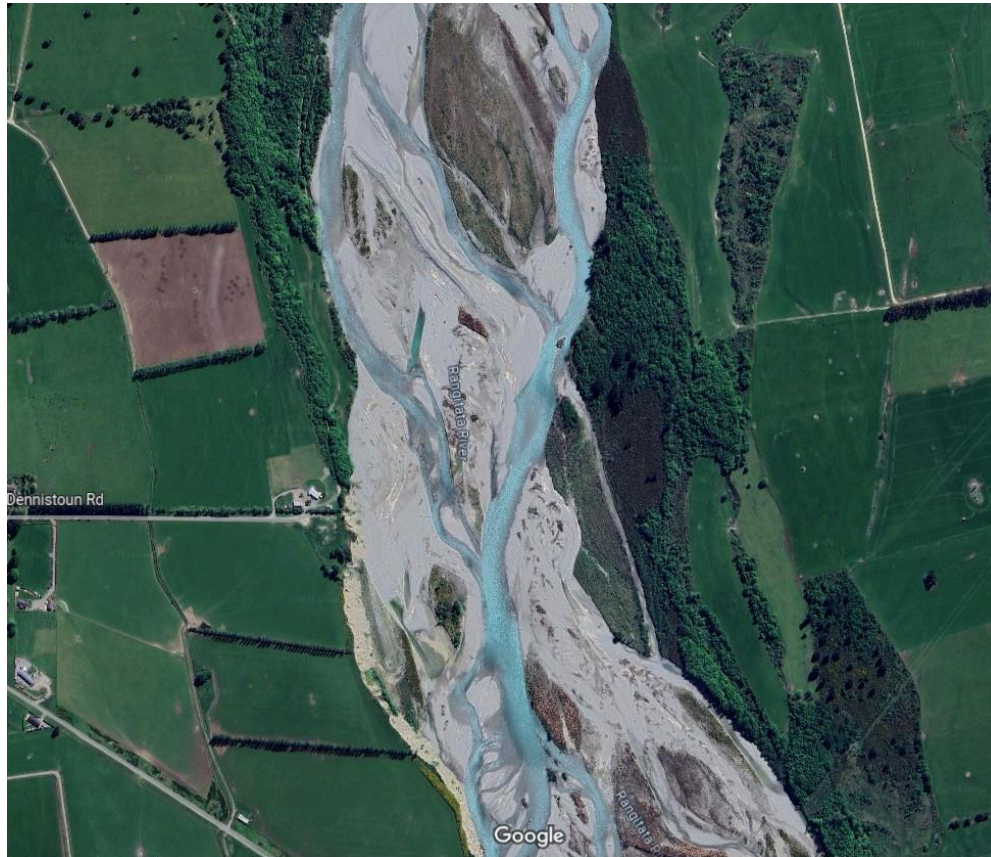
Aerial photograph showing channel alignment changes and in-river guide banks (google maps).

Following the December 2019 Rangitata River flood event, and subsequent smaller floods, significant river management works have been undertaken to reduce the risk of erosion and flooding damage to the Peel Forest landfill. These works include use of gravel guide banks within the river, channel diversion works, gravel fill, and some planting, all of which are intended to guide flood flows away from the terrace edge on which the landfill sits and reduce potential for erosion of that site.

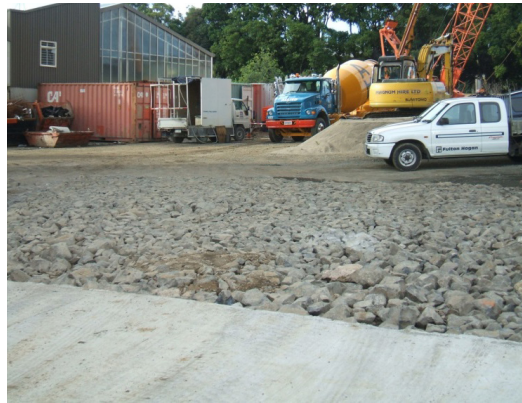
CHECKLIST 5
FIGURES: Stabilised entranceway

Stabilised entranceway (Source: SouthernSkies)

Stabilised entranceway
