**General distribution and characteristics of
active faults and folds in the Timaru District,
South Canterbury**

D.J.A. Barrell

GNS Science Consultancy Report 2014/308
Environment Canterbury Report No. R15/112
December 2016

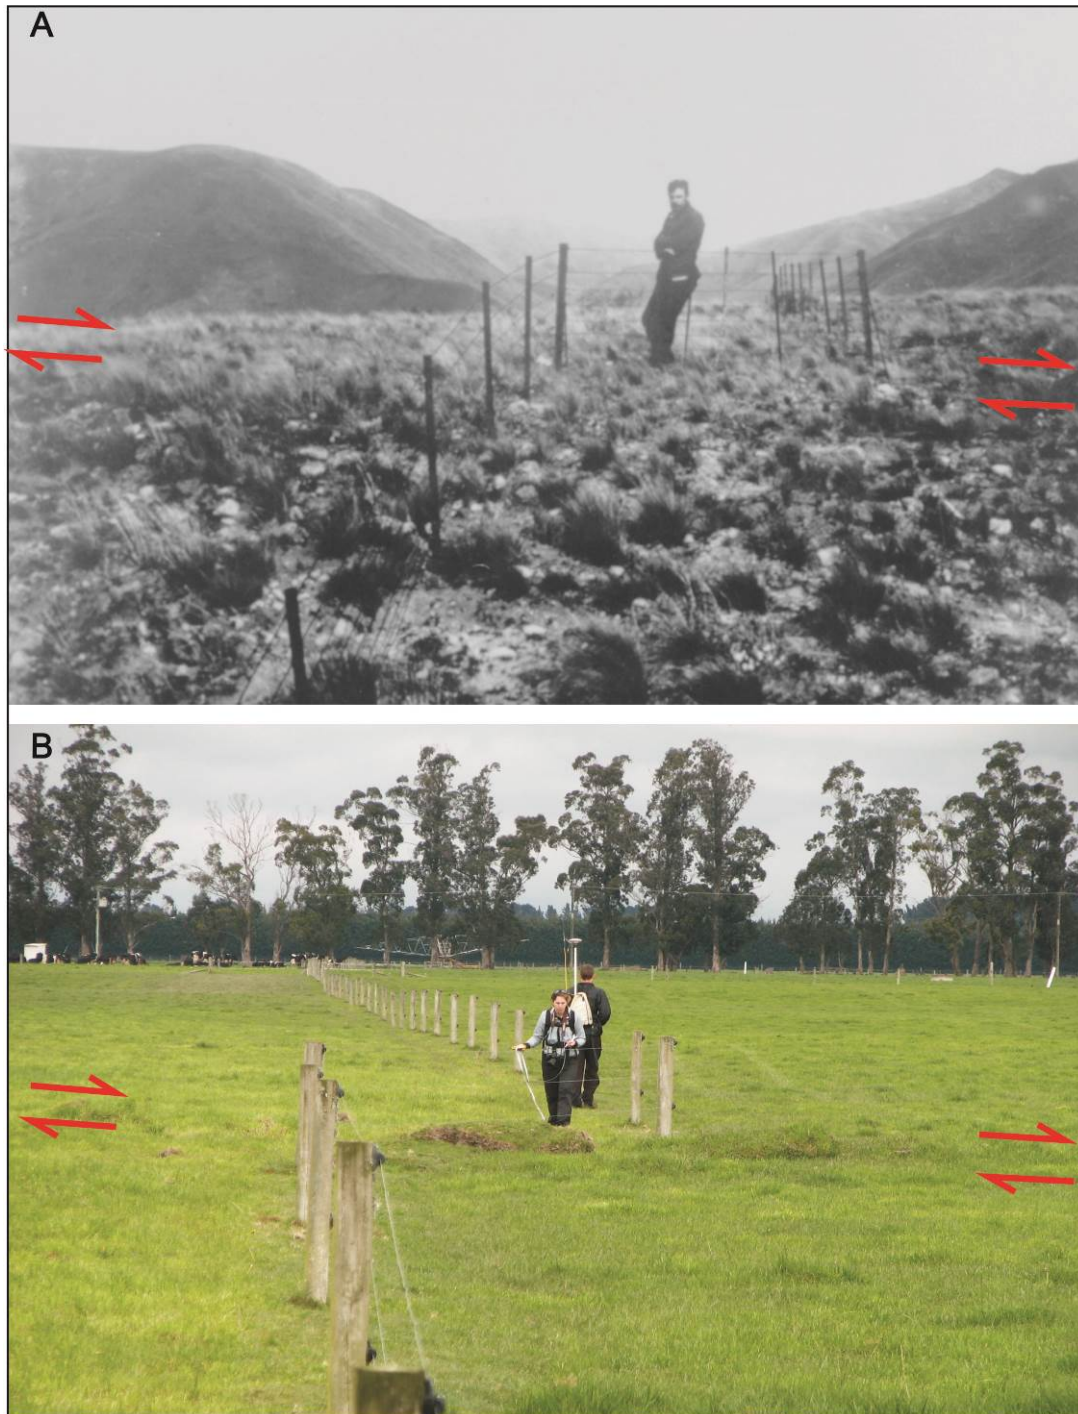
Figure 1.2 Illustrations of historical fault offsets of the ground surface in the Canterbury region. **A:** A fence offset sideways by ~2.4 m of strike-slip rupture on the Hope Fault at Glynn Wye during the 1888 North Canterbury Earthquake (Photo: A. McKay, GNS Science CN4852). **B:** A fence offset sideways by ~4.5 m of strike-slip rupture on the Greendale Fault during the 2010 Darfield Earthquake (Photo: N. J. Litchfield). Half-arrows either side of the fault indicate the direction of movement. In both cases, the movement is 'right-lateral', sometimes called 'dextral'. This means that to an observer, the ground on the far side of the fault has shifted sideways to the right. The effect is the same regardless of which side of the fault the observer is standing. The other type of strike-slip movement is 'left-lateral', sometimes called 'sinistral', but is not common in New Zealand.

Although the movement along the plate boundary is continuous over geological time, and can be measured by ground and satellite (GPS) surveying, rock of the Earth's crust is remarkably elastic and can accommodate a lot of bending before letting go and breaking suddenly (rupturing) along a fault, causing an earthquake. On large faults, the break may be big, and extend up to the Earth's surface, causing sudden offset and breakage (faulting), and/or buckling and warping (folding), of the ground surface, accompanied by a large earthquake. The 2010 Darfield Earthquake provided a good example of the nature and effects of a large, ground-surface-rupturing earthquake on a geological fault (e.g., Barrell et al. 2011; Villamor et al. 2011) (Figure 1.2).

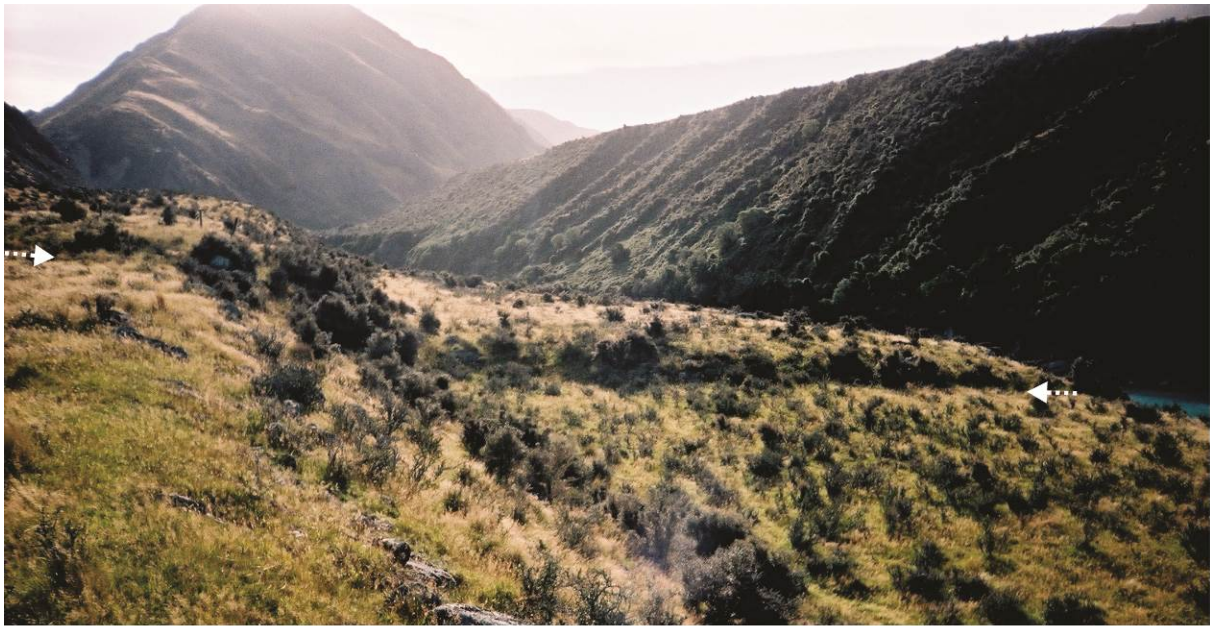
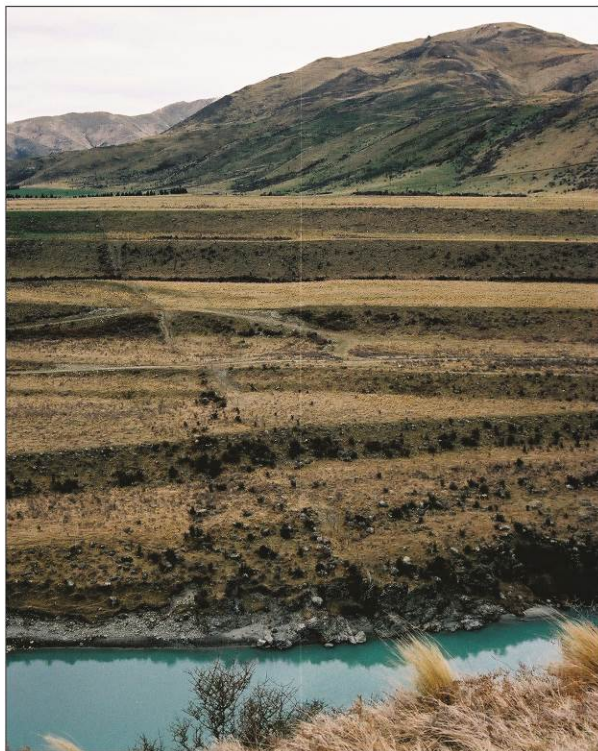
Figure 3.1 The ground surface expression of the Klondyke-Moorhouse fault (feature 9 in Appendix 2; Figure 5.1) across a flight of river terraces on the south bank of the Rangitata River (Timaru District) opposite the Rangitata Diversion Race intake at Klondyke (in Ashburton District). Upper photo: Looking northwest (upstream), the fault scarp is about 2 m high and runs left to right between white arrows, across the two lowest terrace levels. Lower photos: Looking southwest, the fault (solid white line = crest, dotted = base) becomes broader and less well defined on the higher terraces, transforming into a monoclinical fold (dashed line = crest). Black lines mark the river-ward edge of each terrace level. For reference, arrows are placed in the same positions as seen in the upper photo. This fault was first reported by Speight (1941), first depicted on a geological map by Gair (1967). In the GIS dataset (Cox & Barrell 2007; Heron 2014), the feature is classified as a fault, because its extent is too limited, on regional-scale geological maps, to segregate the fault and fold components. The Klondyke-Moorhouse fault is described in more detail by Barrell et al. (1996), and also mentioned by Barrell & Strong (2009). Photos: D.J.A. Barrell, taken 1995.

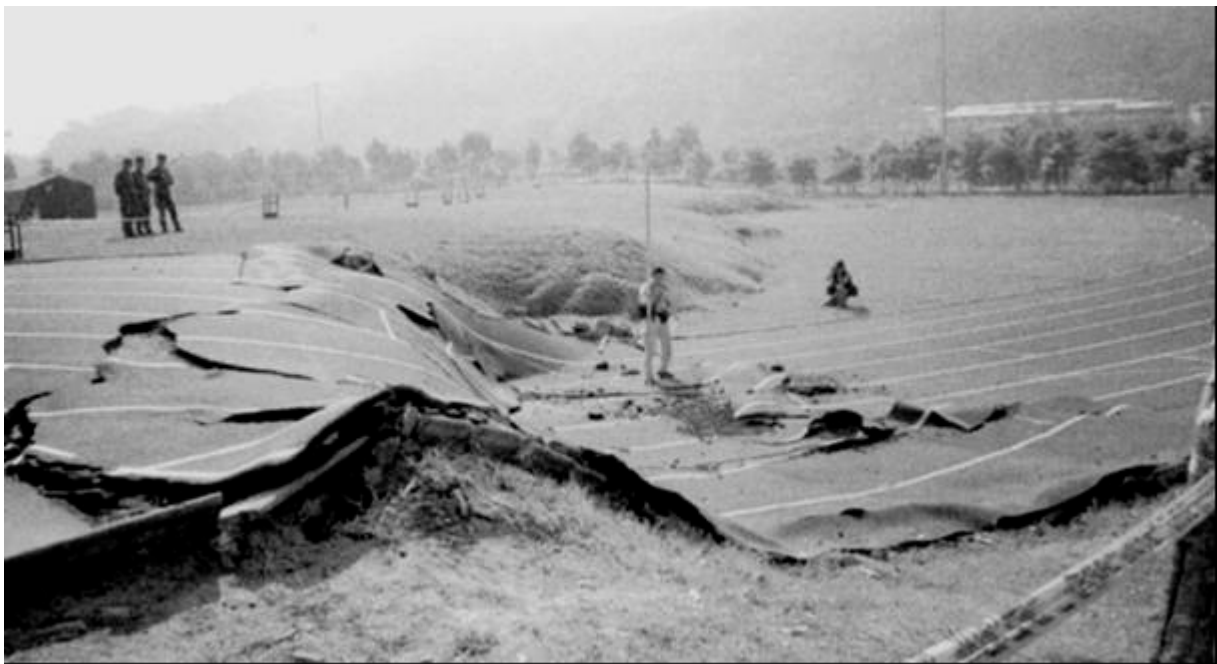
Figure 6.1 Fault scarp formed on the Chelungpu Fault during the magnitude 7.6 Chi-Chi Earthquake, Taiwan, 1999. The disrupted running track shows damage typical of a reverse fault ground-surface rupture, which is well expressed on the brittle surface (note the smoother rupture across grass behind). This location lies on a stream terrace that is younger than the previous rupture event on the fault, so that there was no scarp here before the earthquake. This example illustrates the sorts of effects that can be expected across fault scarps in the Timaru District the next time any particular fault experiences a surface rupture earthquake. Photo from Kelson et al. (2001).

Figure 6.1 illustrates an example of the ground-surface deformation hazards associated with active faults or active monoclines, noting that at any location, elements of both faulting and folding may be present within a deformation zone. In general, faults and monoclines present the most focused forms of ground deformation, in regard to direct rupture or significant tilting of the ground surface. Such effects will occur in a sudden event. The presence of active folds indicates that there may be an underlying active fault at depth that may generate a local, large, shallow earthquake, were it to rupture.
