Community Services Committee Meeting Tuesday, 26 November 2019

6.4 Aigantighe Art Gallery Strengthening Project - Interim Progress Report November 2019**Author:** Hamish Pettengell, Acting Art Gallery Manager**Authoriser:** Sharon Taylor, Group Manager Community Services**Recommendation**

**SHALLOW GEOTECHNICAL INVESTIGATION AND FOUNDATION ASSESSMENT:
AIGANTIGHE ART GALLERY, 49 WAI-ITI ROAD, TIMARU (LOTS 1 – 3 DP 1717 & LOT 31 DP
1493)**

Heritage Assessment
Aigantighe Art Gallery, Timaru
July 2019

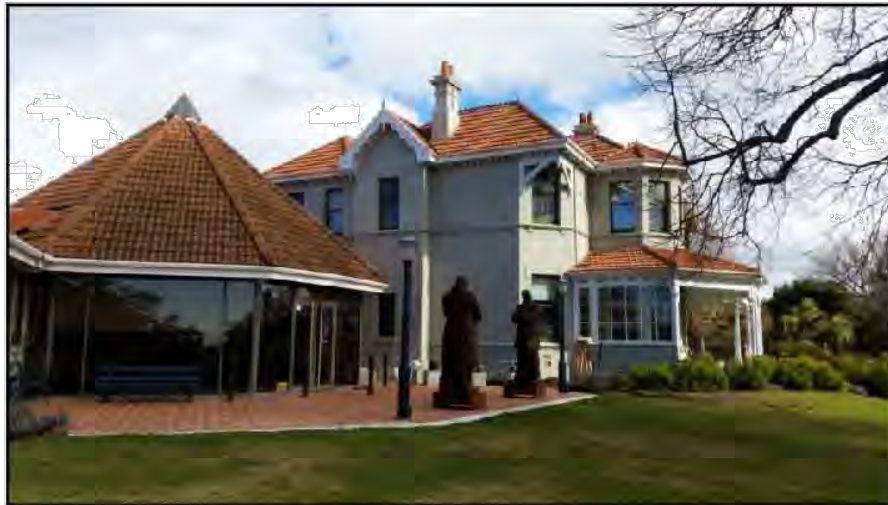
Figure 2: View to the south of the Aigantighe Art Gallery original (1908) two storey building and part single storey, 1978 extension. Photo taken 21/08/2019.

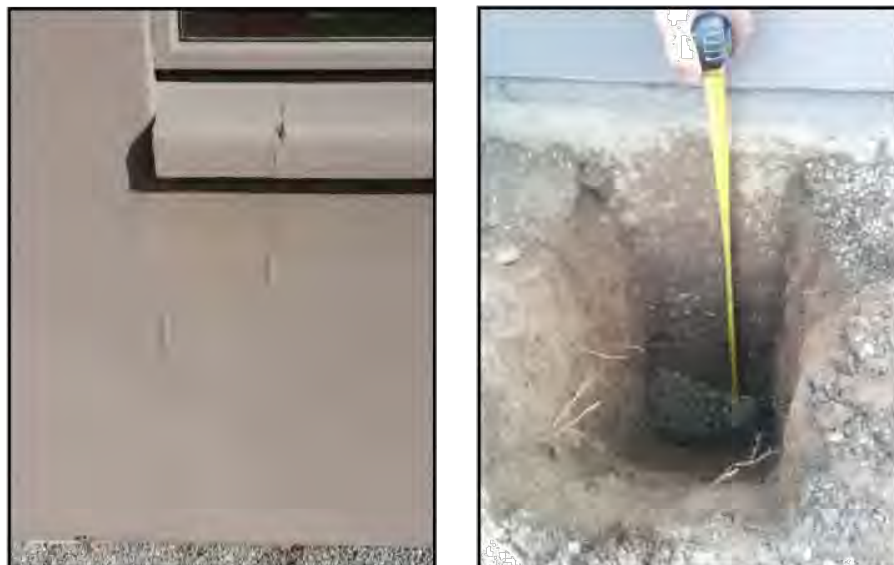
- Step cracking was noted in the cladding at an isolated area on the northern side of the 1978 extension, as shown in Figure 3.0. The cracking noted in the external cladding was reflected inside the building with damage to internal tiling. A hand excavation and DCP testing was undertaken at this location and the results and possible cause of the building damage are discussed further in Section 4.0.

Figure 3: Photos showing the area along the northern side of the building (DCP4 location) where cracking of the block cladding was evident (left). Note the hand excavation below the area of cracking revealed drainage material, a PVC pipe and standing water. Photo taken 21/08/2019.

As discussed in Section 3.1, evidence of distressed cladding was observed on one location the northern elevation of the 1978 extension. Hand excavations revealed the foundation in this area extended to competent natural silt, however, excessive water was present around the base of foundation level. Soils samples taken from below the base of the foundation were saturated. Drainage material and the presence of what may be a stormwater pipe, suggests that the water may be originating from either this pipe or a nearby leak. Although soil strengths below the foundation did not indicate any significant softening of the founding soils, it is likely that nearby soils have softened and/or the effects of shrinking and swelling have led to foundation movement and the damage observed in this area. It is recommended that this area is further investigated and that the source of the water is determined and remediated.

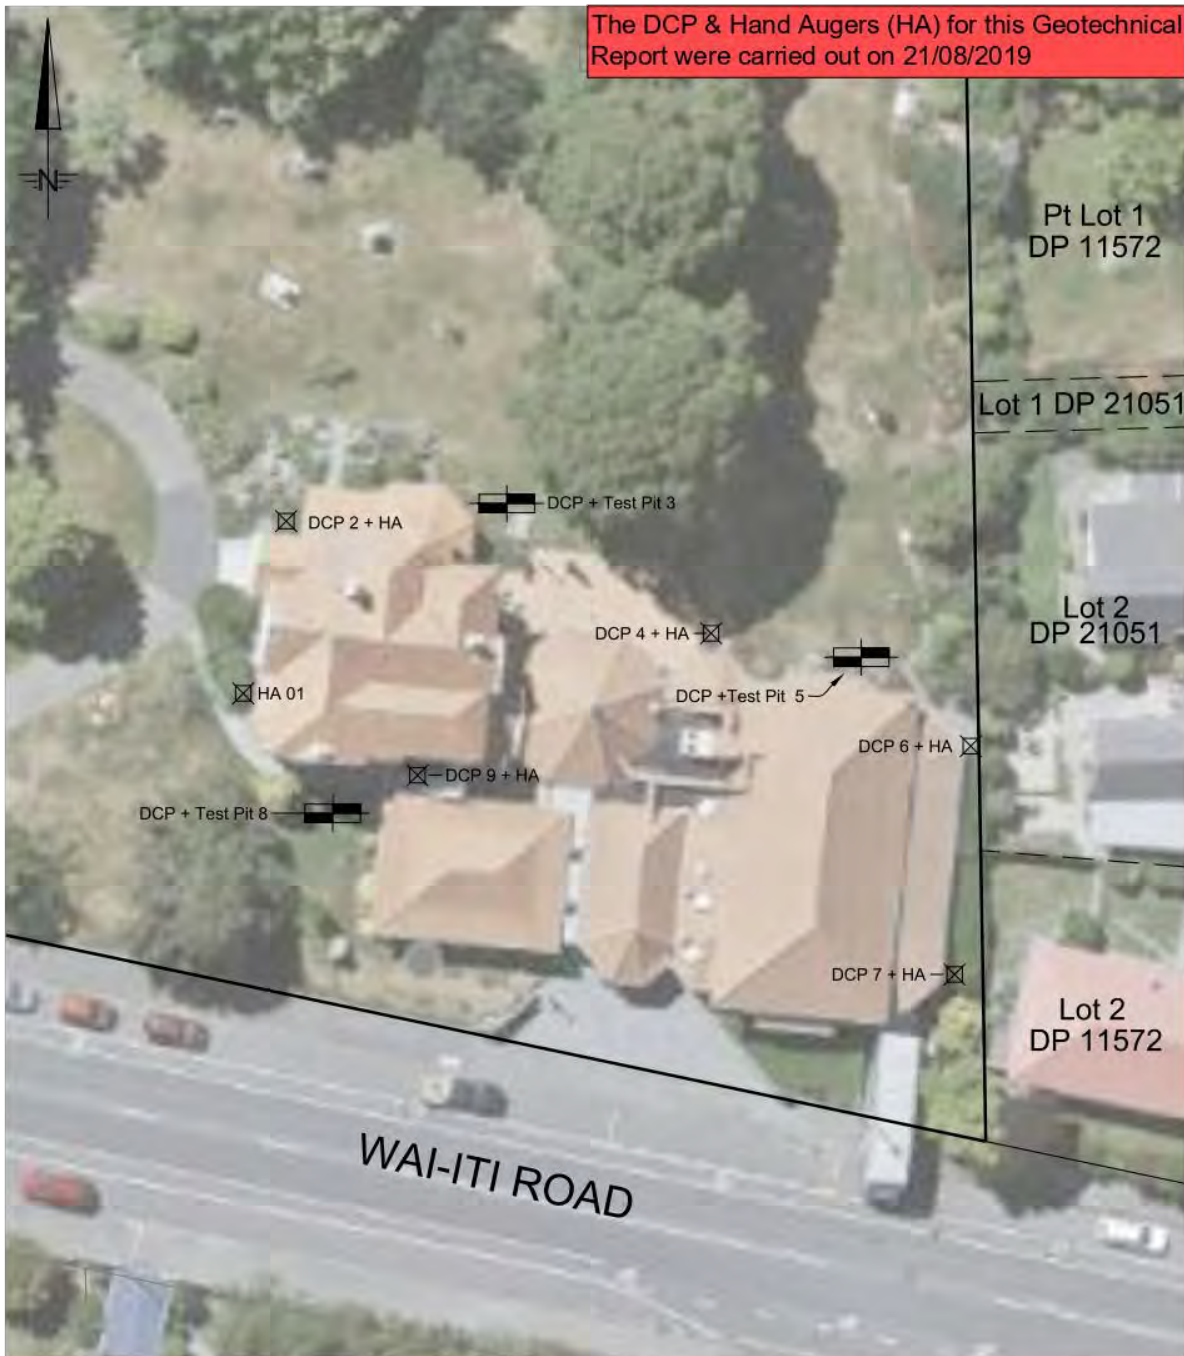
Test locations are approximate.
 Boundaries are taken from Quickmap.
 Aerial image obtained from Canterbury maps

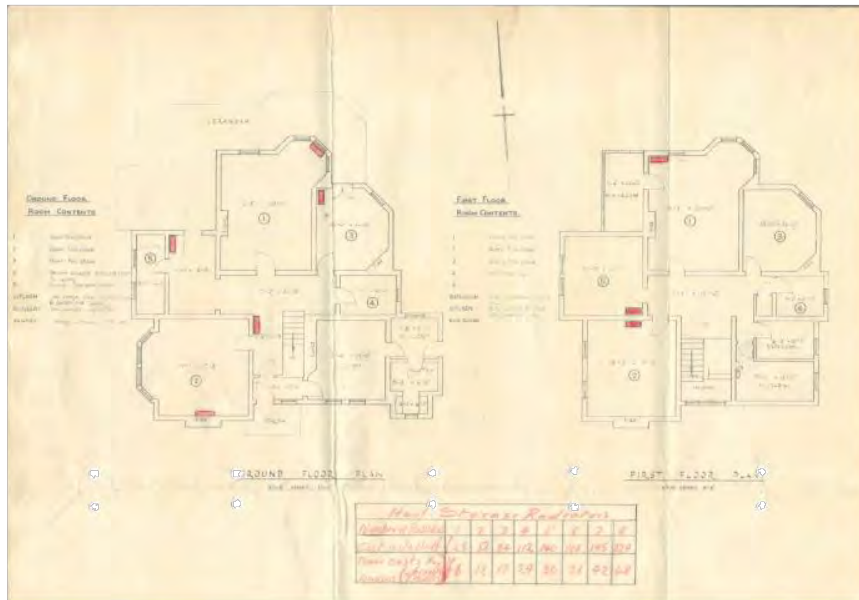
Figure 11 Floor plans, prior to additions to Gallery, Aigantighe Art Gallery Archive.

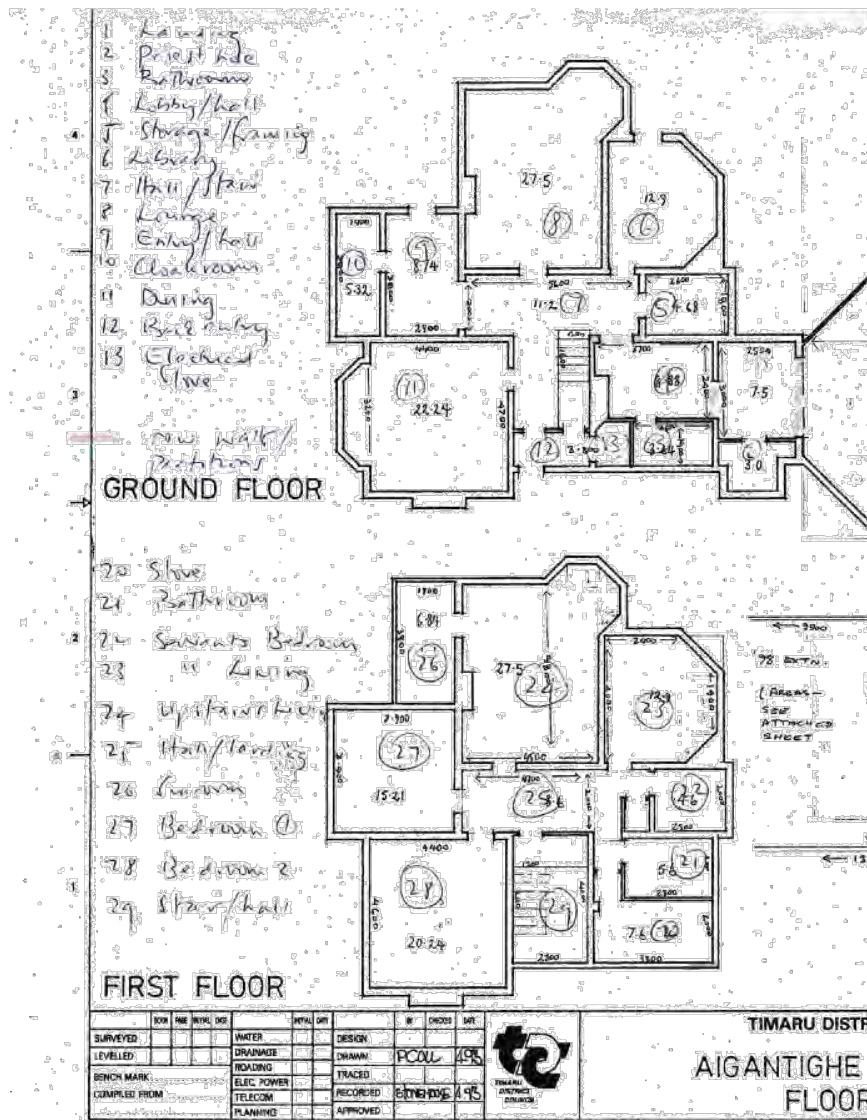
Figure 12 Current floor plan, Aigantighe Art Gallery Archive.
