**EVIDENCE OF ROBERT KERR
ON BEHALF OF WAIPOPO HUTS TRUST AND TE KOTARE TRUST REGARDING
HEARING (E2) CULTURAL VALUES**

**Timaru District
recreational hut
communities, overview
assessment of flooding
hazards**

Report No. R20/57
ISBN 978-1-99-002723-9 (print)
978-1-99-002724-6 (web)

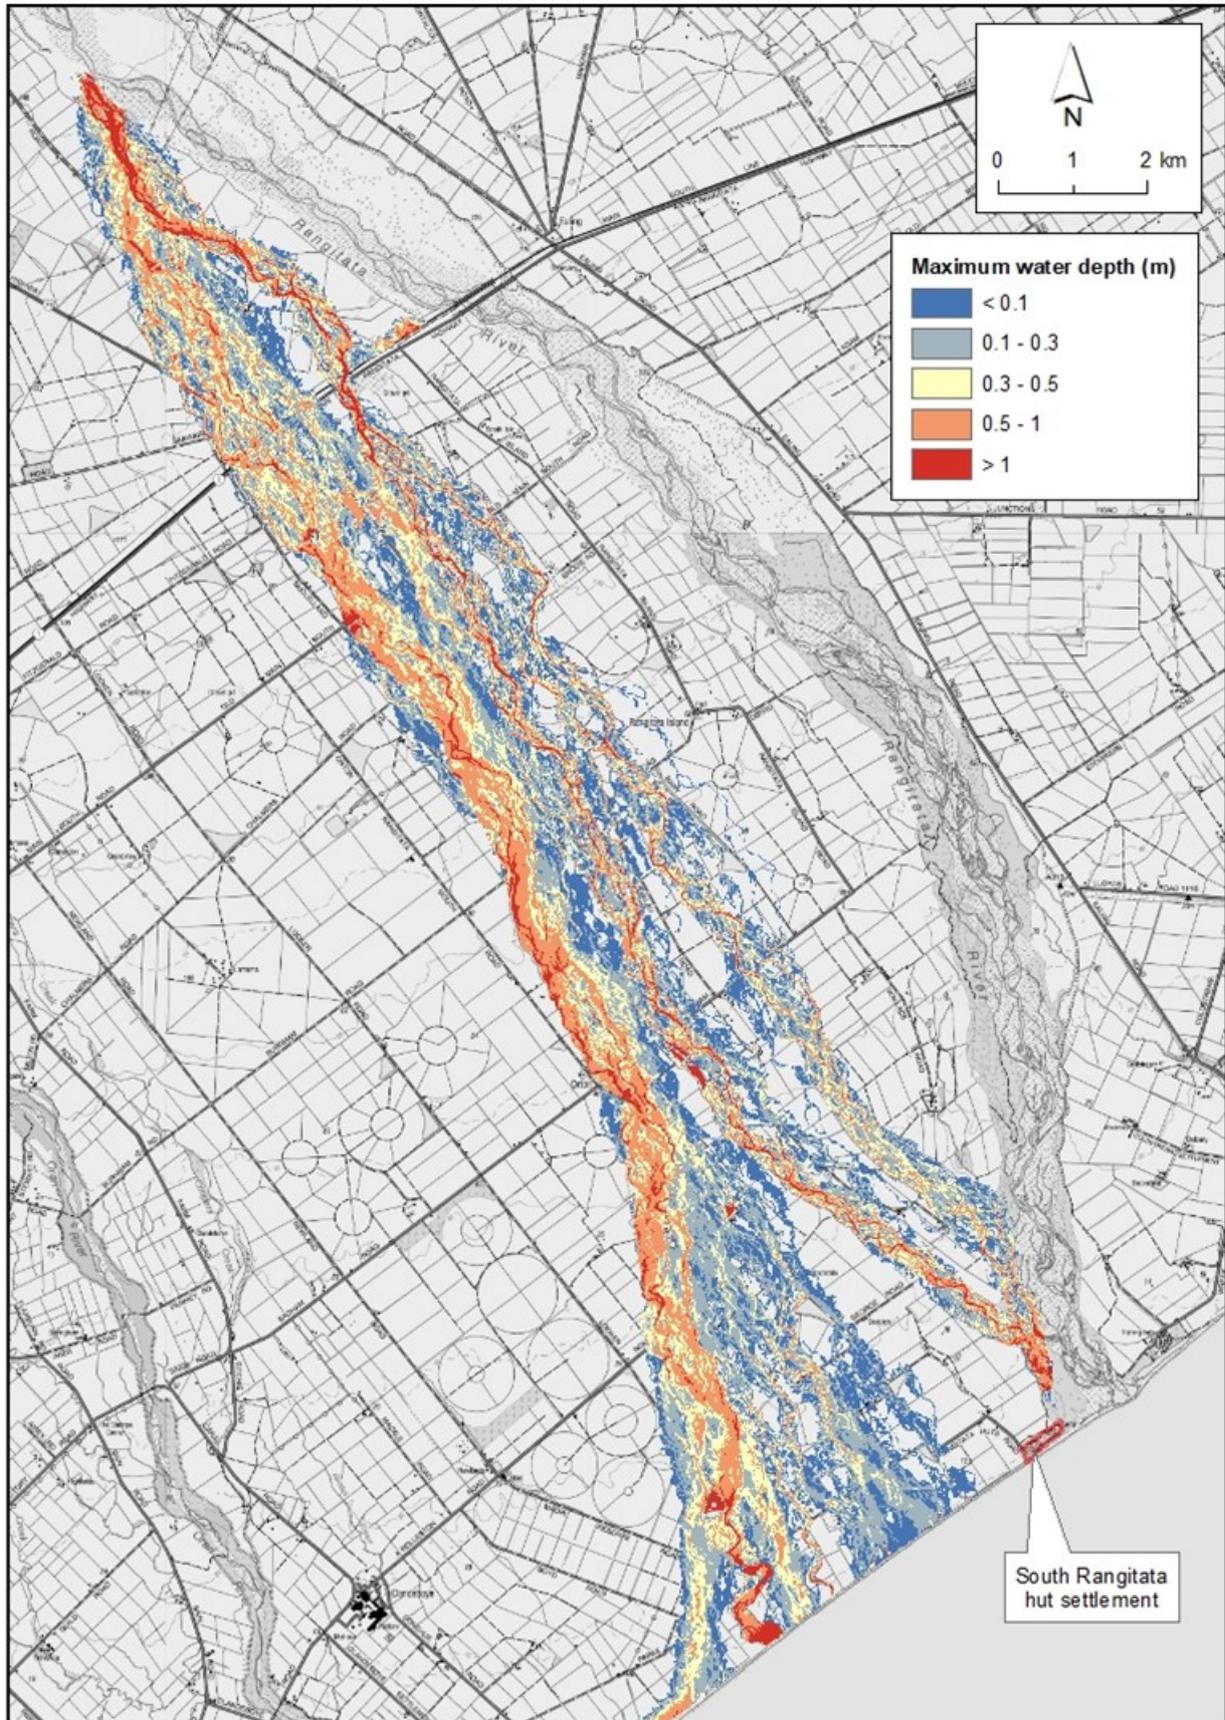
Figure 2-8: Flood extent and depth from a modelled 800 cumecs breakout into the South Branch Rangitata River Channel upstream of State Highway One (Wild, 2016)

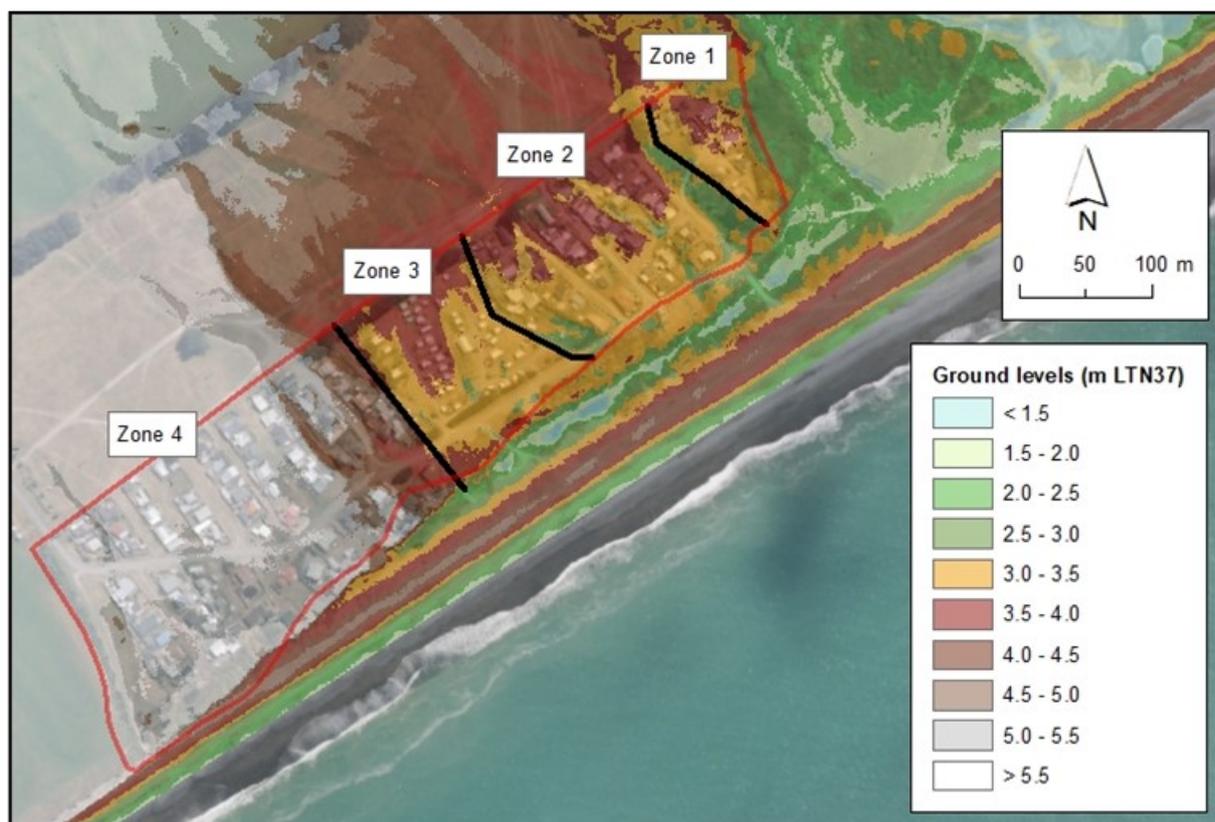
Figure 2-9: 2010 LiDAR (ground level) data, and the four river flooding zones

River flooding at the South Rangitata hut settlement has previously been divided by Environment Canterbury into four zones (Figure 2-9). These zones were defined by Hall (1996) and have been used by Environment Canterbury and the community to help understand the hazard present. The zone boundaries relate to rises in ground level in a southwest direction away from the river. The lowest of these four zones, Zone 1, was close to the river with Zone 4 on the highest ground at the southwest end of the settlement. The definition of four zones in previous investigations assisted Environment Canterbury (in providing advice) and the community (in understanding risk) and will remain a source of information in future.

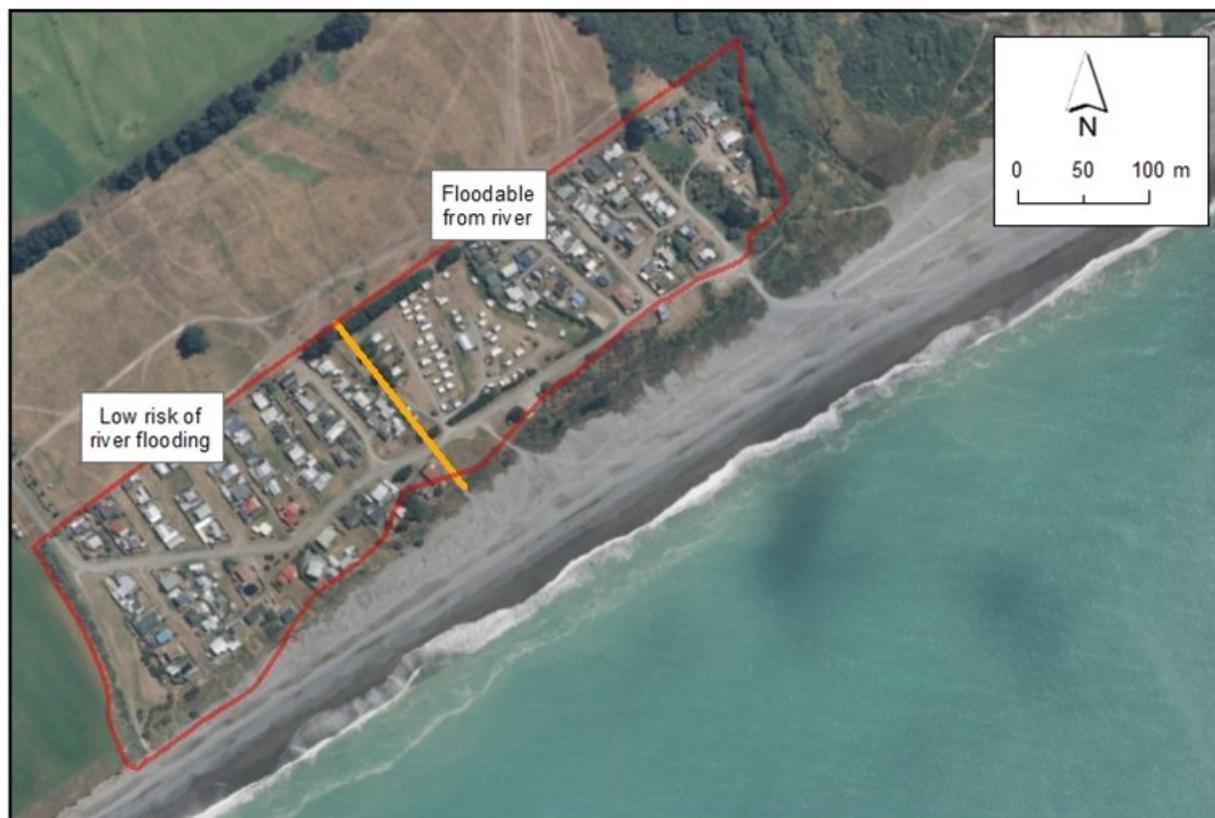
Figure 2-10: Proposed simplified Rangitata River flooding zones

In order to simplify the information around river flooding hazard at the South Rangitata hut settlement we show all land north east of the west boundary of the campground as floodable (Figure 2-10). All land south west of the campground can be considered very unlikely to be subject to river flooding. This simpler distinction is in keeping with how floodable areas have been mapped in the rest of the district. Rather than trying to define the severity of flooding at a mapping level, the area is broadly defined by potential susceptibility to future flooding. Site specific investigation can be used to refine the flood hazard as required.

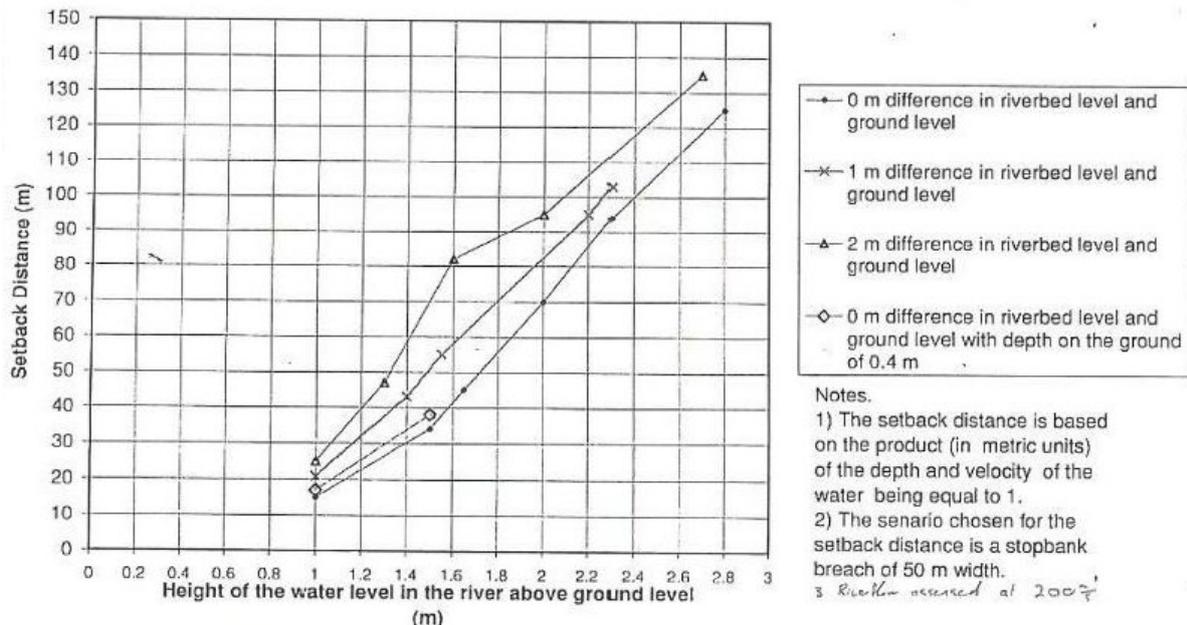
Figure 3-1: Setback distance from stopbanks for dwellings graph (summarising breach modelling results). This graph output from breach modelling is used to obtain final setback in all areas

Using the parameters discussed above, the setback distance can be estimated from the results of breach modelling analysis produced in Connell (1998). Connell (1998) includes a graph displaying setback distances for a range of water level and ground level/riverbed level scenarios (Figure 3-1). Once these parameters are known for a given site, the setback distance can be taken from this graph.

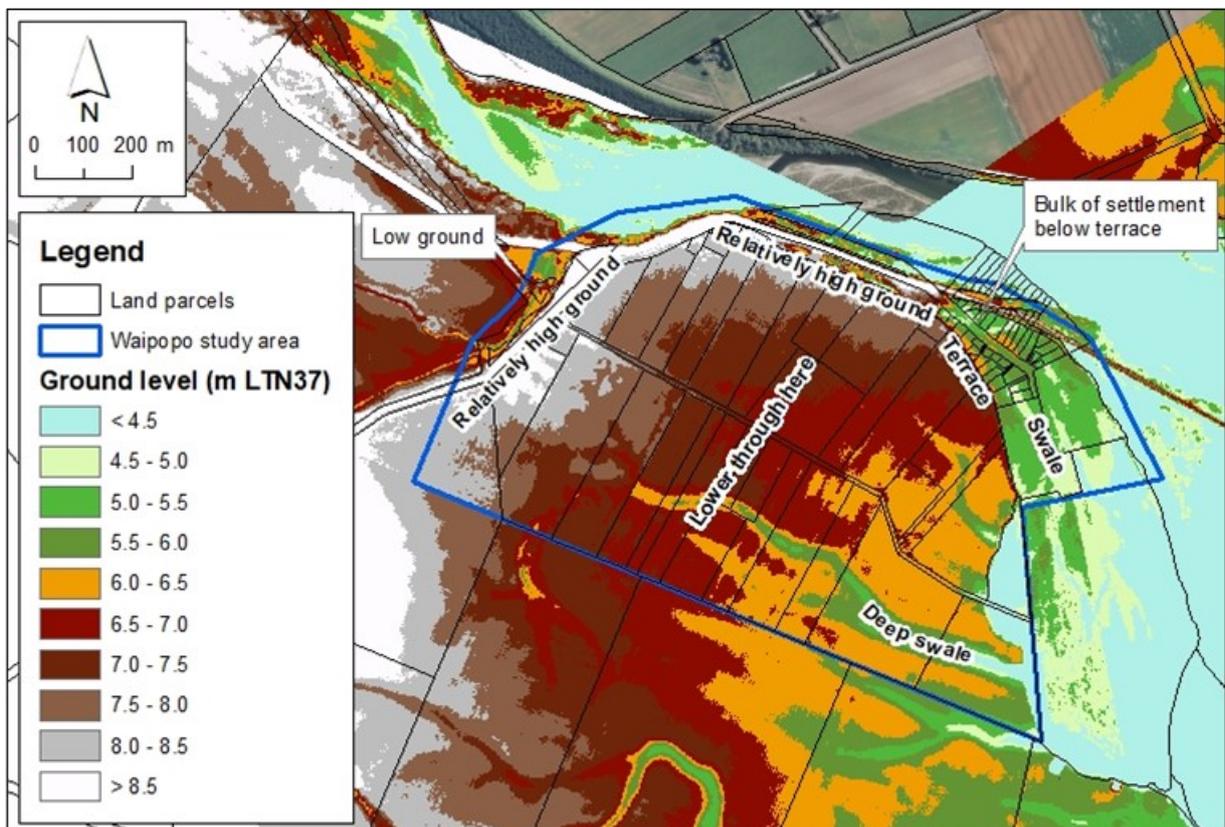
Figure 4-5: 2010 LiDAR (ground level) data for the Waipopo hut settlement area

Ground levels vary significantly across the study area (Figure 4-5), with most of the established dwellings in the main huts area located below a significant terrace immediately to the southwest.

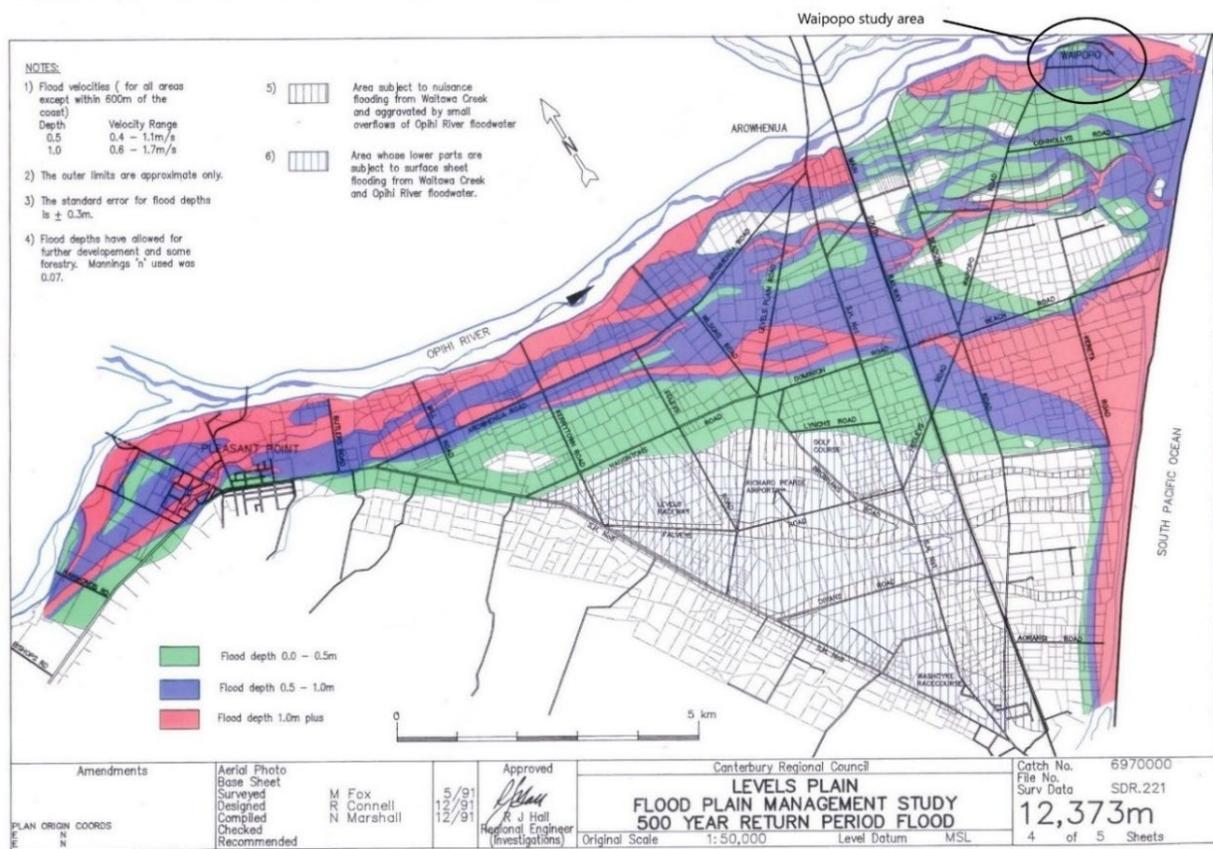
Figure 4-9: 500 year ARI flood showing Waipopo Study Area [Source: Connell & Miller, 1992]

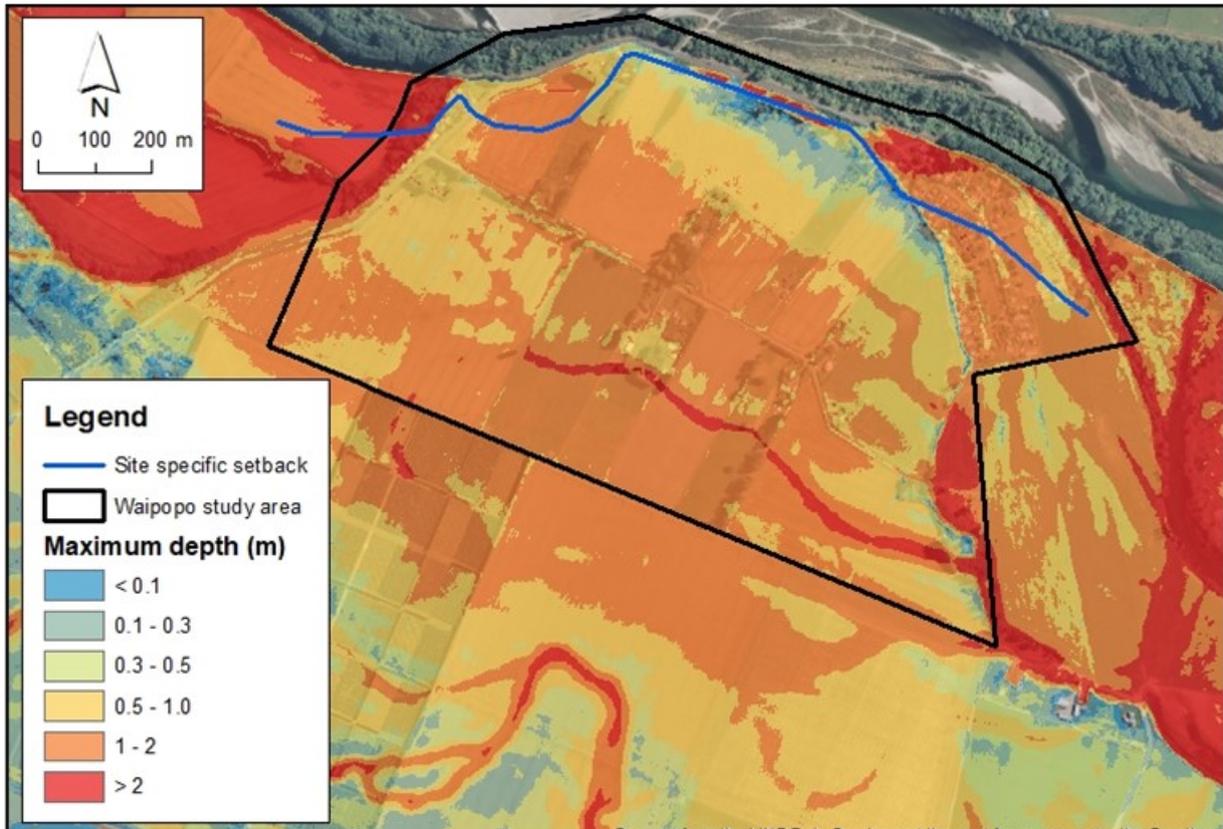
Figure 4-11: Waipopo hut settlement stopbank setback distances and modelled maximum flood depths (elevated scenario with all breakouts occurring)

Note that the high hazard area defined by the blue line in Figure 4-10 and Figure 4-11 relates only to stopbank breach and does not account for overland flooding from breakouts originating further upstream.

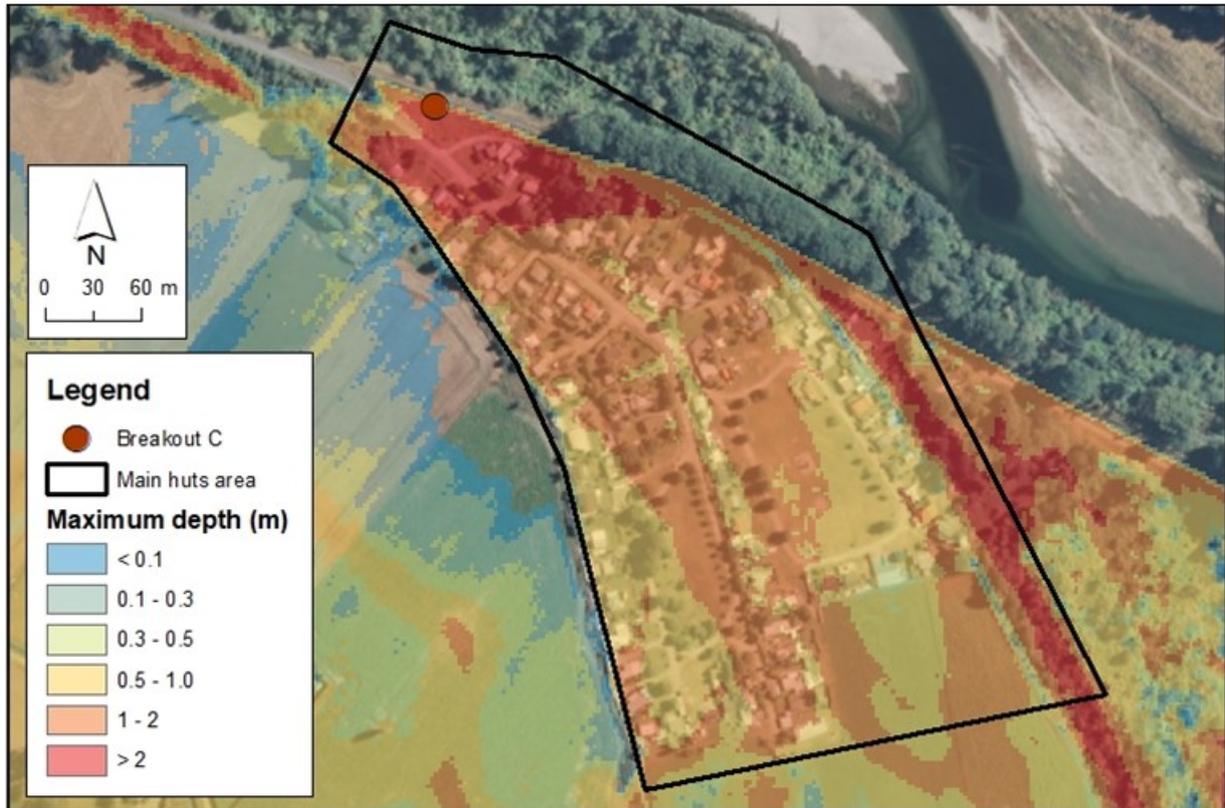
Figure 4-16: Modelled maximum flood depths for elevated SH1 and C breakouts at main huts

The potential frequency of severe flooding within the main huts area is lower than for much of the rest of the study area due to the limited number of breakout locations that will affect the area. While a low probability outcome, there would be very high consequences if the adjacent stopbank were to breach at or near breakout location C. The high hazard stopbank setback area goes some way to defining this hazard but flooding impacts will be significant to the terrace bounding the main huts to the southwest.

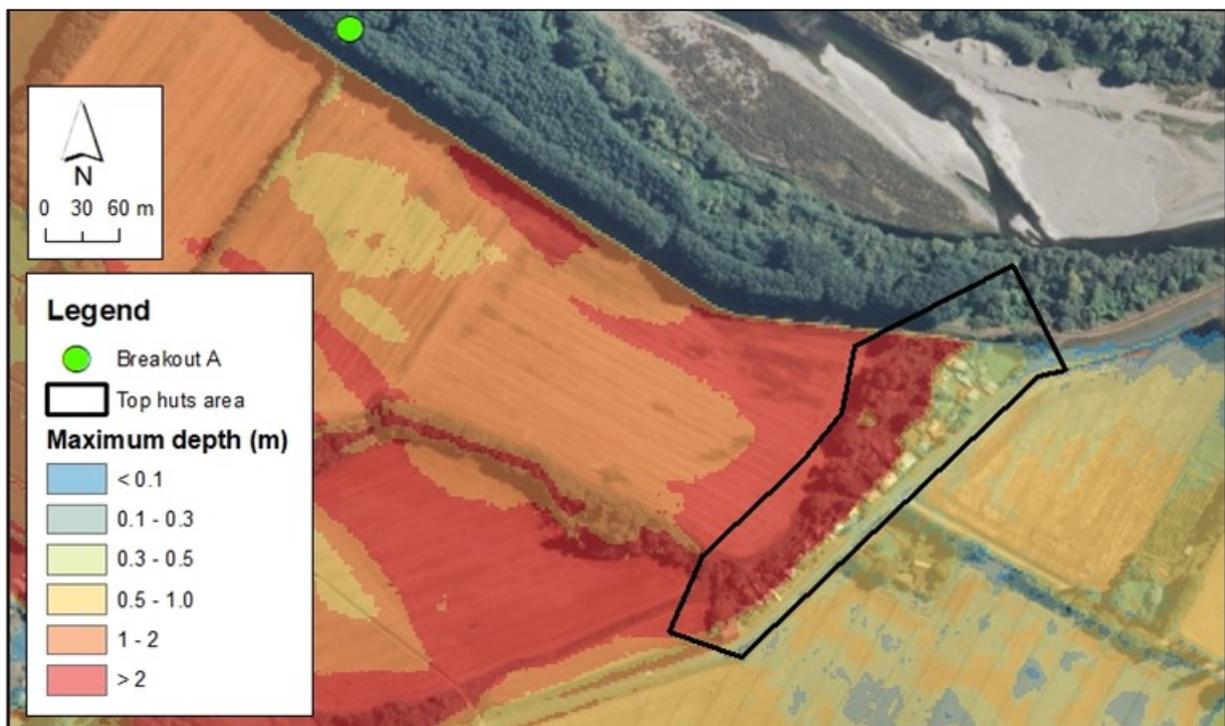
Figure 4-17: Modelled maximum flood depths for elevated SH1 and A breakouts at top huts

Breakouts at locations B and C are downstream of the top huts and will not affect these dwellings. However, upstream overflows from the river, and breakouts at location A, would cause flooding to these dwellings (Figure 4-17).

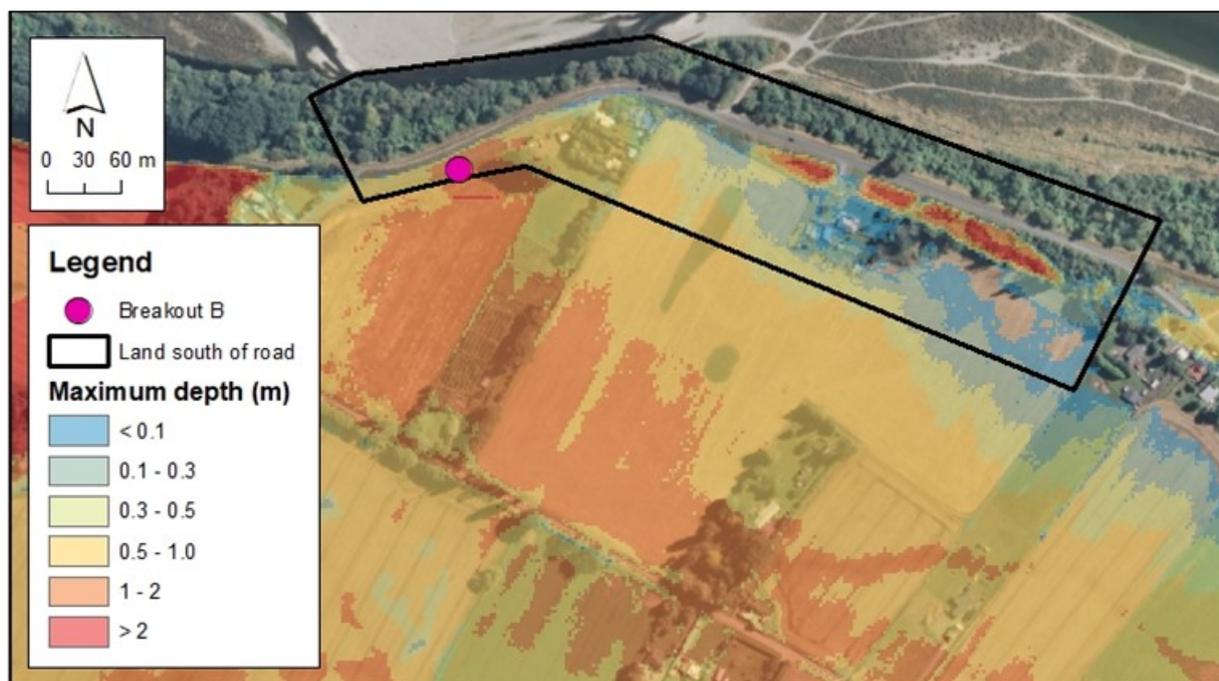
Figure 4-18: Modelled maximum flood depths for elevated SH1 and B breakouts south of road

This strip of land is relatively high and is not considered as prone to the impacts of stopbank breach. Stopbank breach is considered less likely in this reach and, if it were to occur, the extent of high hazard flooding would be small. The topography of the area directs most flooding from upstream to the south and southeast, although with a breakout at location B (Figure 4-18) some, mostly shallow, water can affect the area. There are isolated depressions where deep flooding could occur. This area stays clear, or receives only moderate flooding, in all scenarios and is the least susceptible part of the whole Waipopo study area.

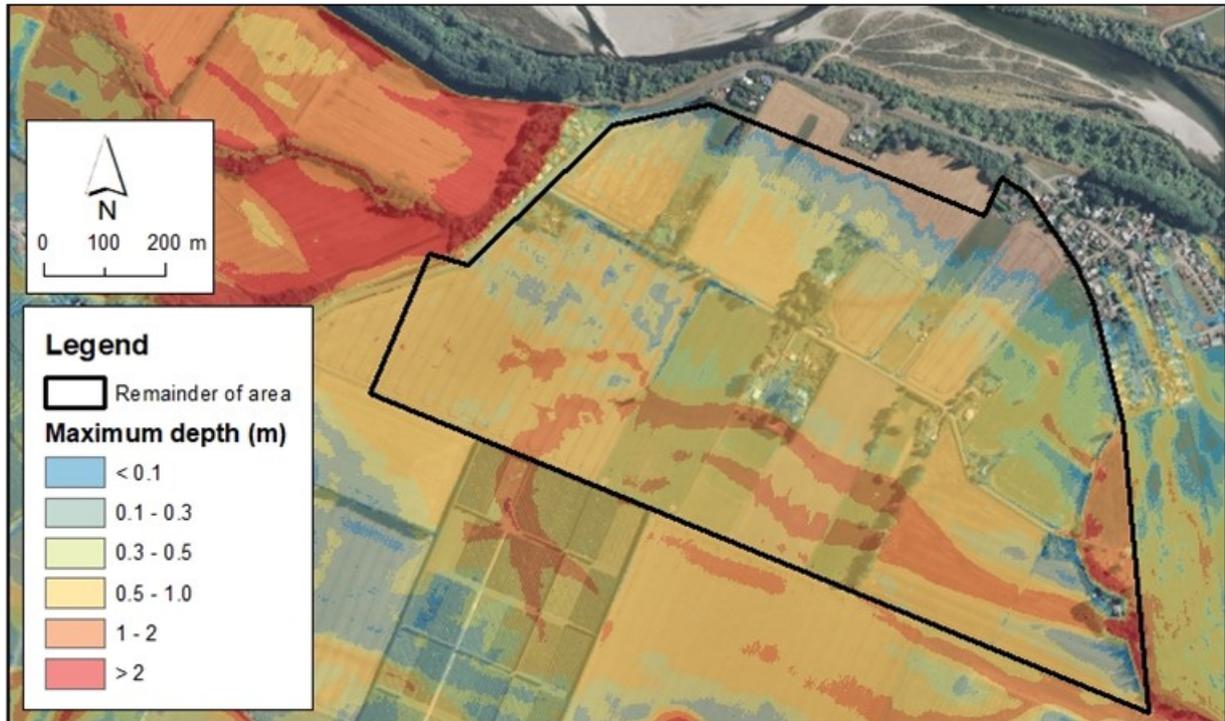
Figure 4-19: Modelled maximum flood depths for elevated SH1 breakout over remainder of area

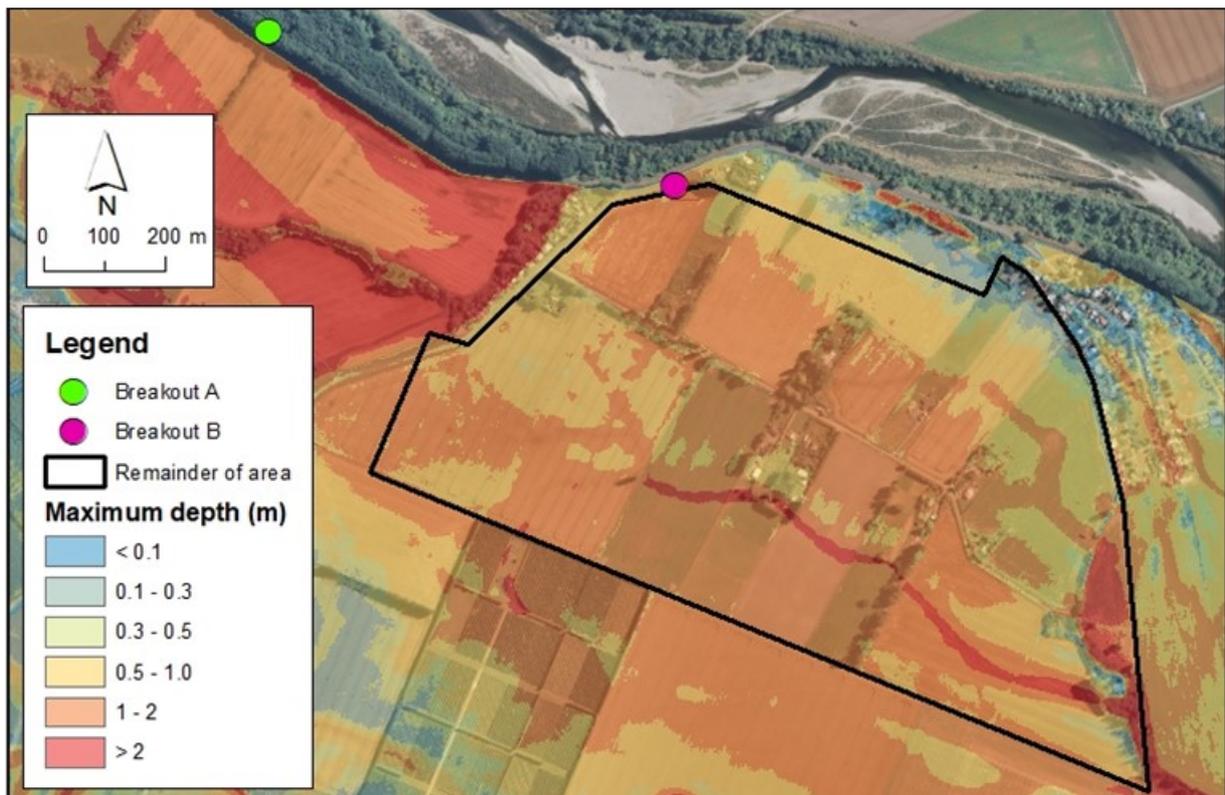
Figure 4-20: Modelled maximum flood depths for elevated SH1, A and B breakouts over remainder of area

When considering the worst case scenario of a breakout at SH1 combining with breakouts at locations A and B, flooding over much of this undeveloped part of the study area is 700 mm to almost 1 m deep (Figure 4-20). The depths do not reach high hazard criteria for areas clear of the main channel and depressions, but they are still significant. In lesser flooding scenarios, where only one breakout (either A or B) coincides with the SH1 breakout, the depths are slightly less.

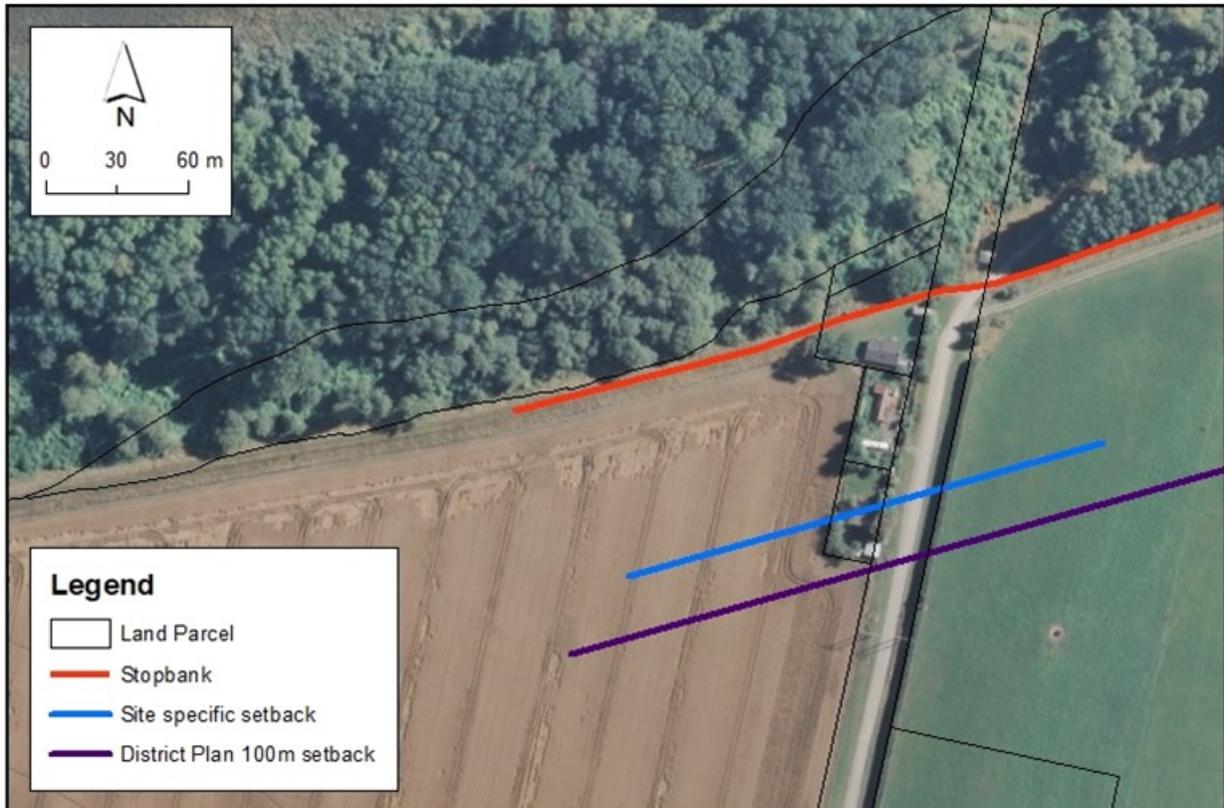
Figure 5-5: Grassy Banks hut settlement setback distances

Connell and Miller (1992) indicates the Grassy Banks hut settlement is not expected to flood in the 100-year ARI flood event. The huts may be affected by some minor flooding from upstream break outs from the Opihi River in the 200-year ARI flood event and larger. Flood depths of 300 mm or less are expected even in the 500-year ARI flood.

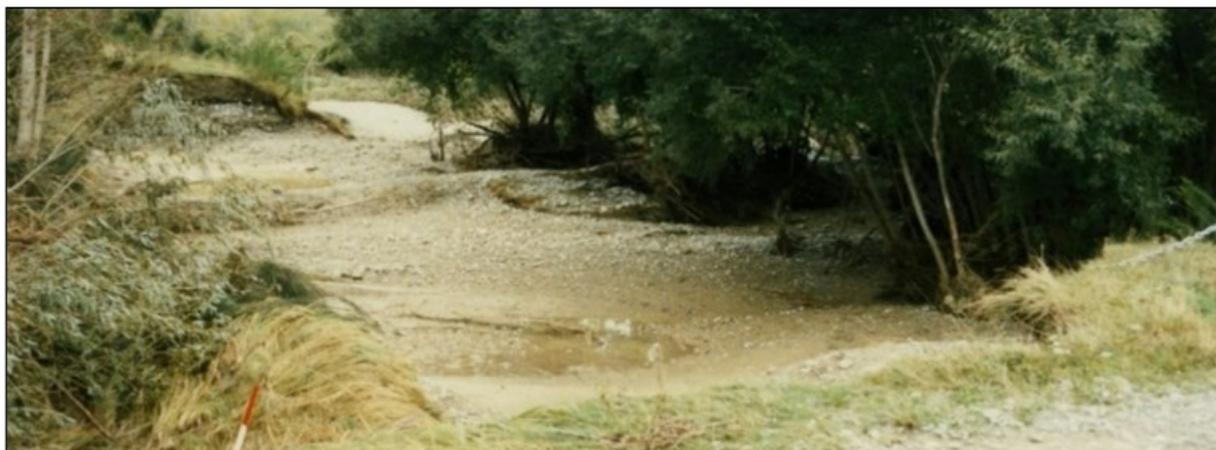
Figure 6-5: 13 March 1986 - breach through stopbank (40 m wide) looking from Mill Road downstream

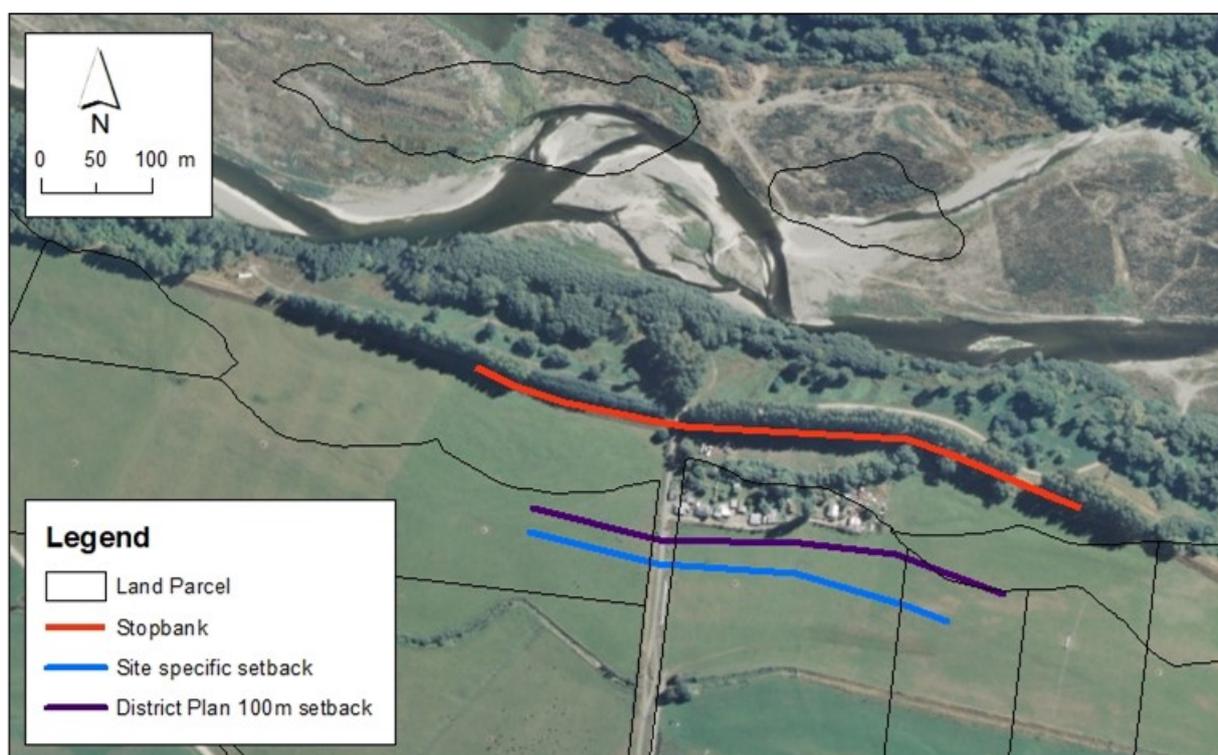
Figure 6-8: Mill Road hut settlement setback distances

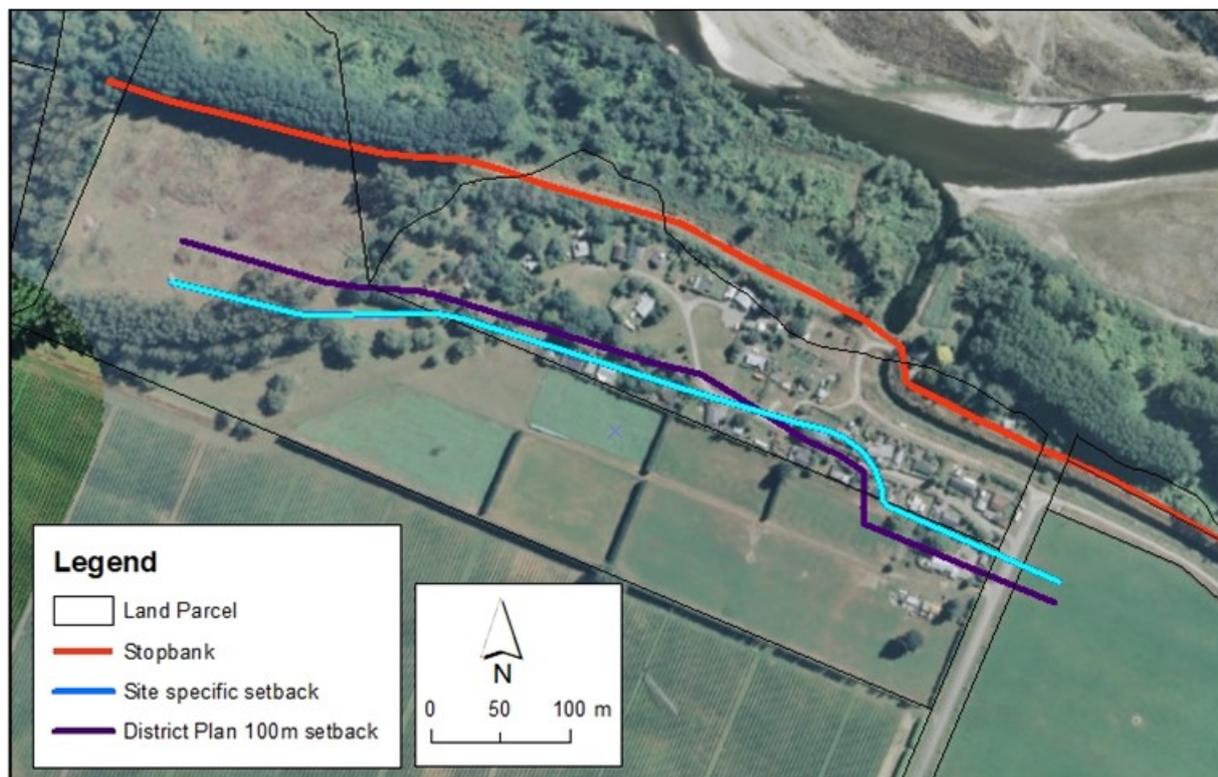
Figure 7-6: Butlers Road hut settlement setback distances

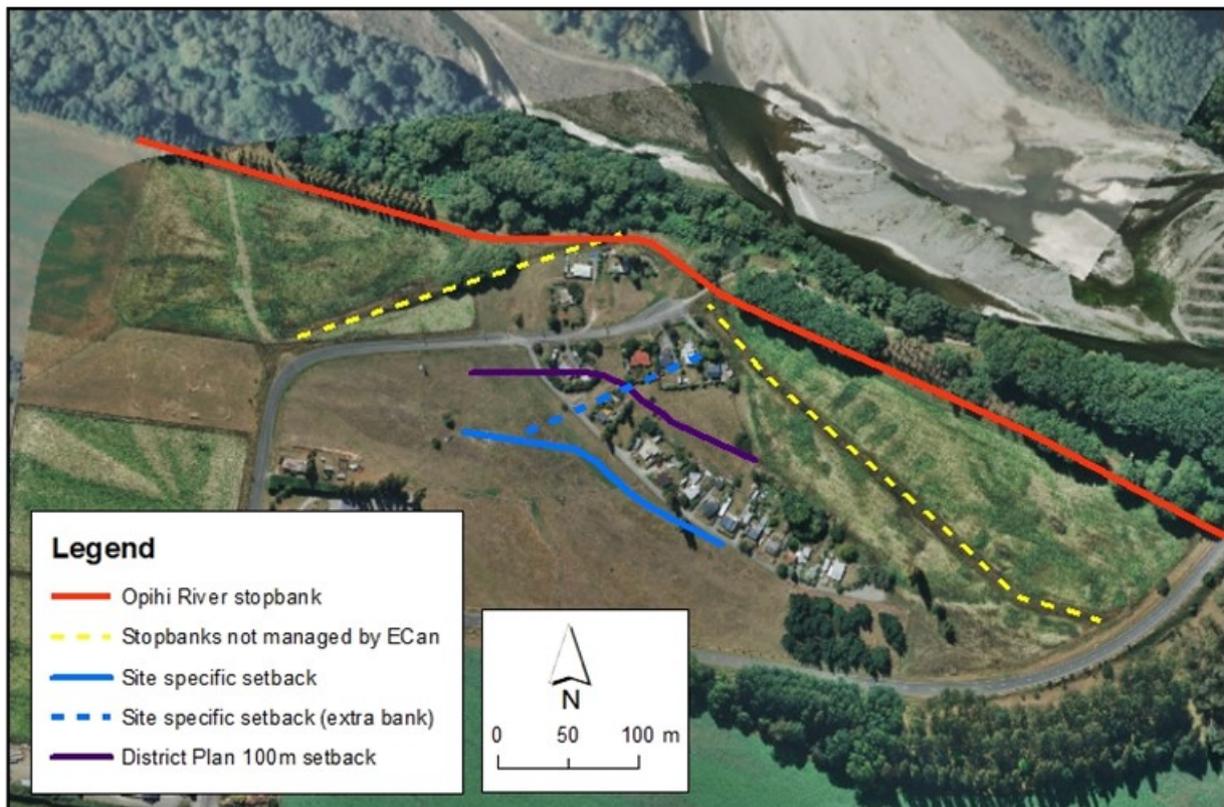
Figure 8-8: Stratheona hut settlement setback distances and stopbank locations

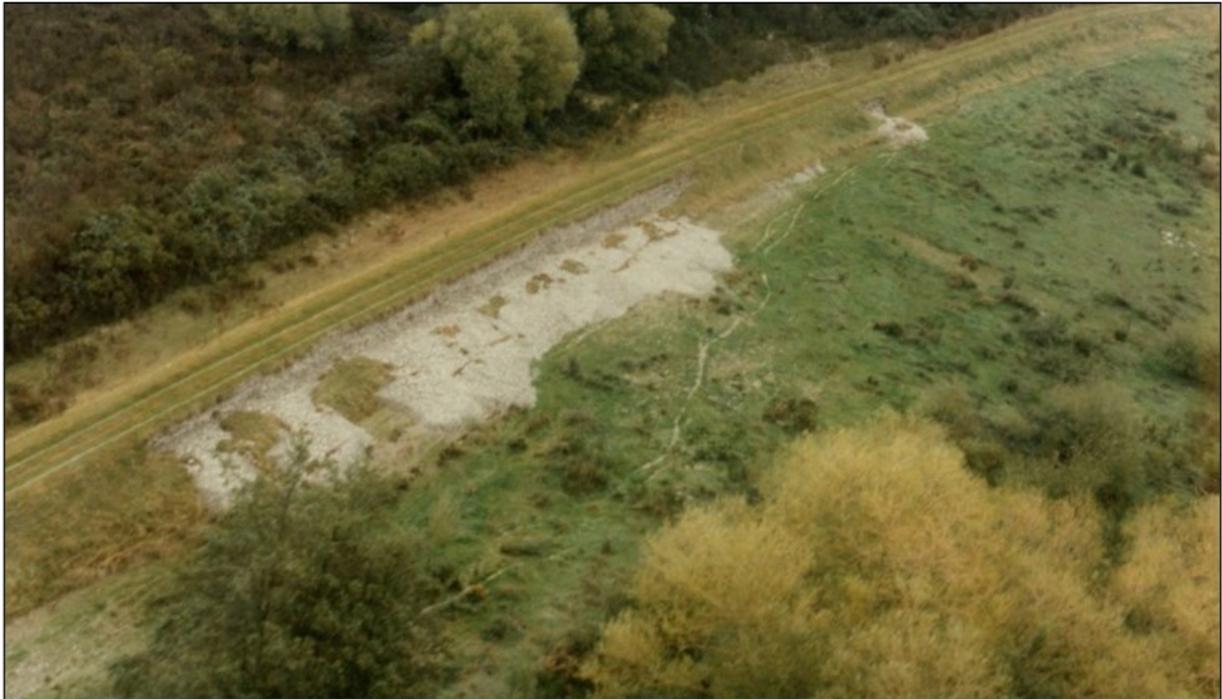
Figure 9-5: Opihi River stopbank on true right bank ~300 m upstream of Collett Road following overtopping during the 13 March 1986 flood

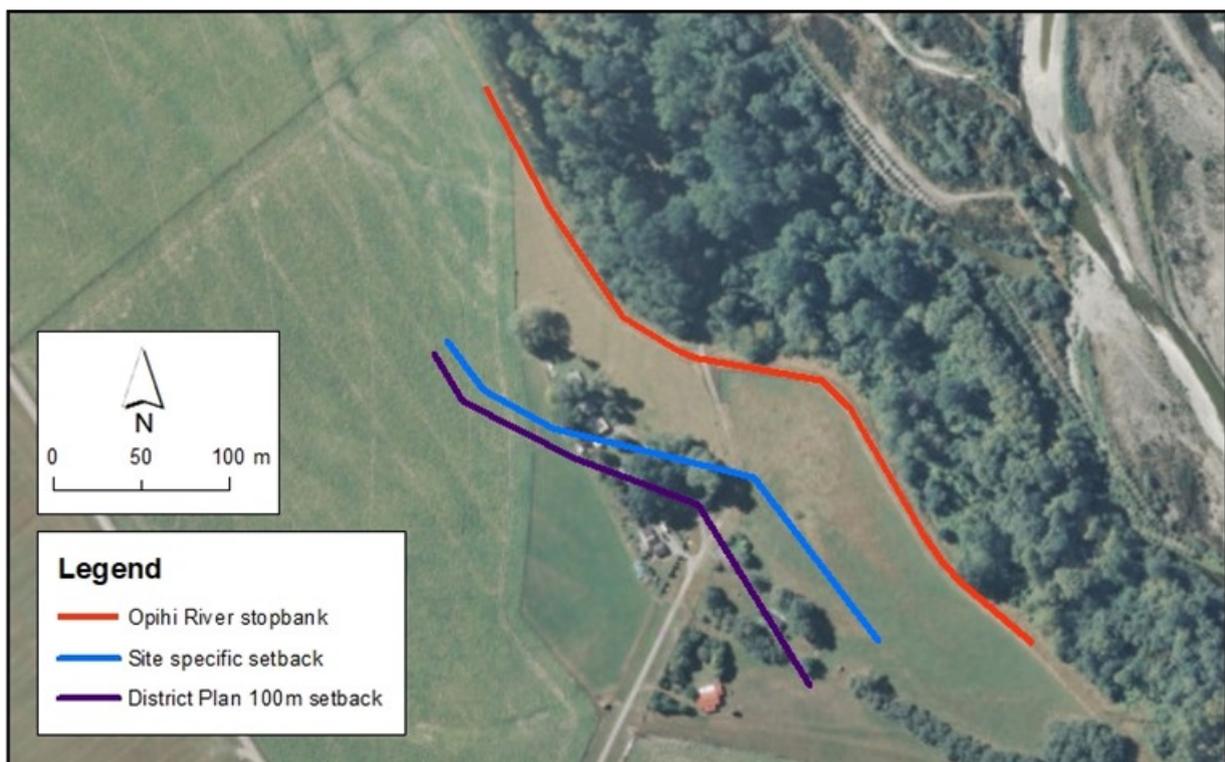
Figure 9-6: Collett Road hut settlement setback distances and stopbank location

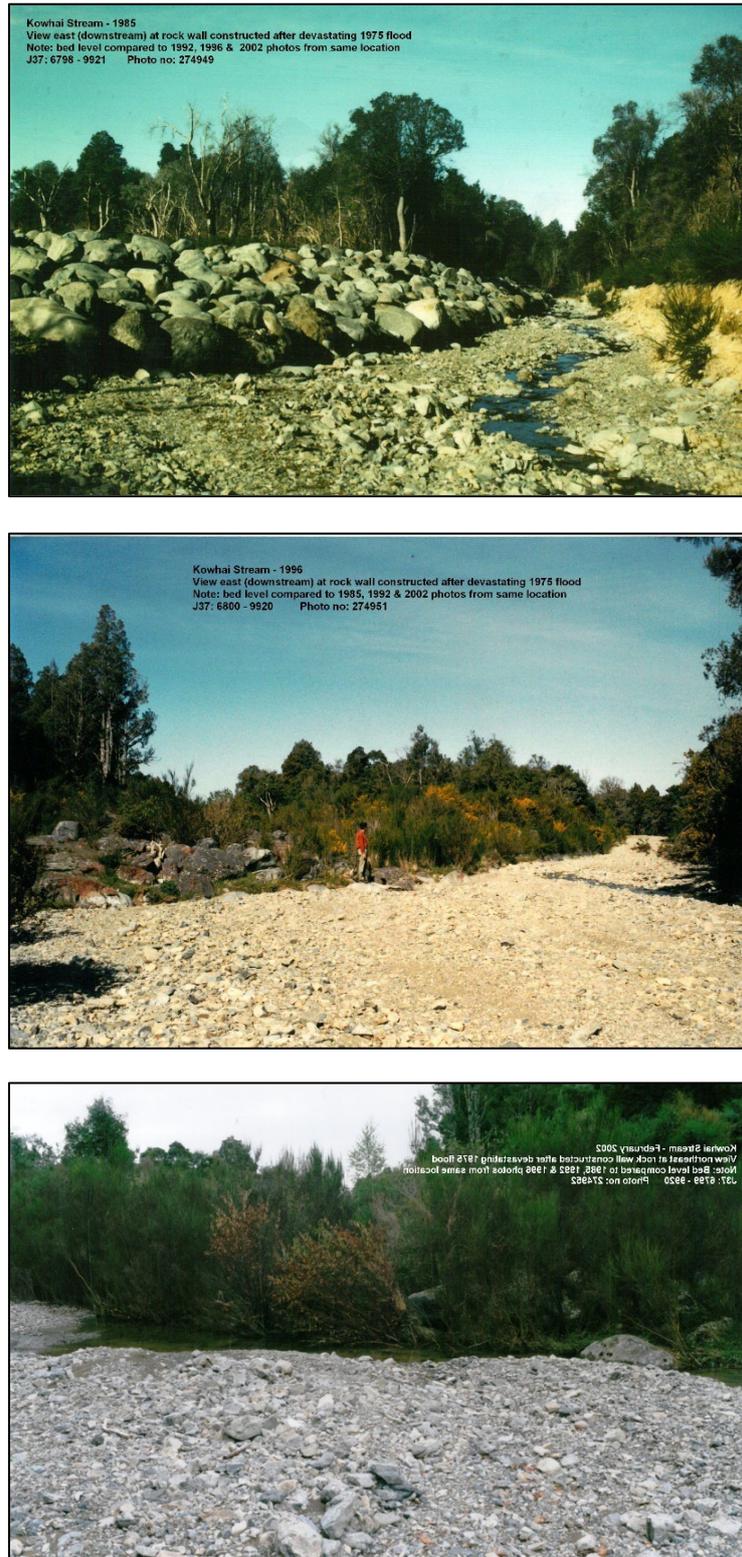
Figure 11-4: Series of photographs (Top: 1985, Middle: 1996 and Bottom: 2002) taken of rock protection put on true left stream bank upstream of ford following the devastating 1975 flood. Note photographs are all the same location and show the very rapid gravel bed aggradation occurring

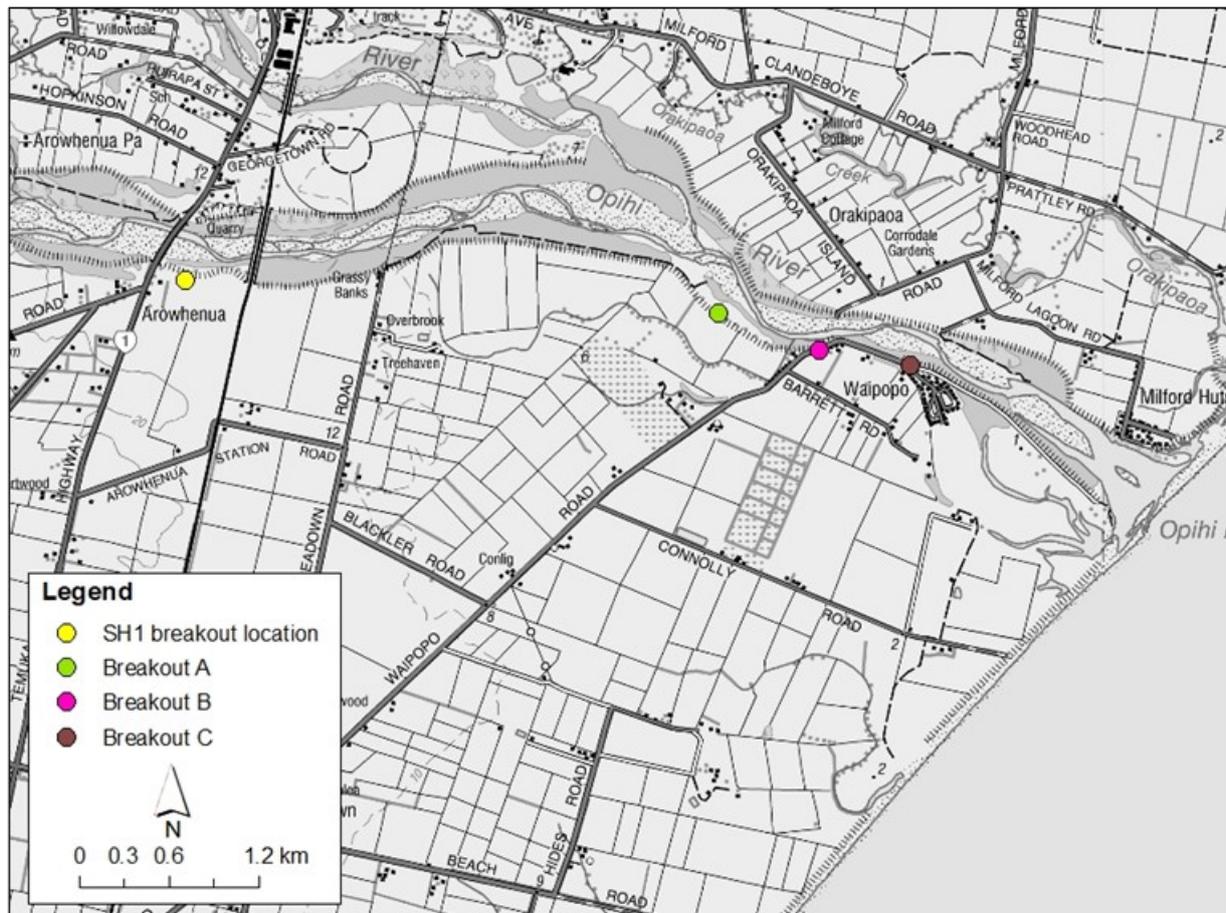
Figure A1-1: Map showing modelled breakout locations
