**EVIDENCE OF ROBERT KERR
ON BEHALF OF WAIPOPO HUTS TRUST AND TE KOTARE TRUST REGARDING
HEARING (E2) CULTURAL VALUES**

**Timaru District
recreational hut
communities, overview
assessment of flooding
hazards**

Report No. R20/57
ISBN 978-1-99-002723-9 (print)
978-1-99-002724-6 (web)

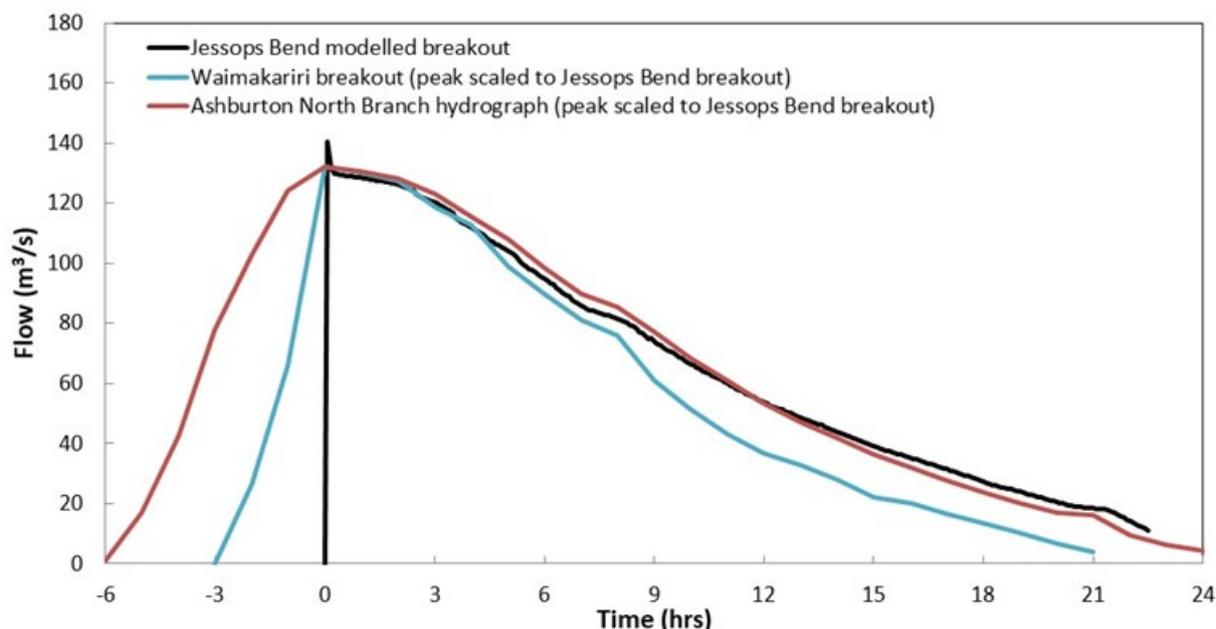
Figure A1-4: Comparison of breakout flows and Ashburton North Branch flood hydrograph (scaled to match Jessops Bend peak breakout flows)

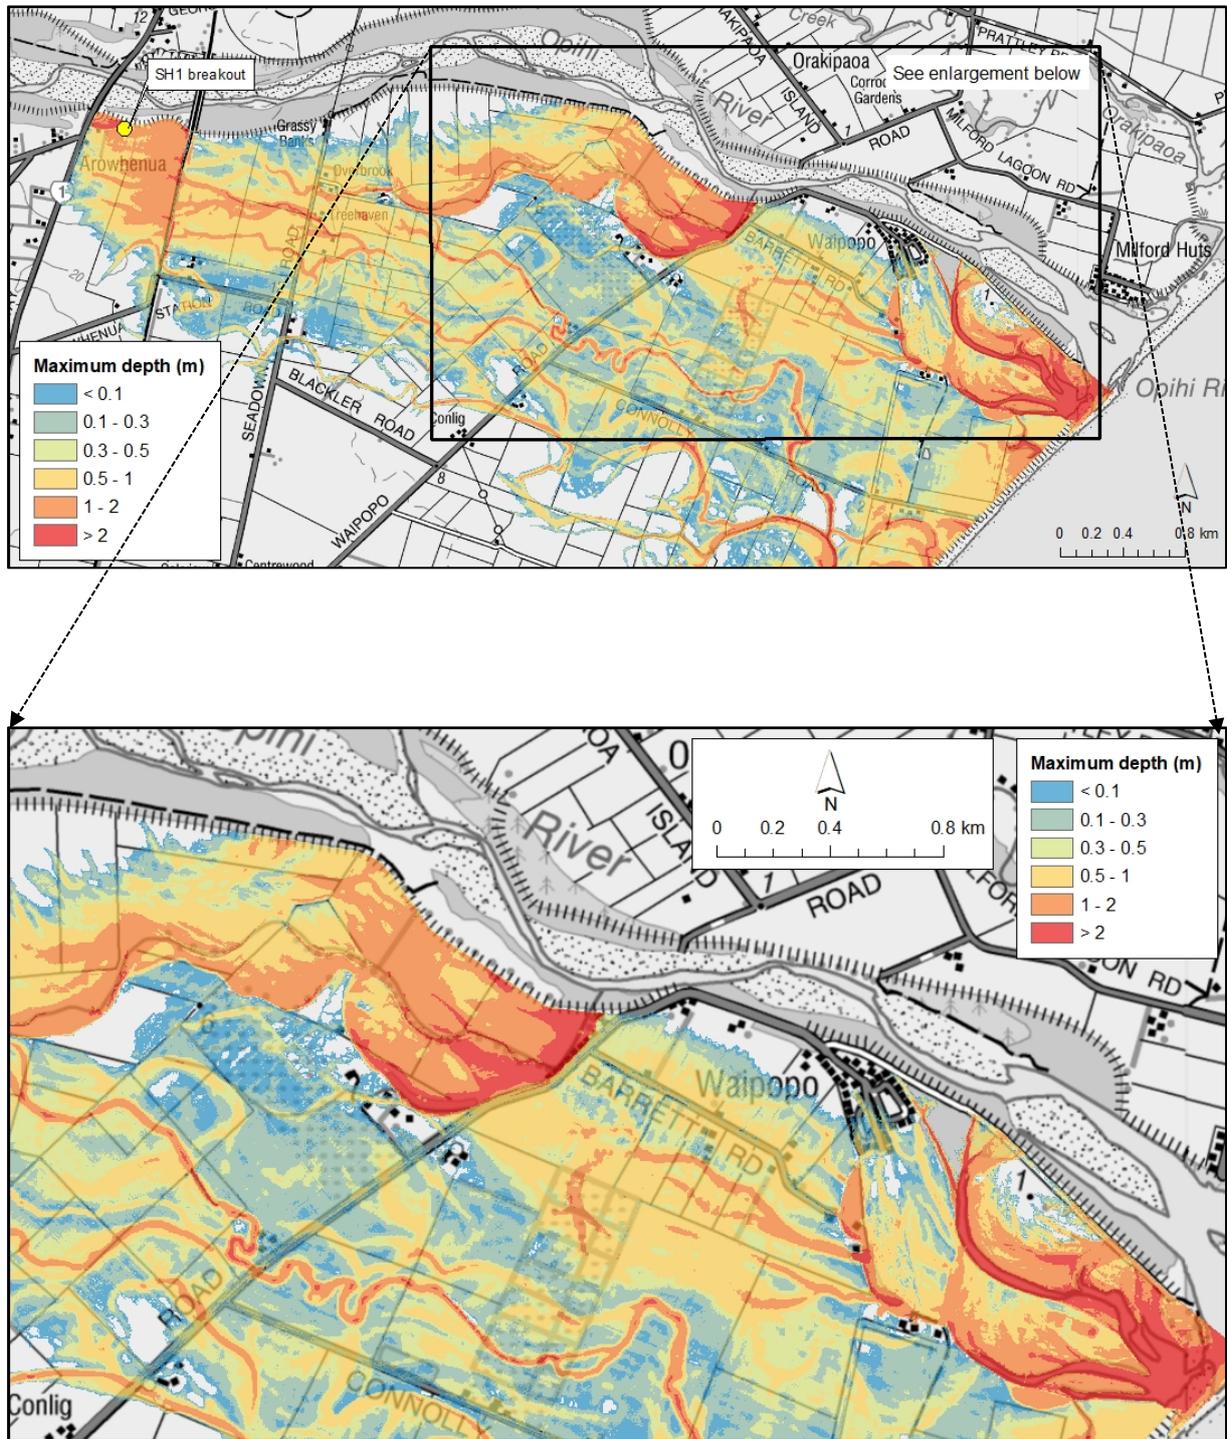
Figure A1-5: Maximum water depth for SH1 breakout flow of 540 m³/s - base scenario

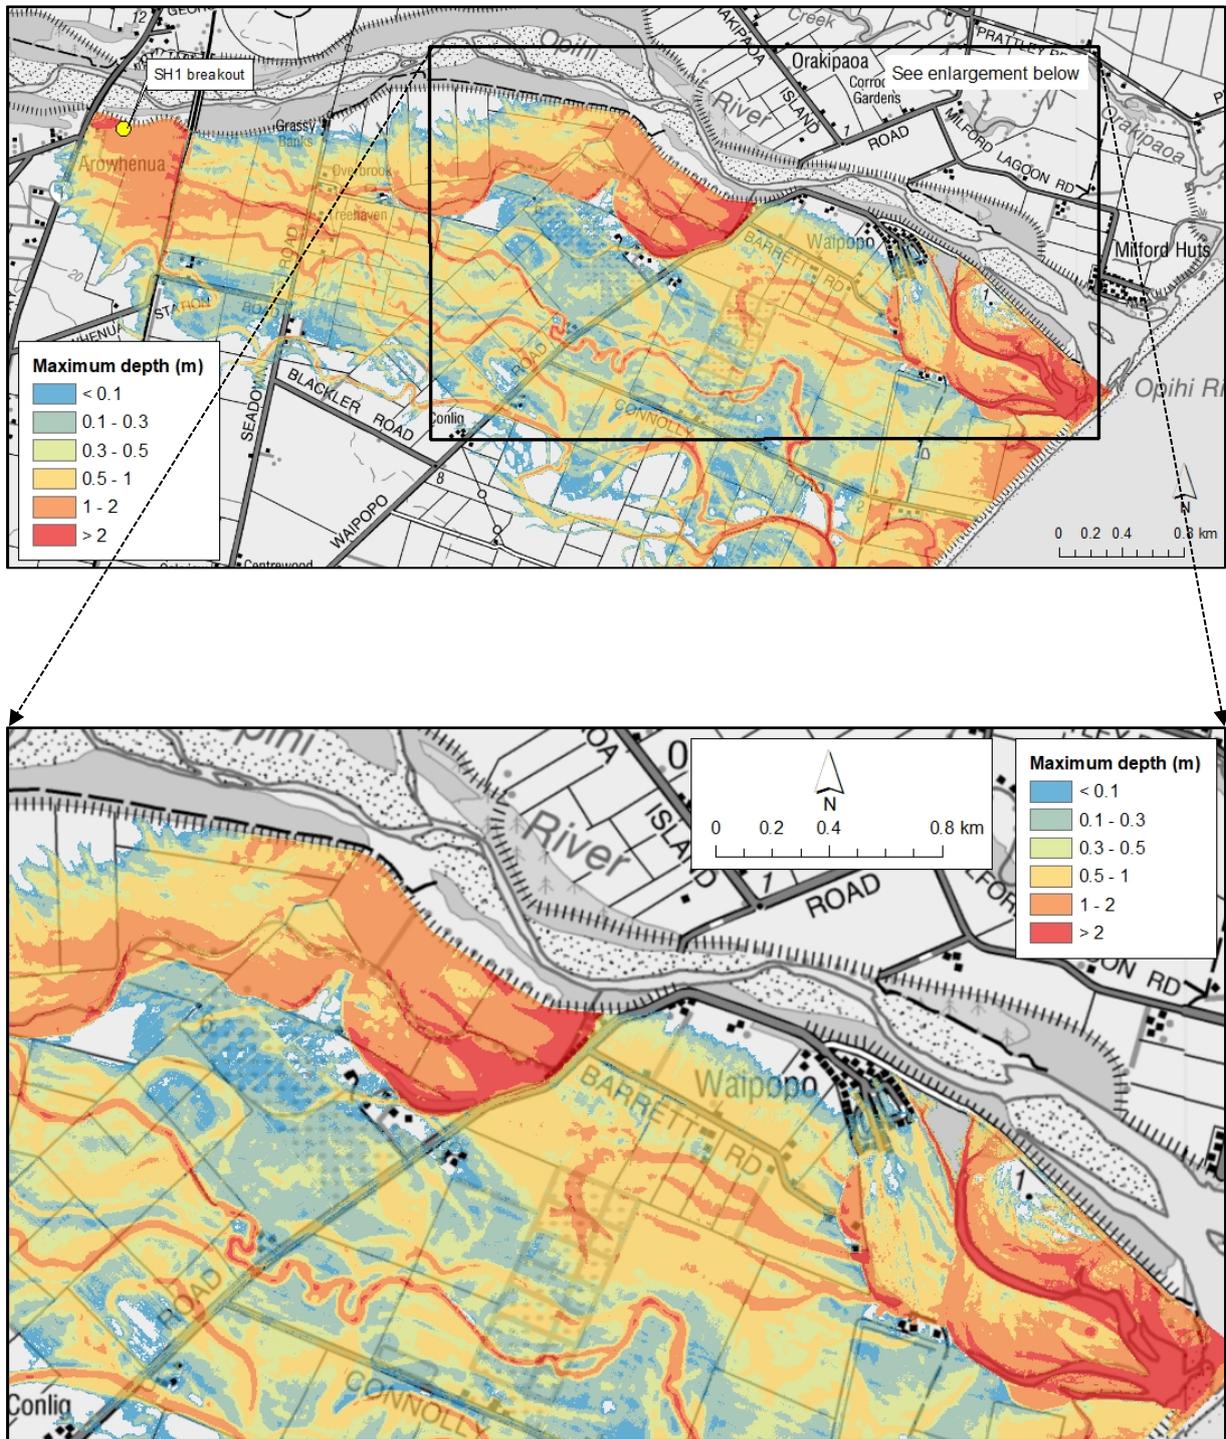
Figure A1-6: Maximum water depth for SH1 breakout flow of 700 m³/s - elevated scenario

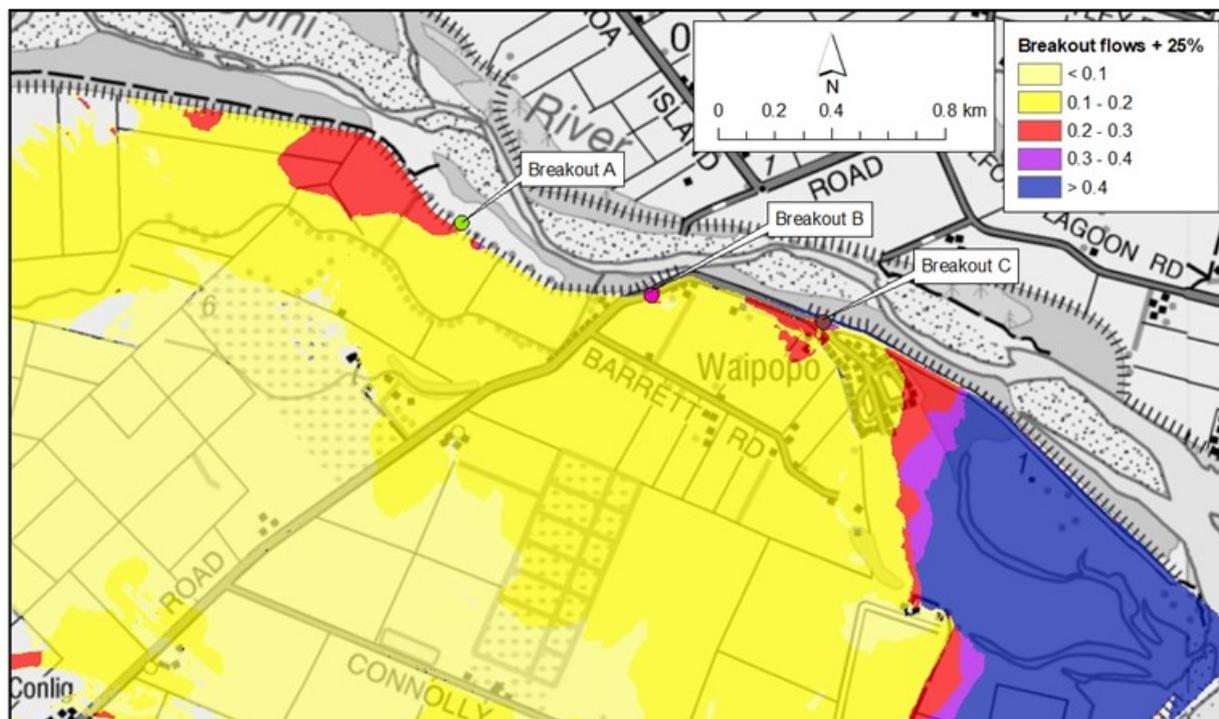
Figure A1-16: Increase in modelled water depths if breakout flows are increased by 25% [for elevated scenario breakouts at SH1 and locations A, B and C]

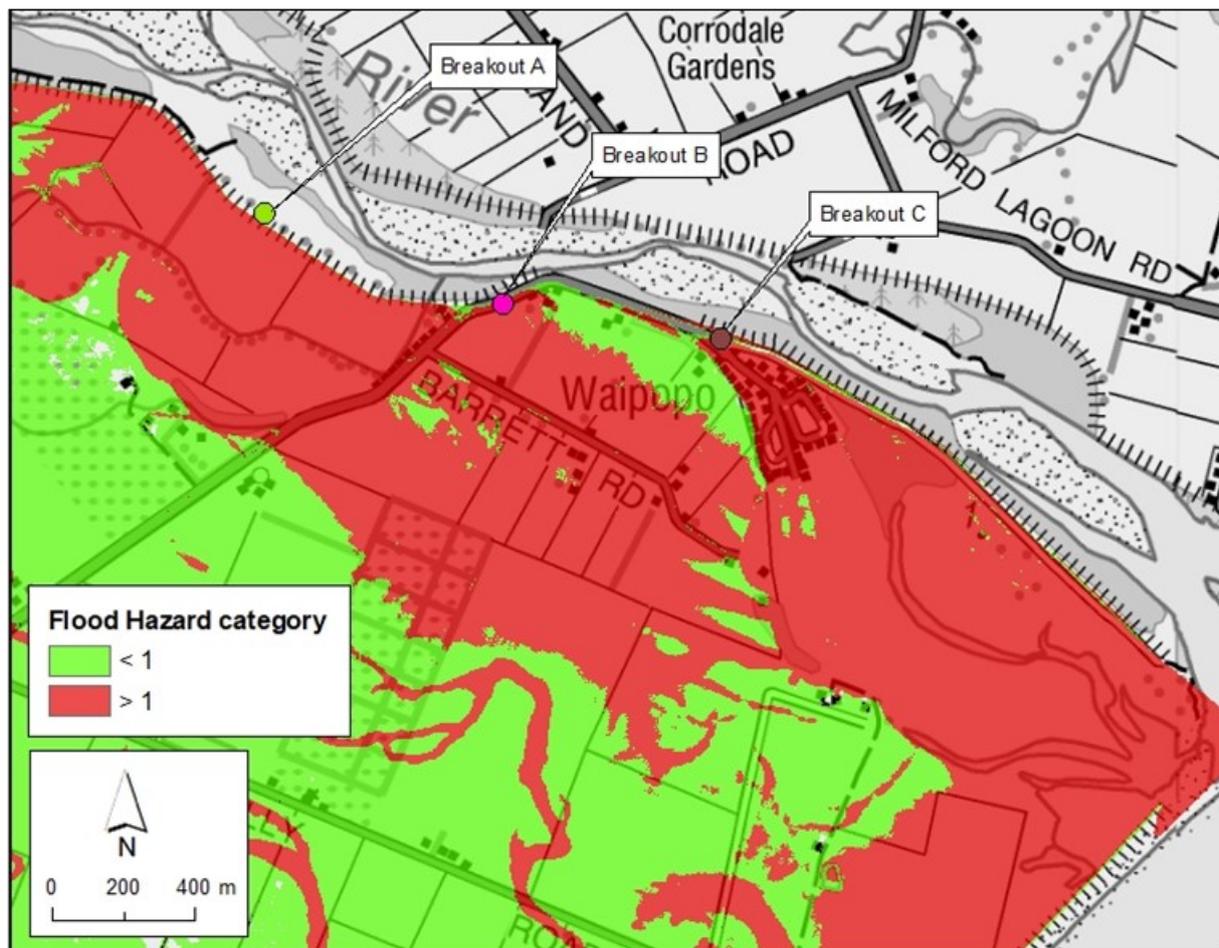
Figure A1-17: Flood hazard category [elevated scenario breakouts at SH1 and locations A, B and C with either flows increased by 25% or floodplain roughness increased to 0.07]

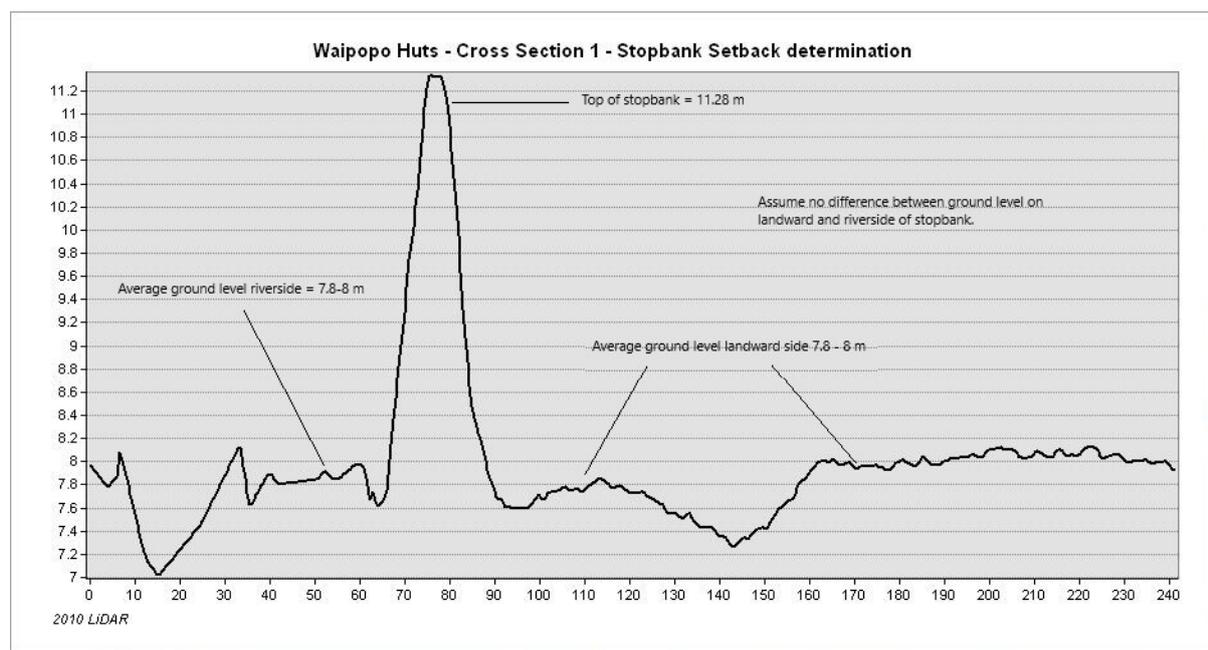
Figure A3-2: LiDAR cross section 1 Waipopo Huts Setback Distance Determination. LiDAR Cross Section 2

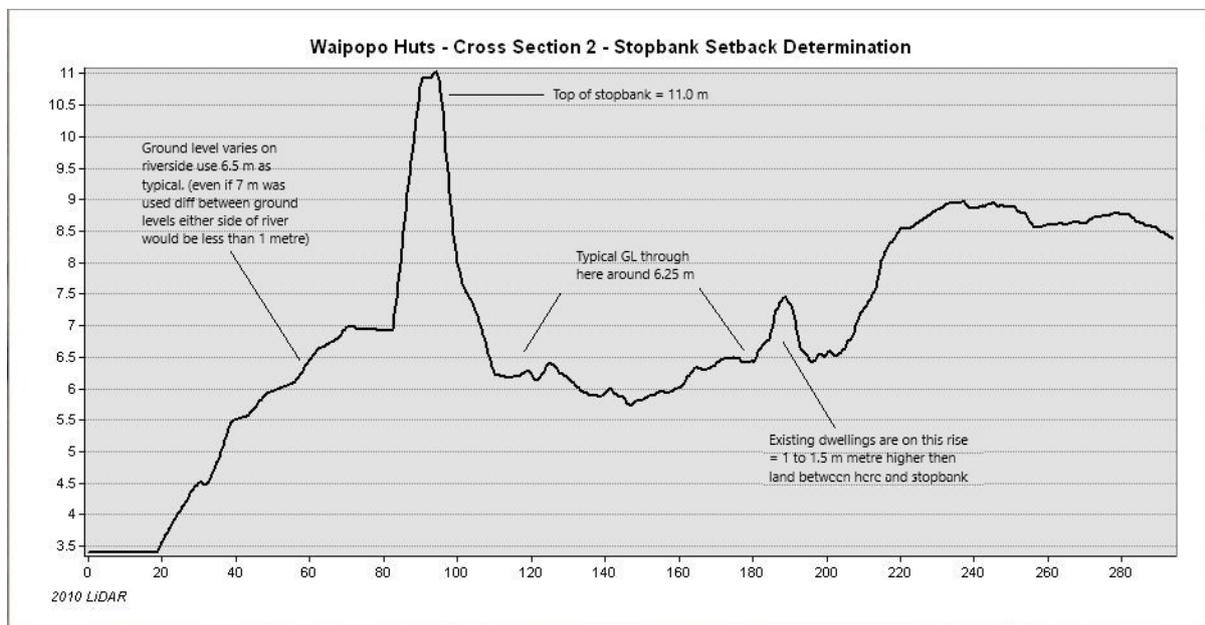
Figure A3-3: LiDAR cross section 2 Waipopo Huts Setback Distance Determination

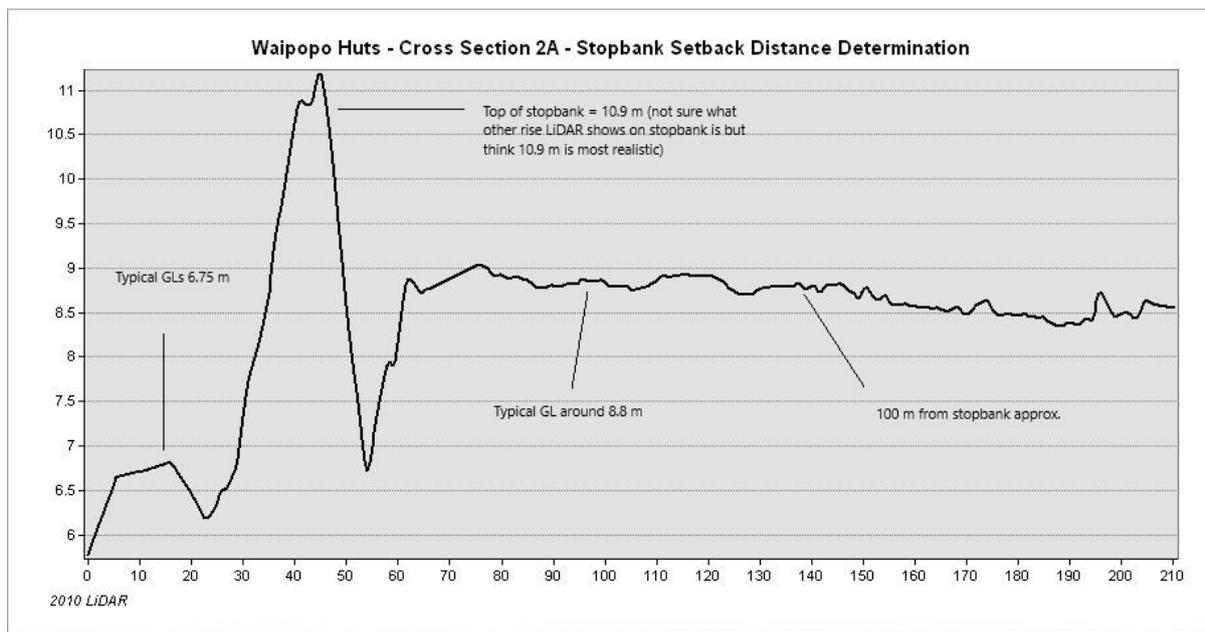
Figure A3-4: LiDAR cross section 2A Waipopo Huts Setback Distance Determination. LiDAR Cross Section 3

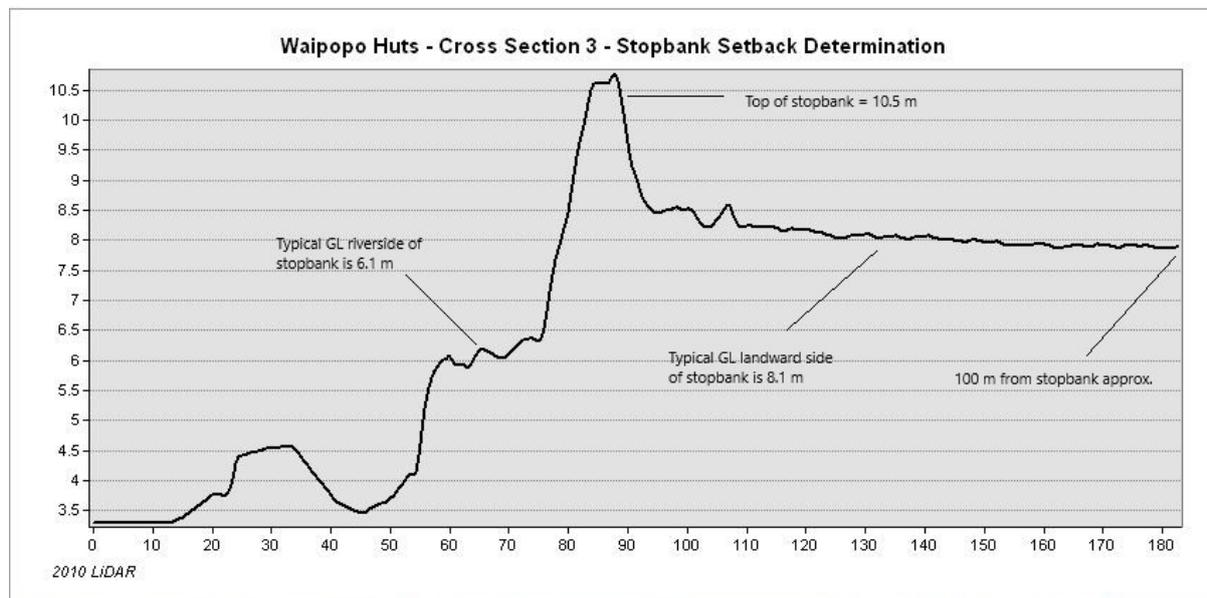
Figure A3-5: LiDAR cross section 3 Waipopo Huts Setback Distance Determination. LiDAR Cross Section 4

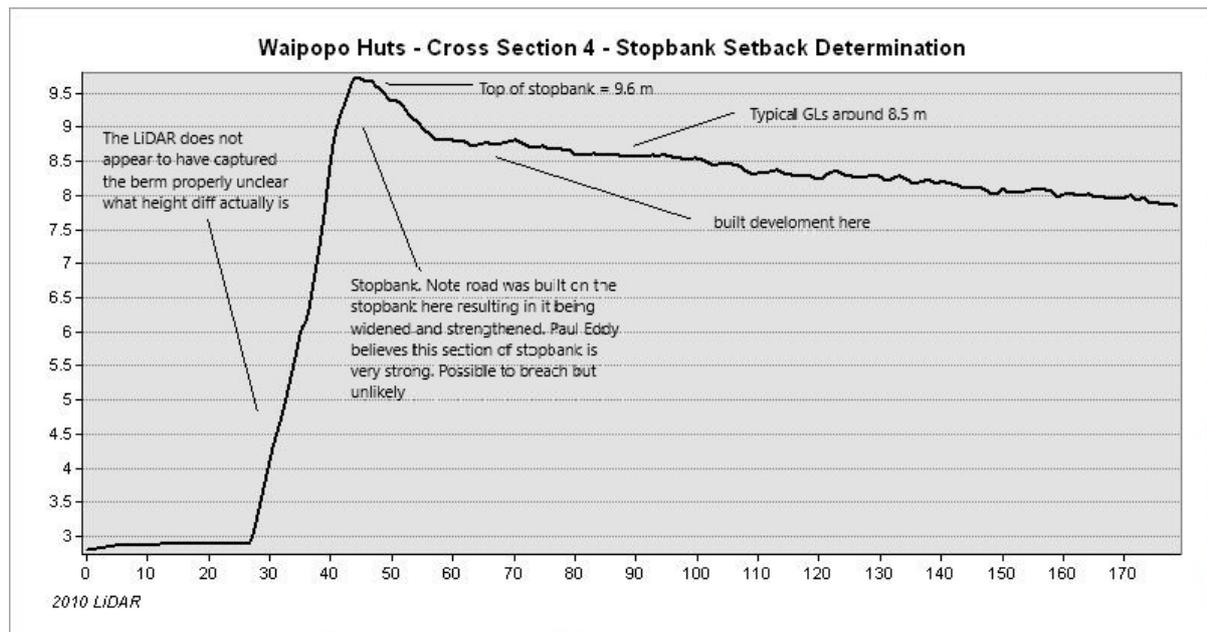
Figure A3-6: LiDAR cross section 4 Waipopo Huts Setback Distance Determination, LiDAR Cross Sections 5 & 6

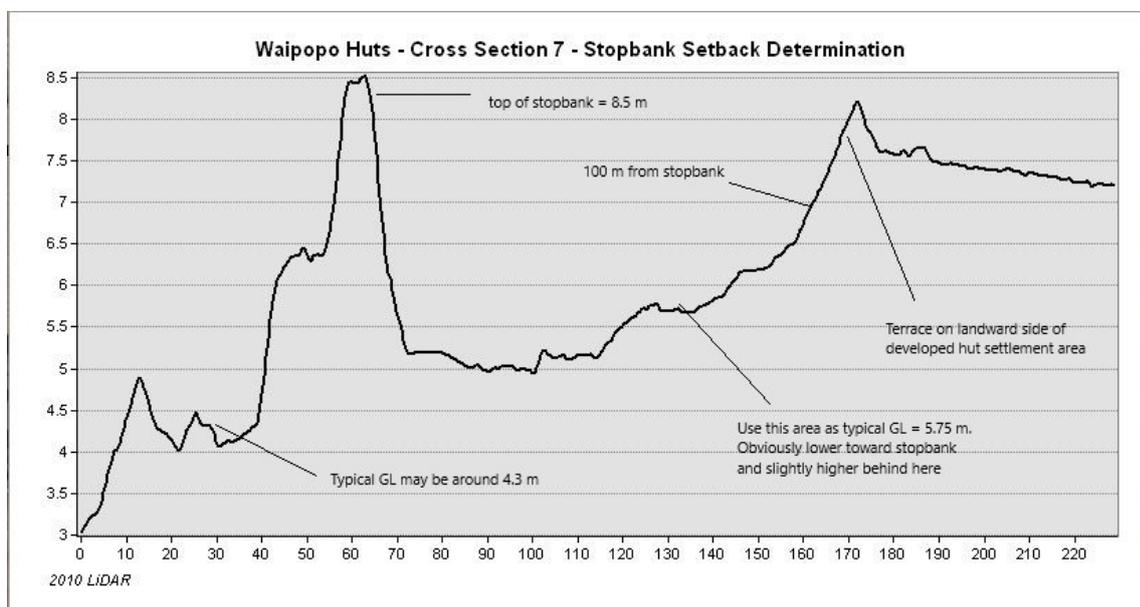
Figure A3-8: LiDAR cross section 7 Waipopo Huts Setback Distance Determination, LiDAR Cross Section 8

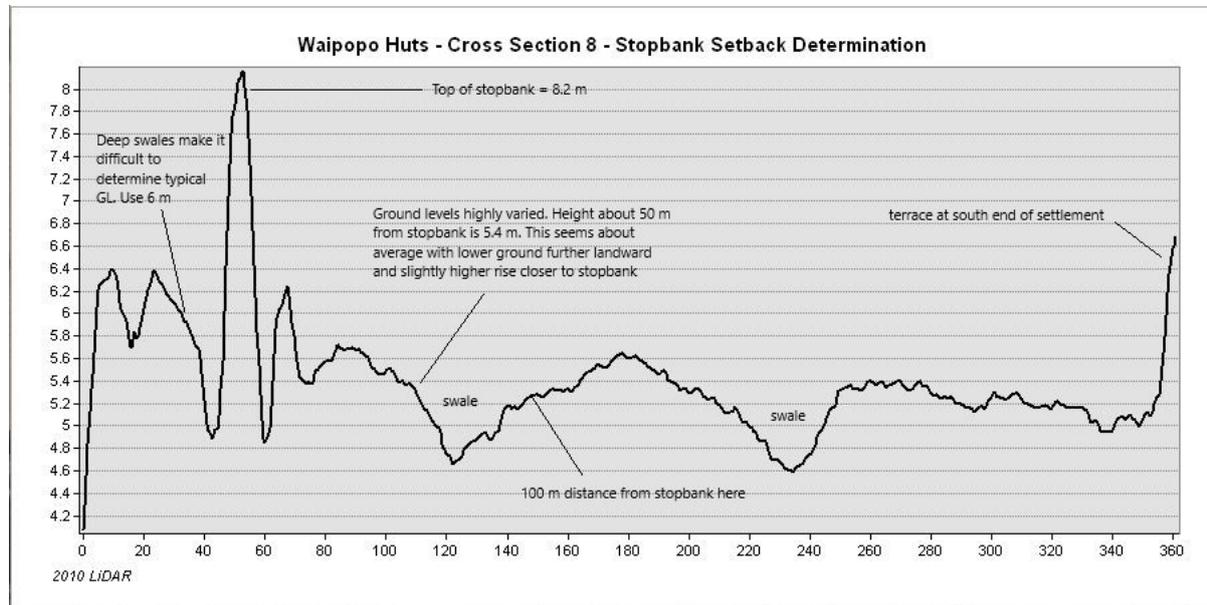
Figure A3-9: LiDAR cross section 8 Waipopo Huts Setback Distance Determination, LiDAR Cross Section 9

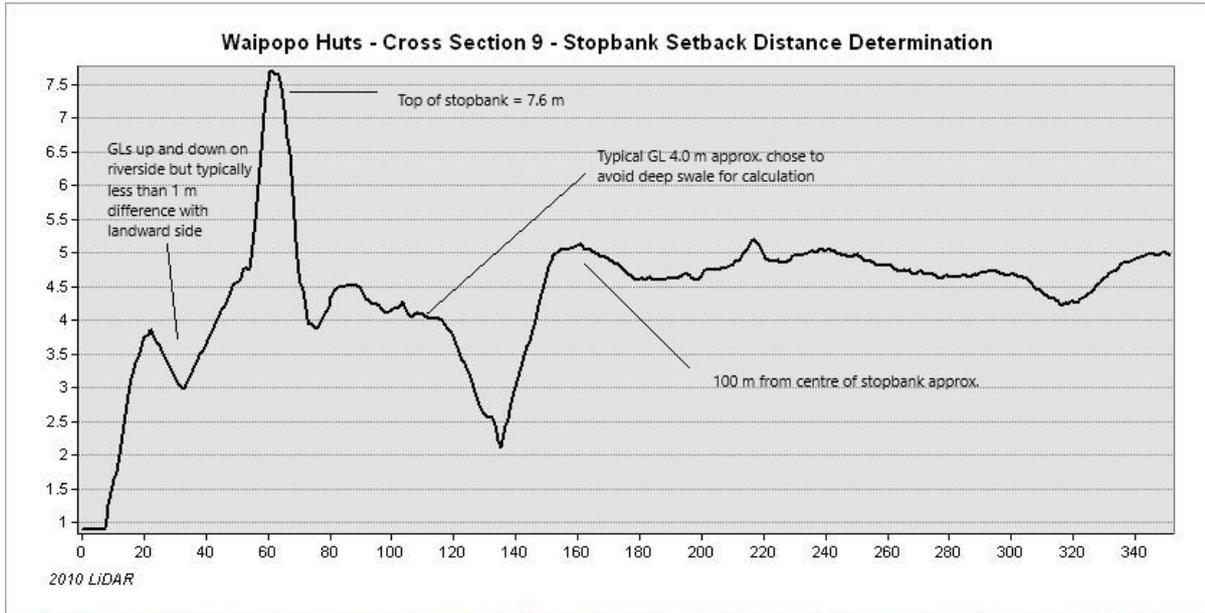
Figure A3-10: LiDAR cross section 9 Waipopo Huts Setback Distance Determination

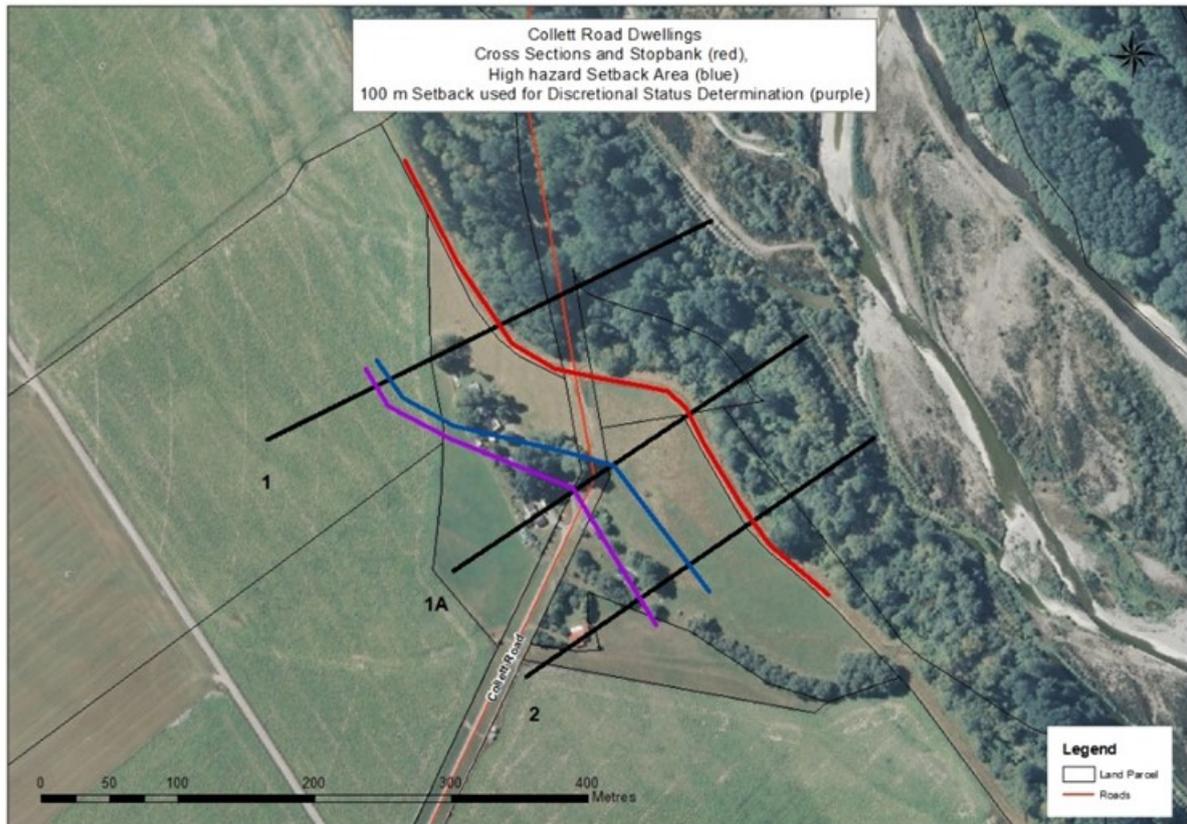
Stopbank (red), high hazard setback area (blue), 100m discretionary status trigger (purple)
