# **Bayhill Developments Ltd**

Demolish the Hydro Grand Hotel building and develop a mixed use office, apartment, retail, and hotel complex

10 The Bay Hill, Timaru

Resource Consent Application to the Timaru District Council

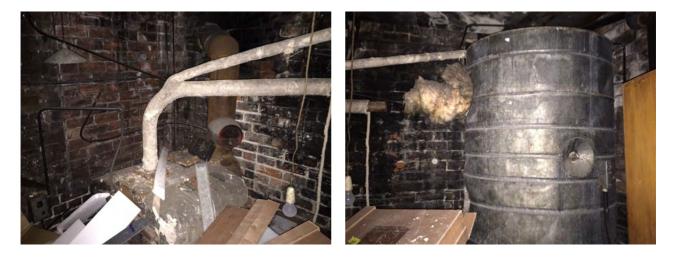
Photo 1 Original Boiler

The hotel was originally provided with heating by a central boiler. This boiler circulated hot water throughout the building for heating and domestic hot water. This boiler is now out of commission and has been redundant for many years. The photos below show the state of the old boiler. It would not be practical to reinstate any of this plant.

Photo 2 Original Heating Water Cylinder

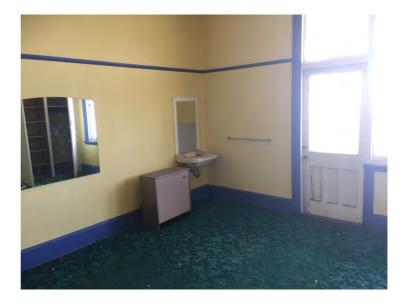
Photo 4. Typical Room heater, sink, opening windows

The plumbing and drainage systems throughout are very old and most components have deteriorated through lack of use. The potential corrosion and contamination inside the pipework means that all of these systems would require replacing.

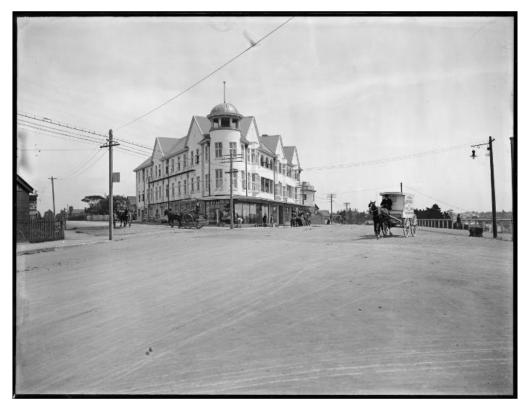
The Hydro Grand is a three-storey building in what has been described as Edwardian Baroque-style, but also owes something to the English Queen Anne style of architecture.

The triangular shape of the site has resulted in a wedge-shaped building, which celebrates the acute angle at the meeting of Stafford and Sefton Streets, with a domed turret over an open circular balcony at roof level. As originally built, the ground floor walls of the corner dining room were glazed floor to ceiling, but these were later replaced by masonry walls with the present arched window openings. An original canopy has also long since disappeared.

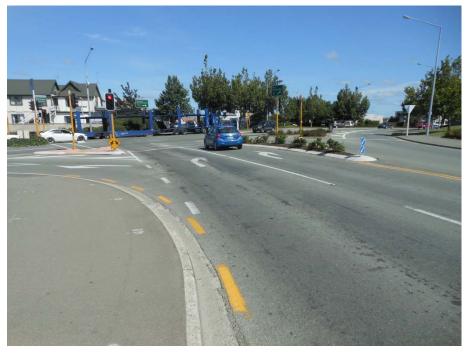
Photograph 1: Sefton Street Approach to SH1 Theodosia Street

Sefton Street along the southern boundary of the site forms part of State Highway 78 (SH78) which provides access to the Port of Timaru via Port Loop Road. Sefton Street meets Theodosia Street at a signalised intersection. There are left turn slip lanes on the Sefton Street approach and on the northern approach to the intersection. The lane markings and islands on the Sefton Street approach have been upgraded recently to enable dual right turn movements. The signals operate with three phases so that right turn movements are fully protected and not opposed by any through movements.

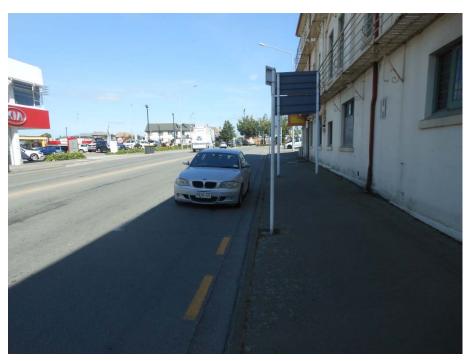
Photograph 2: On-street Car Parking on the Northern Side of Sefton Street

Sefton Street has been constructed with a 13m wide carriageway that provides a single traffic lane towards the port and two traffic lanes towards SH1. Parking is permitted on the northern side of the road over a distance of about 20m.

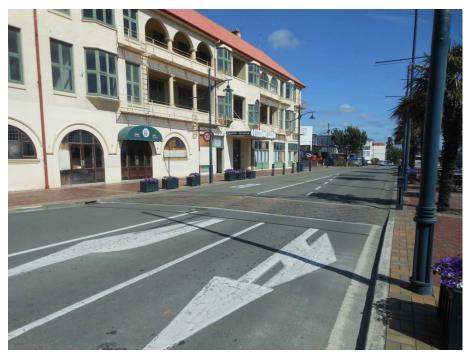
Photograph 4: Ramp and Raised Platform on The Bay Hill

The Bay Hill is classified as a local road and has been constructed to promote a low speed traffic environment with a narrow carriageway, parking on both sides of the road, wide footpaths and a 30km/h speed limit. There is a shallow ramp at the entry to The Bay Hill from Sefton Street that leads to a raised platform that reinforces the need for low vehicle speeds.

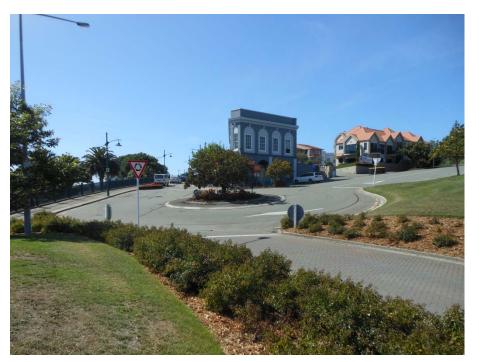
Photograph 7: Roundabout at Northern End of The Bay Hill – View South

The northern end of The Bay Hill can be accessed from Theodosia Street via a one-way road that leads to a small roundabout with a connection to two small public car parks with a total capacity of 56 spaces. The entry from SH1 includes a road hump to encourage drivers to reduce their speed.

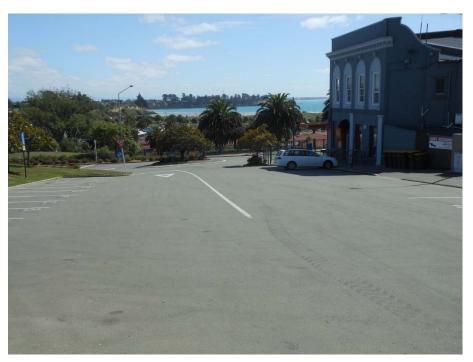
Photograph 8: Northern Car Parking Area at Midday

The northern car park includes 21 right angle parking spaces with a P120 restriction. The southern car park is accessed via a short lane and includes 35 public spaces with 15 spaces marked as privately leased and 17 spaces allowing all day parking.

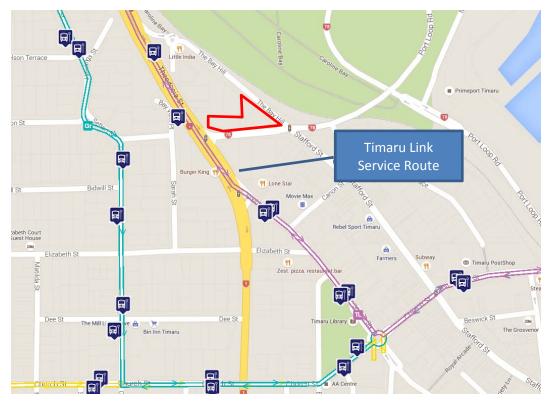
Figure 4: Public Transport Services

**Figure 4** shows public transport service routes in the vicinity of the site. The Timaru Link service connects the central business district with the outer suburbs. It includes clockwise and anti-clockwise routes that have bus stops on Theodosia Street west of the site.
