**Resource Consent No. 102.2026.59.1 response to request for further information**

**Resource Consent No. 102.2026.59.1**  
**Section 92 Request for Further Information**  
**Canterbury Regional Council**  
**Seadown Drain & Stopbank Realignment (GLOBAL) -**

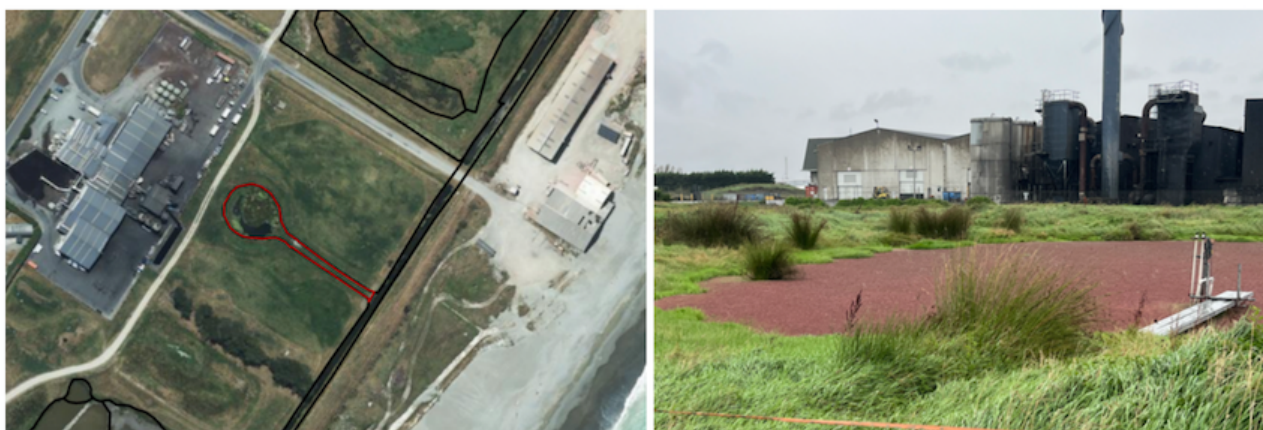
This is a small circular constructed wetland, built 10-15 years ago as a stormwater retention pond. It will be completely reworked, and replaced with a similar facility that partially overlaps the footprint to the west, to allow for the new drain alignment to pass east of it. The wetland report states that this wetland:

*presents shallow water with floating Azolla rubra (Figure 11) and is not considered ecologically significant.*<sup>1</sup>

Isolated individual rush plants are also growing on the banks of this wetland. The wetland location and character are shown below.

Figure 1: FBNZ wetland (Source: wetland report Figure 11)

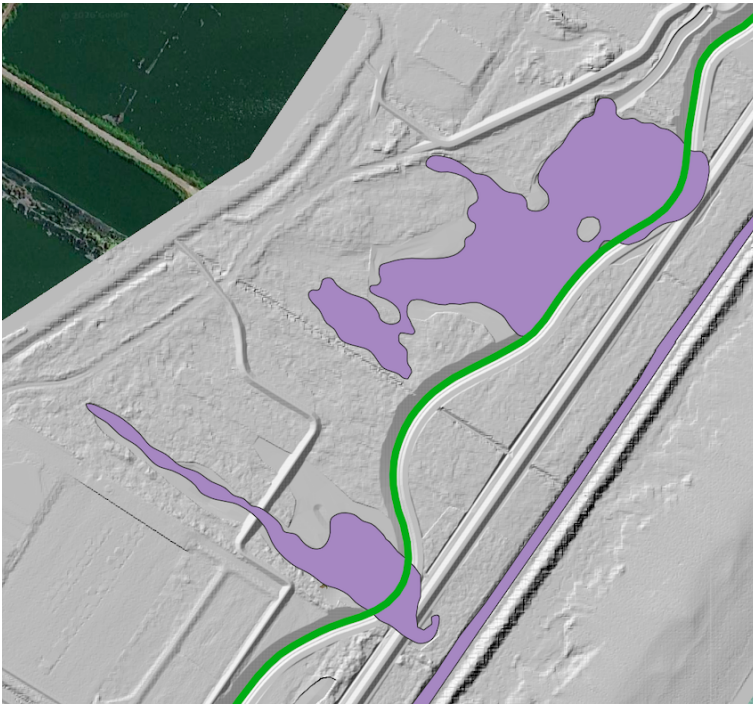
Earthworks and vegetation removal will partially overlap with these wetlands as the alignment passes through their eastern extents (Figure 2 and Figure 3 below). An estimated 0.5ha of rushland may be removed.

Figure 2: Existing pit-derived wetland extents (purple) and new drain alignment (green)

The raupō reedland, which is identified as ecologically significant and will be avoided as far as practicable. If works in that area is unavoidable, plants will be relocated to somewhere suitable onsite to support their survival.

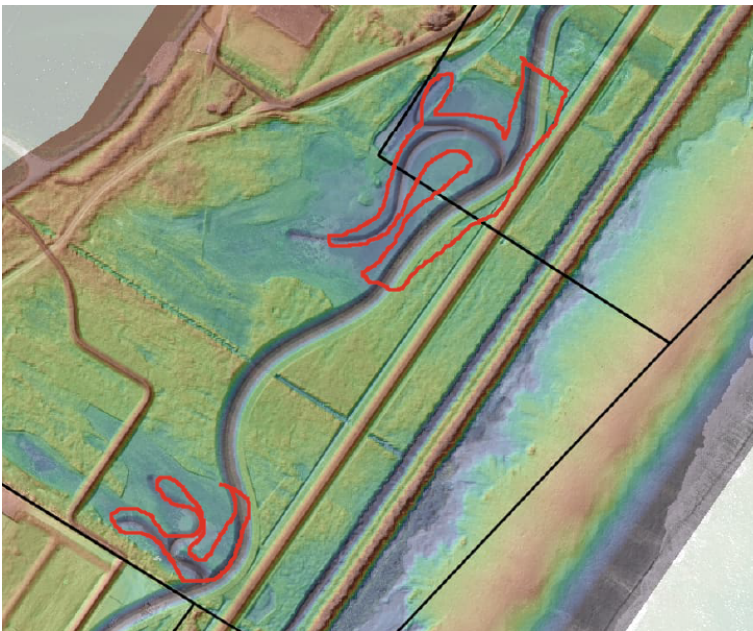
Figure 3: Anticipated earthworks extents in pit-derived wetlands (red).

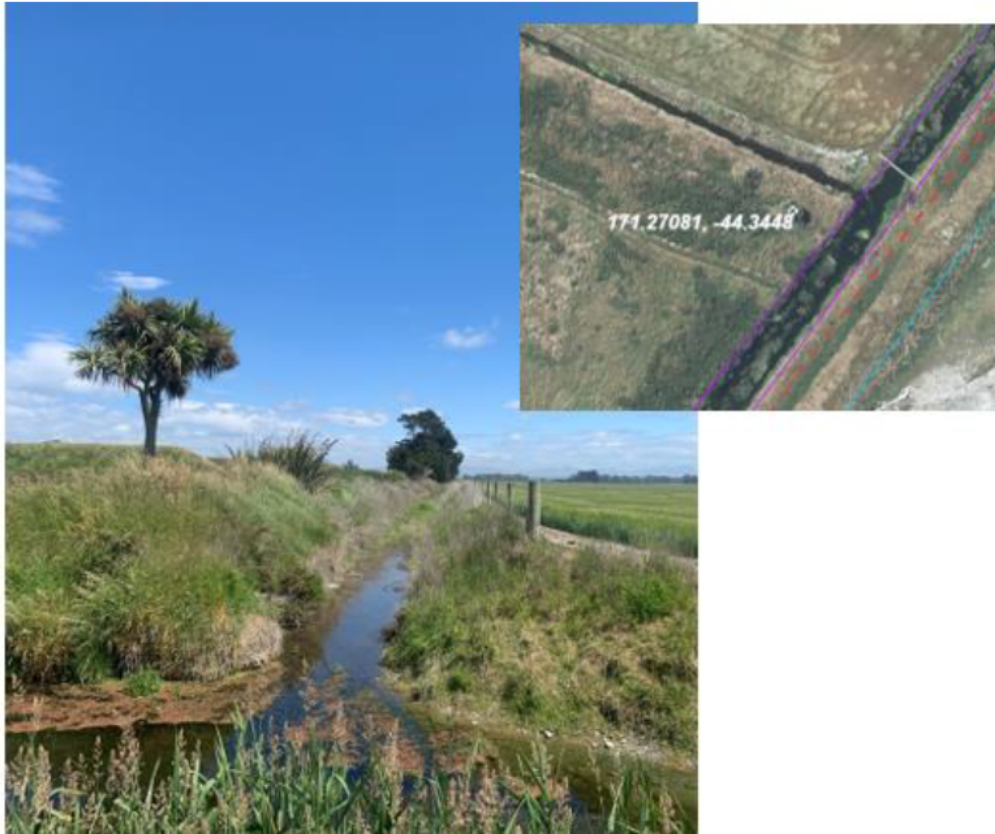
As shown in Figure 4 below, one cabbage tree and one flax are present on the south bank of number 2 drain where the connection of the realigned and existing main drain alignments will occur. These plants will be removed during construction and this is not considered to be significant.

Figure 4: Two indigenous plants on number 2 drain (Source: Internal Environment Canterbury document)
