Infrastructure Committee Meeting

Tuesday 12 March 2019

Policy Analyst	
Patiti Point Access

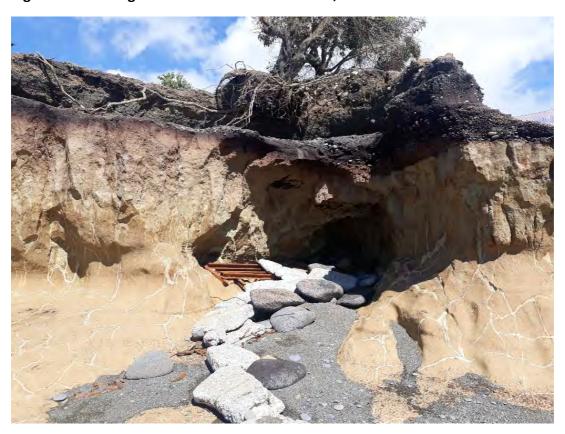
Figure 2: Showing cliff erosion at South Street, Patiti Point. 13 December 2018

- 9. In November 2018 a WSP-Opus geotechnical engineer undertook a walkover of the site and noted that since the March assessment several metres had been lost at some locations along the cliff, and that the wave action was causing the lower parts of the cliffs to erode (see Figures 2-5).

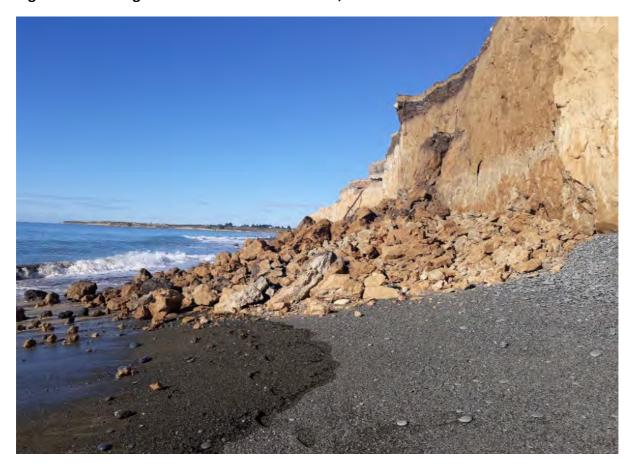
Figure 3: Showing cliff erosion at South Street, Patiti Point. 1 March 2019.

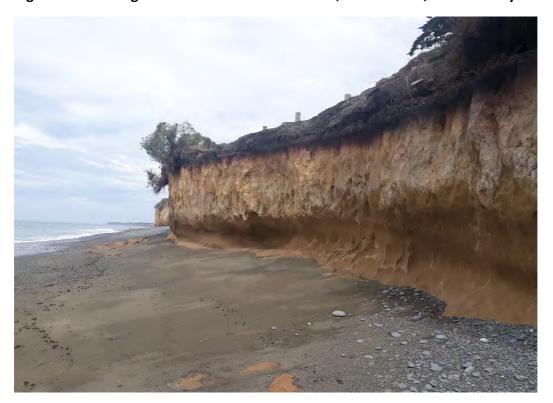
Figure 4: Showing cliff erosion at South Street, Patiti Point, 19 February 2019

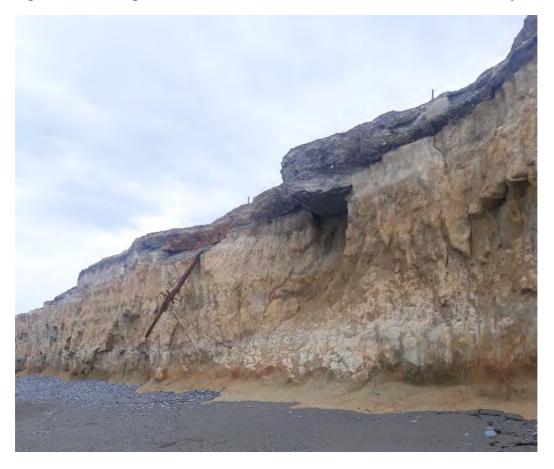
Figure 5: Showing cliff erosion at South Street, Patiti Point, 19 February 2019

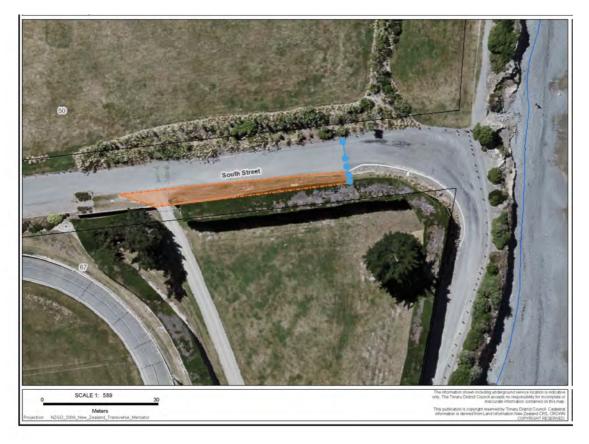
Figure 6: South Street, Patiti Point Car Park Option Concept

- 16. Once the trigger points are reached and vehicle access is no longer safe, it is recommended that only pedestrian access be allowed. Figure 6 shows a concept drawing of the closure of the South Street access road. There will be minor upgrades to the berm outside the pistol club for drainage and to create an informal carpark. Permanent bollards and fencing have already been installed at this site (Figure 7).

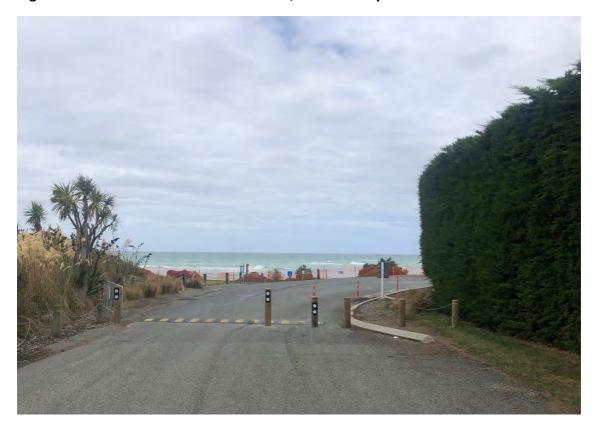
Figure 7: South Street Barrier and Gate, 19 February 2019
