DRAFT - Timaru Stormwater Management Plan

Prepared for Timaru District Council

3 May 2023

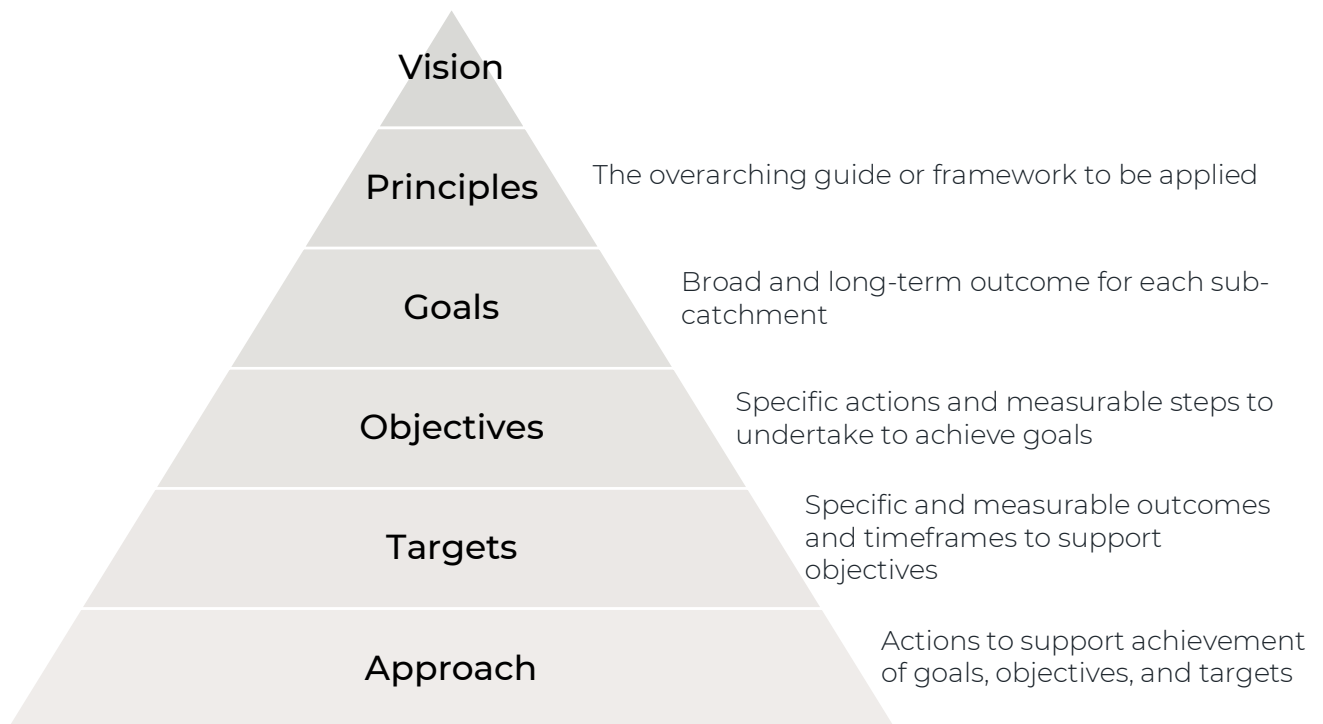
Figure 2-1 Stormwater Strategic Hierarchy

The structure of this SMP applies the planning framework presented in Figure 2-1. Where the vision describes the future and hopes for the management of stormwater for the community Timaru and the environment, and each subsequent component in the hierarchy supports the vision.

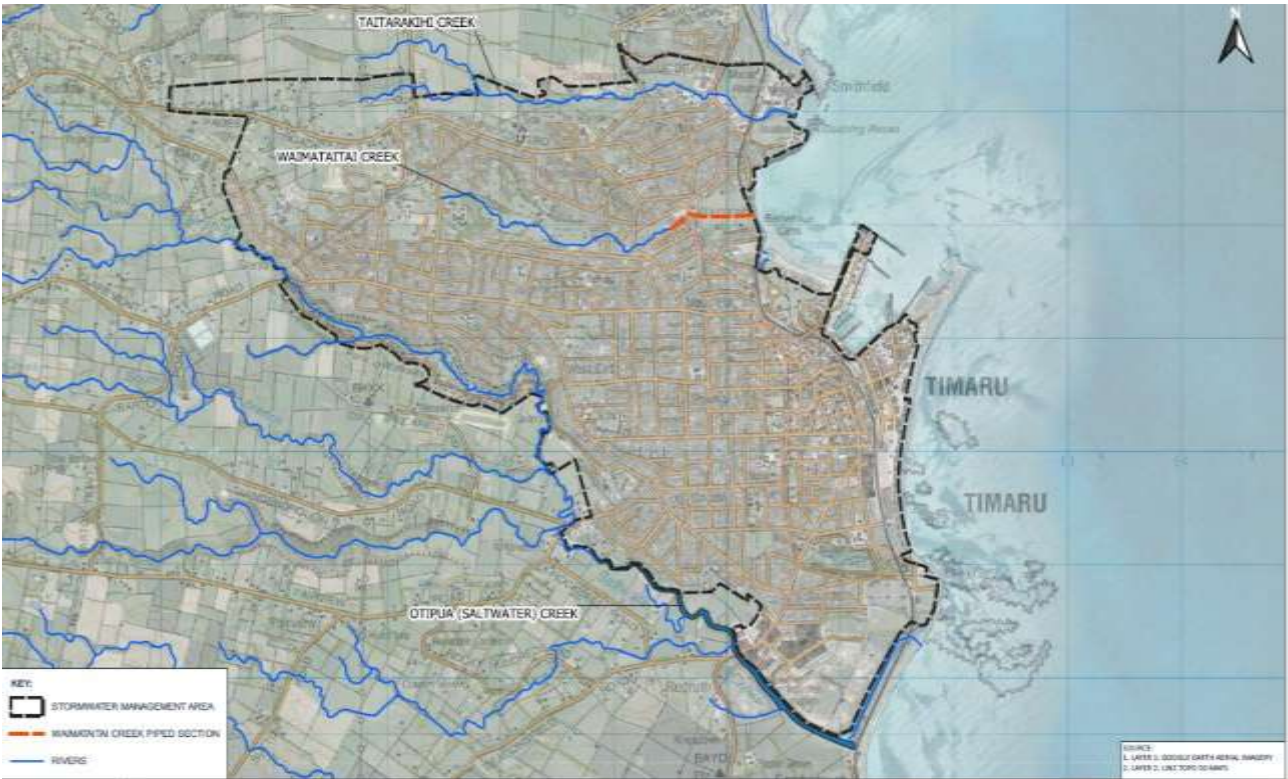
Figure 3-1 Timaru Stormwater Management Area

The Timaru SMP covers the stormwater activities and TDC’s infrastructure within the Timaru Stormwater Management Area (SMA) that is shown in Figure 3-1.

The SMA extent is based on both the existing urban area and most of the anticipated urban Future Development Areas (but still zoned rural) set out in the proposed Timaru District Plan (pTDP). TDC has obtained a series of Resource Consents from Environment Canterbury that permit TDC to manage and discharge stormwater from existing urban areas and future urban growth to groundwater, surface waters, and coastal environments.

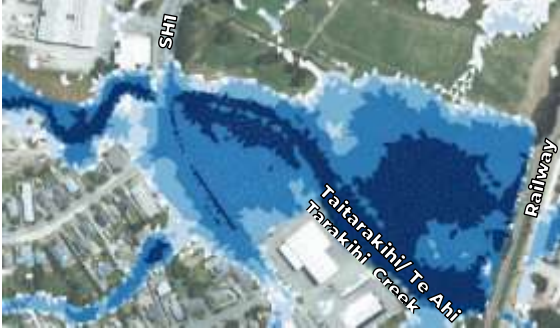
Location	Description
<p>1. Taitarakihi/Te Ahi Tarakihi Creek</p>

<p>The area around State Highway One (SH1) near the bottom of the Taitarakihi/ Te Ahi Tarakihi Creek catchment is arguably the highest flood risk area in Timaru, with multiple instances of property and businesses flooding in recent years and flooding of SH1. Upgrades to increase the culvert capacity beneath the railway was completed in 2022 and Waka Kotahi have plans to also upgrade the culverts beneath SH1. These two major upgrade projects will greatly increase the capacity of the Creek but a wider catchment-scale option (e.g. attenuation of the upper catchment and creek widening) will be required to lower the flood risk in this area to an acceptable level.</p>
<p>2. Waimataiati Stream</p>

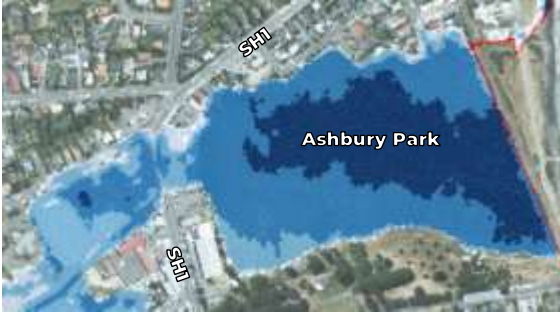
<p>There are known flooding issues in the lower parts of the Waimataiati Creek catchment, particularly around the commercial area including Pak-n-Save. However, the modelled flood extents may be overstating the flood risk as downstream of the Highfield Golf Course, the stormwater network has not yet been added to the stormwater model. Results are based on rain-on-grid modelling and areas like Ashbury Park show as flooded because the railway embankment acts as a dam. TDC have a current model build project for the Waimataiati and Whales Creek catchments which is scheduled for completion mid-2023, from which the flood risk can be better understood, and solutions investigated.</p>

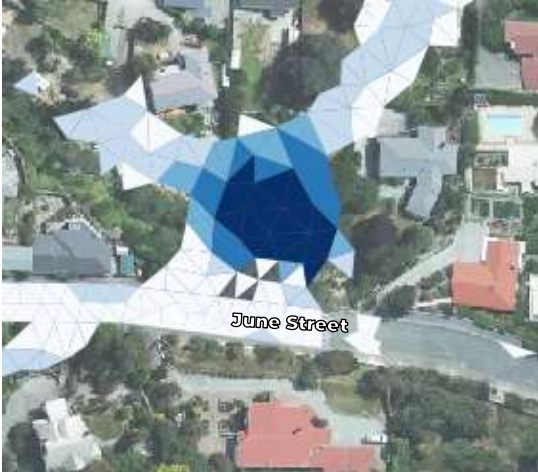
<p>3. June Street</p>

<p>The June Street issue is with a vertical stormwater pipe that was installed to convey stormwater from June Street over a 20m high cliff to the property below. In this high energy environment, surcharging of the downstream manhole caused flooding in the shared driveway and adjacent properties. A grated manhole lid was installed on the manhole to release air pressure which has helped, however overland flow from June Street continues to be an issue in heavy rainfall. TDC's Land Transport unit are investigating a solution to improve inlet capacity in June Street</p>

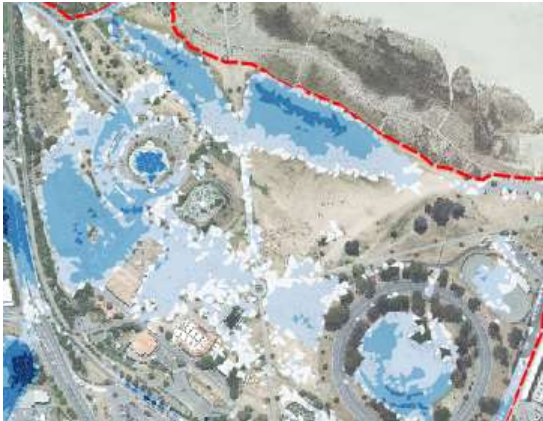
<p>4. Caroline Bay</p>

<p>Caroline Bay is an area well known for flooding of the roads, playground and paddling pool following heavy rainfall, caused by a combination of overflows from an undersized stormwater main (servicing the large Whales Creek catchment) and inadequate localised drainage to clear excess water after the event. Works are underway to seal the main stormwater line which will increase capacity by allowing the pipeline to surcharge without spilling. Combined with this are improvements to the local drainage system, including a small pump station to drain low lying areas.</p>
<p>5. Kauri Street</p>

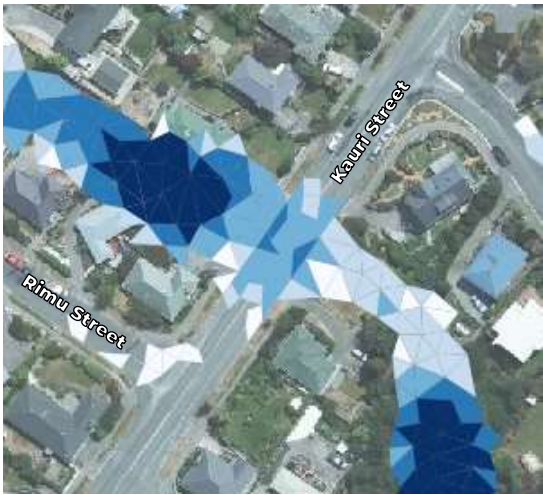
<p>Properties either side of Kauri Street, that are located in the overland flow path, are lower than the road, with the road an obstruction to the overland flow. Recent works have been undertaken to increase inlet capacity in Kauri Street along with some entranceway modifications to prevent surface flow from Kauri Street spilling down the driveway and into the garage/downstairs rooms at 9 Kauri Street. These works improved the situation for small frequent events, but extensive network upgrades and/or major overland flow path modifications would likely be required to make any significant improvements to level of service.</p>

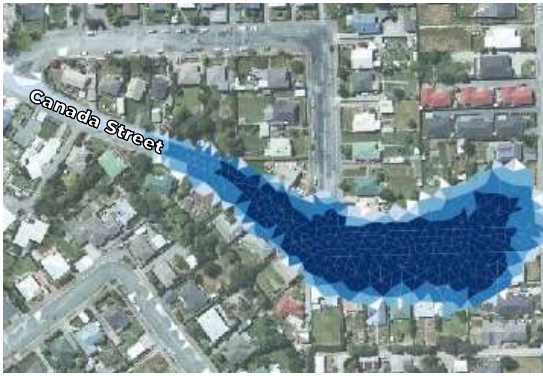
<p>6. Canada Street</p>

<p>This area of Canada Street, in the Gardens Gully catchment, is a low point in the topography with no overland flow path (until ponding has risen over 2m deep to overtop Woodland Road). Some work to clear root intrusion in 2017 helped to improve the level of service in small events. Hydraulic modelling indicates that the area would benefit from both improvements in inlet capacity and pipe network capacity, along with consideration of overland flow path management.</p>

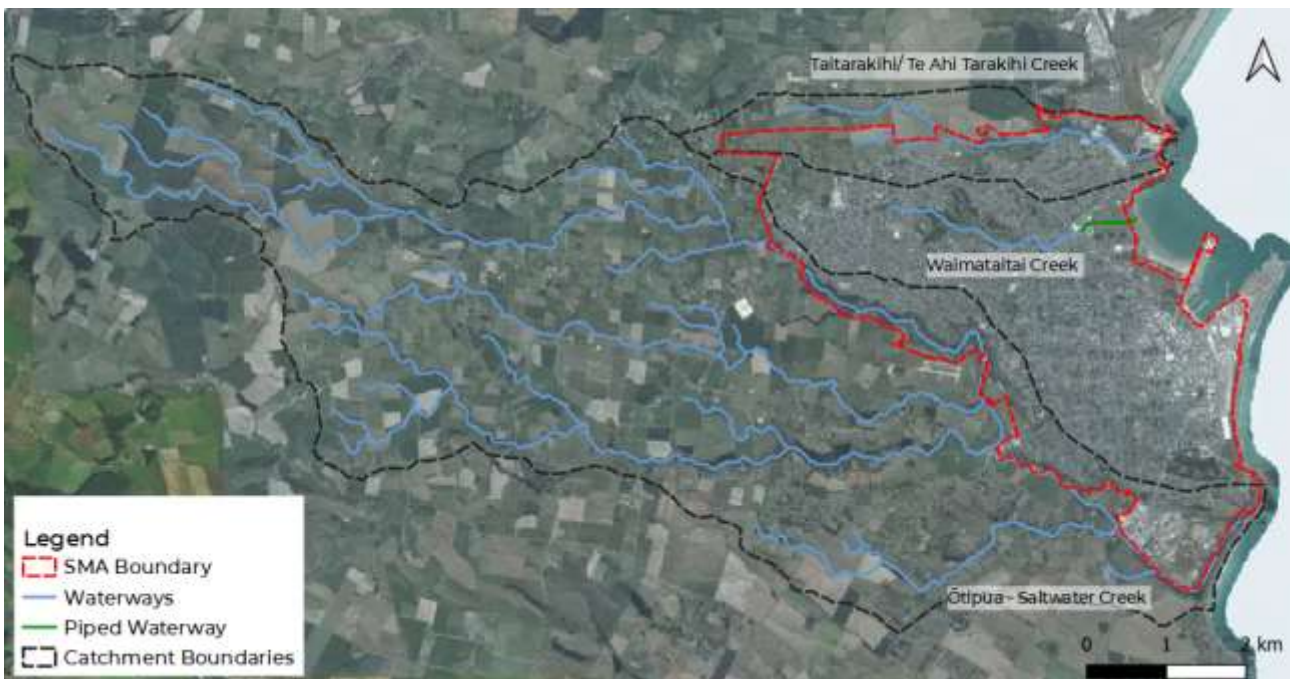
Figure 5-1. Timaru SMA, Catchments and Waterways.

The Timaru SMA is 1,900 ha and is bordered by Ōtipua - Saltwater Creek in the south and Taitarakihi/ Te Ahi Tarakihi Creek to the north. The area of the wider hydrological catchment of both these rivers and including the SMA is 6,456 ha, shown in Figure 5-1.

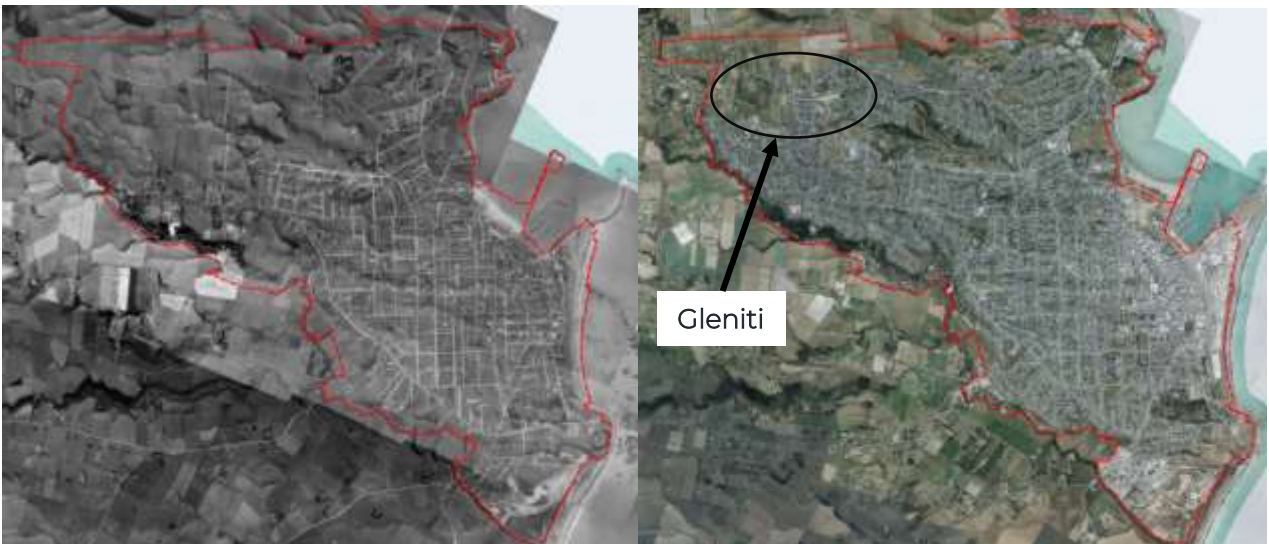
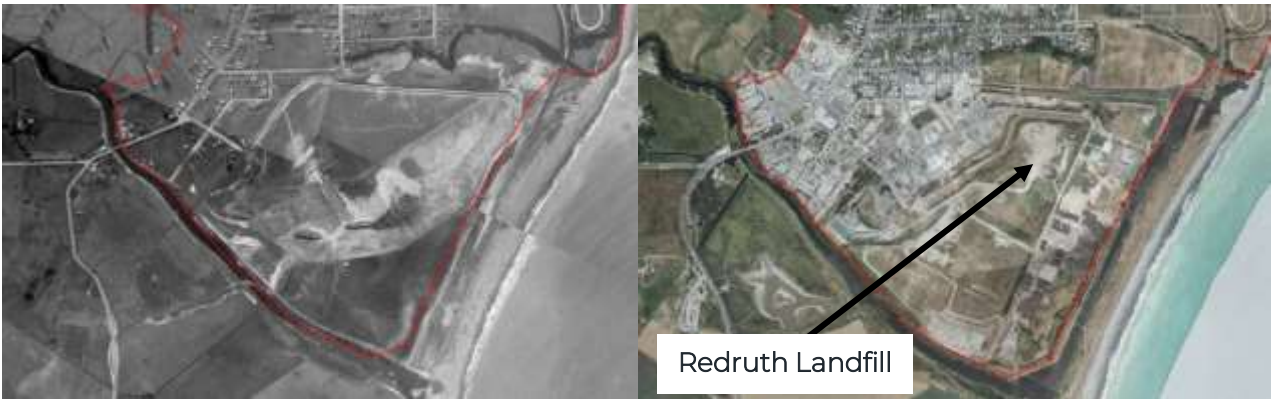
Figure 5-3. Historic imagery (1935 – 1939) and Current LINZ aerial imagery in the Timaru SMA.

Urban growth since the 1970s has predominantly been in the northwestern suburb of Gleniti as depicted in Figure 5-3. Whilst Redruth in the southeast has been the focus of industrial and commercial growth since the 1940s. Currently, Timaru District Council operate the Redruth Landfill and resource recovery park at the south-eastern extent of the SMA. As presented in Figure 5-3, the Ōtipua-Saltwater Creek has been realigned around the landfill, and the outlet to the creek now occurs to the north of the landfill.

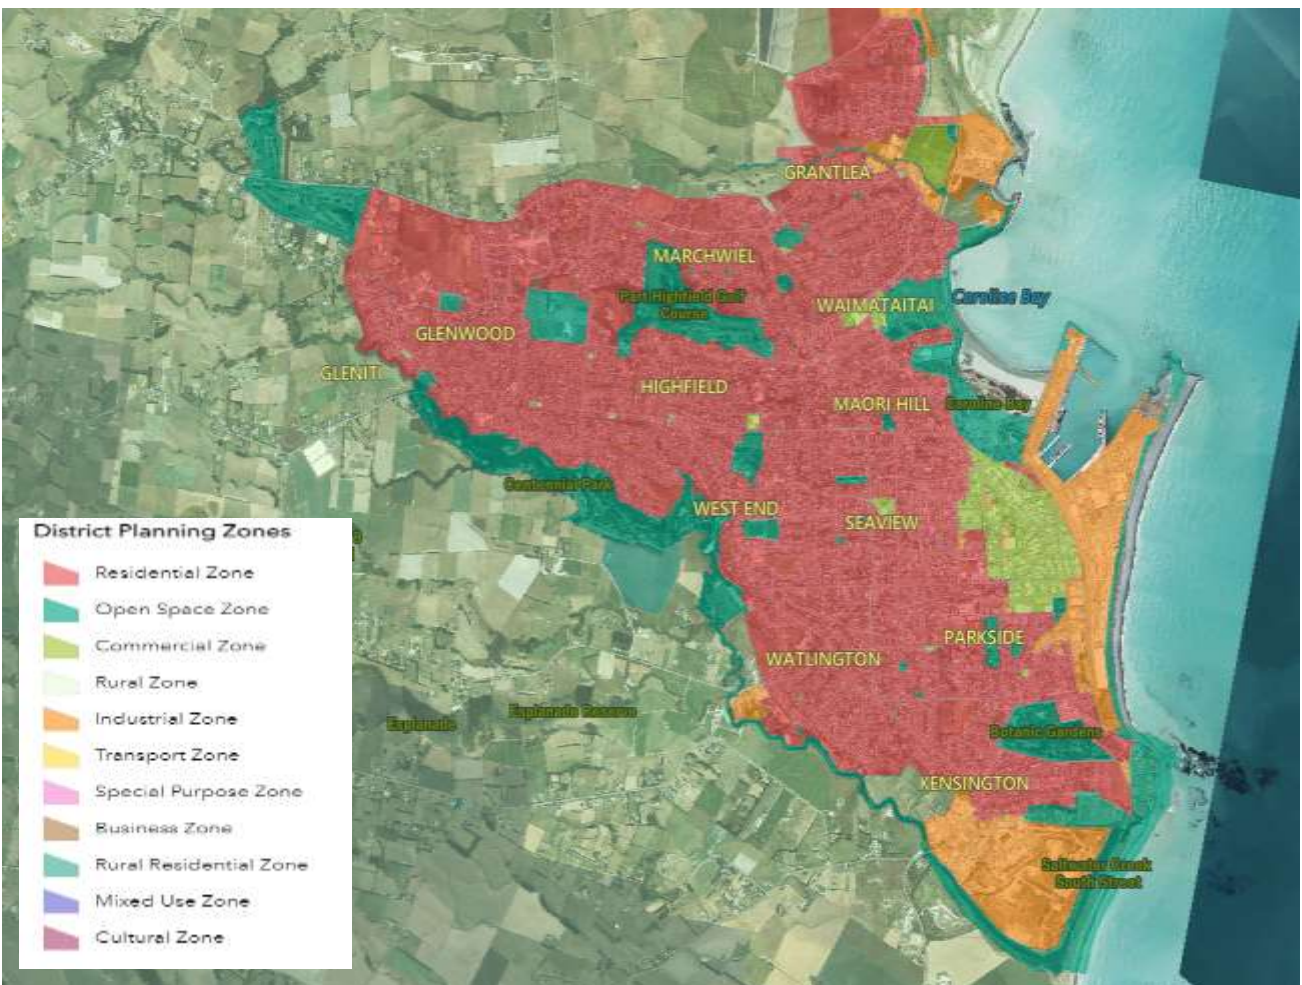
Figure 5-4 Current land use zoning from the operative Timaru District Plan

The land use zoning in the operative Timaru District Plan (TDP) includes Rural, Recreational, Residential, Commercial, and Industrial Light and Industrial Heavy zone types. The land use zones from the District Plan do not separate roads from land. The current district plan provides an indication of the current land use in the SMA, shown in Figure 5-4.

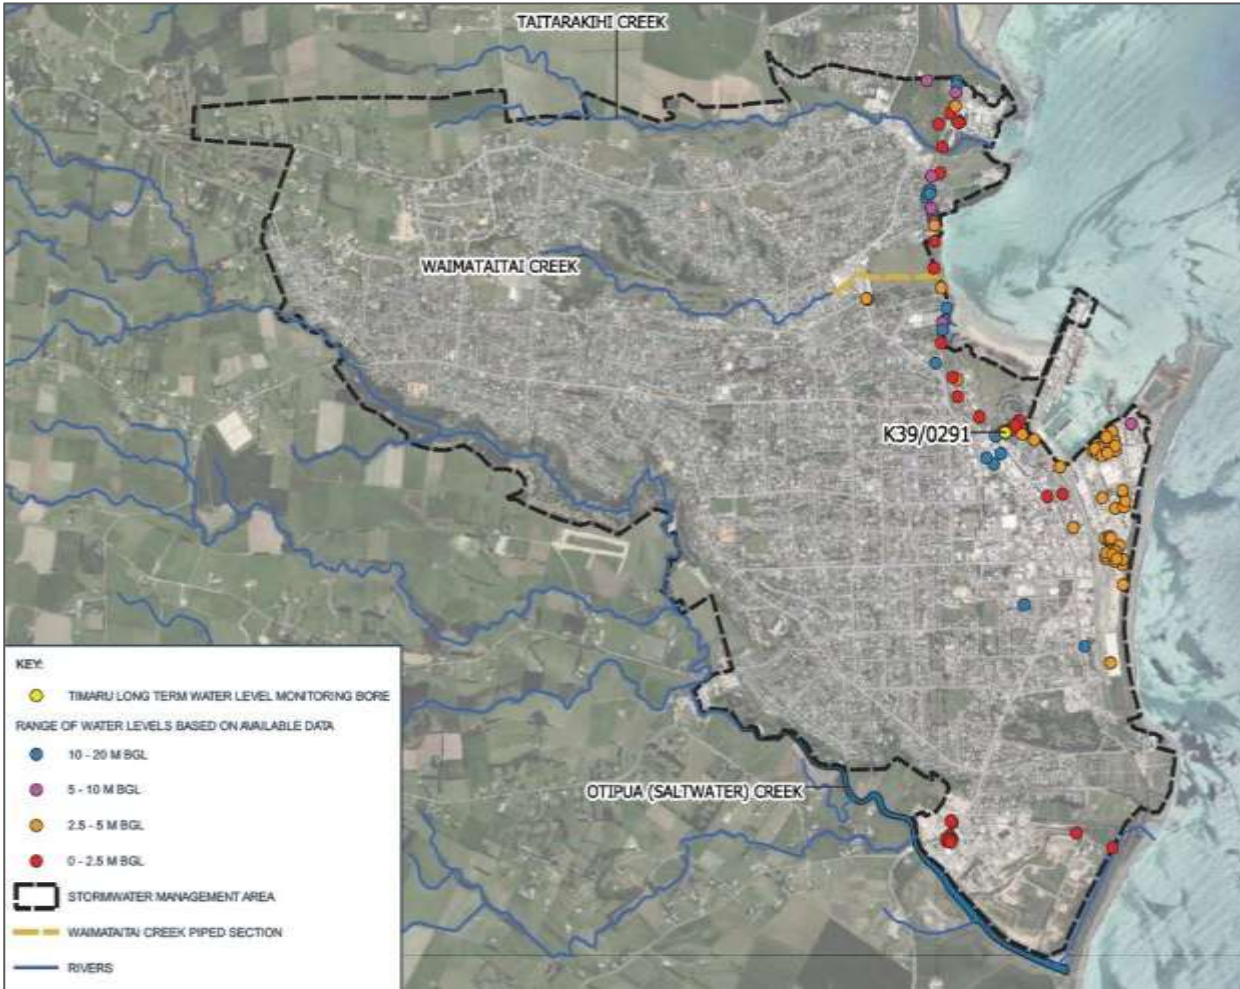
Figure 5-10 Depth to groundwater

In Timaru, the groundwater level varies throughout the SMA, likely a reflection of the city’s undulating topography. Figure 5-10 shows depth to groundwater in metres below ground level (m bgl) measured within shallow bores (< 30 m deep) in Timaru (sourced from ECan).

The depth to groundwater appears to be shallow (0 to 5 m bgl) in areas of low elevation at the coast near the eastern boundary of the SMA. Larger depths (5 to 20 m bgl) are expected in areas of higher elevations near the eastern boundary of the SMA. The available step-drawdown testing information (bore testing data) indicates the shallow strata within the SMA is of relatively low permeability. This is supported by the lack of abstraction bores, which is an indicator of low permeability strata, especially given Timaru is a substantial settlement and many industrial activities could benefit from a groundwater supply. The bores present within the SMA are predominantly geotechnical/geological investigation bores or observation wells. There is a distinct lack of groundwater level readings in the western portion of the Timaru SMA.

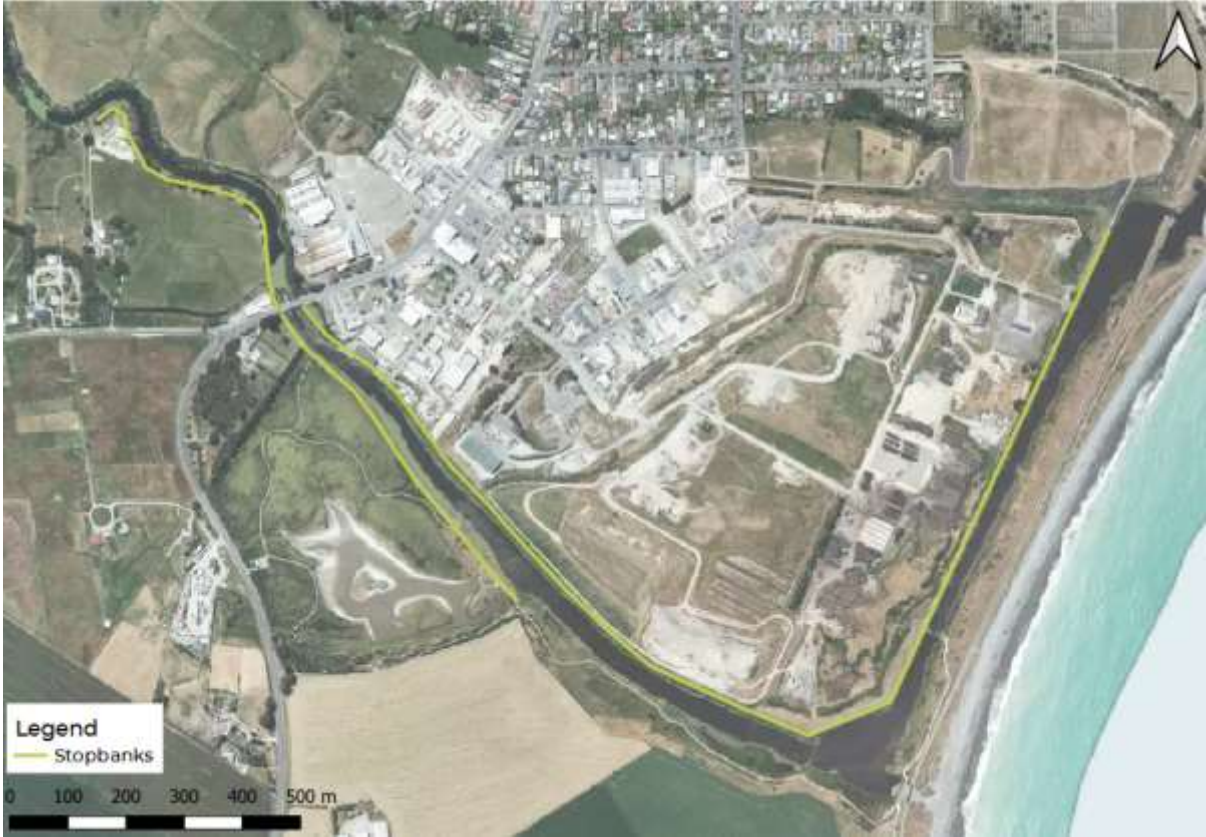
Figure 5-13 Stopbanks along Saltwater Creek

Notable flood protection infrastructure within the SMA includes the stop banks either side of Saltwater Creek near Scarborough (Figure 5-13). These stop banks were constructed to divert the flow around the historic Ōtipua Lagoon, which was drained to construct the Redruth Resource Recovery Park.

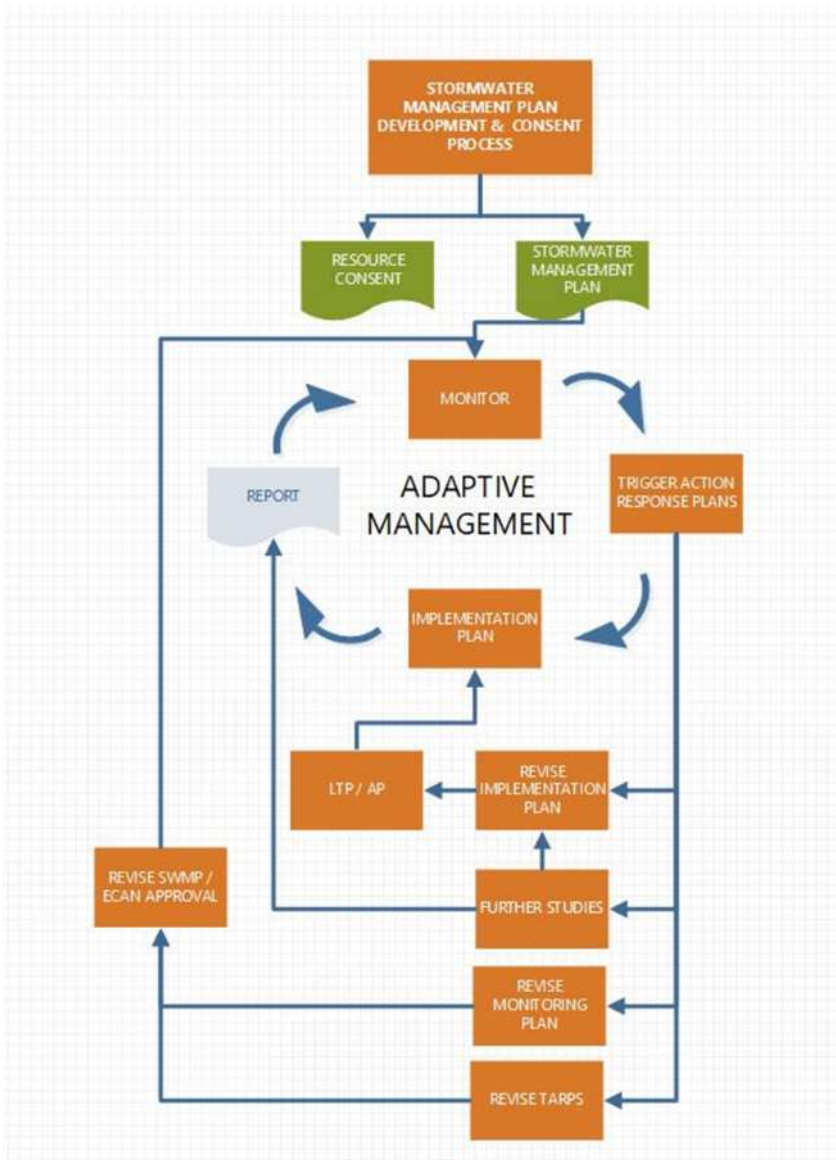
Figure 8-1 Stormwater Management Plan Adaptive Management Approach

As outlined in Section 9.3 the Monitoring Plan will allow TDC to evaluate the performance and progress of the stormwater management infrastructure to achieve these objectives and targets, and more importantly, trigger the identification of additional projects that would improve the outcomes of the stormwater system.
