TIMARU DISTRICT COUNCIL
HISTORIC HERITAGE ITEM RECORD FORM

HERITAGE ITEM NAME former Union Bank of Australia

ADDRESS 119 Stafford Street, Timaru

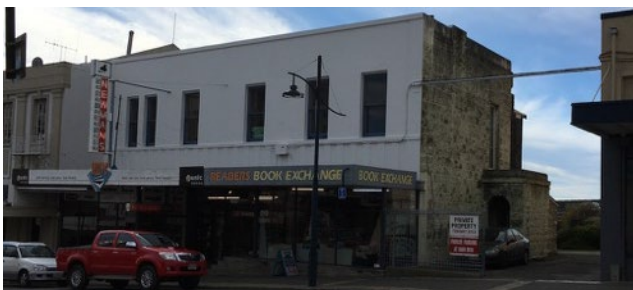
PHOTOGRAPH

Two storey-building with irregular rectangular footprint and hipped and gabled roof forms. Suspended veranda across plastered façade, with modern shop fronts on ground floor and six window openings above. Bluestone construction is exposed on the side (south) and rear (east) walls. Double-hung sash and casement windows. Single-storey gabled extension at rear with hip roofed brick outbuilding beyond that.

Timaru bluestone (basalt), cement plaster, brick, slate and corrugated iron.

Façade remodelled and suspended veranda installed; modern shop fronts erected in front of original building facade (pre-1970?).
