HYDRO GRAND HOTEL

10 THE BAY HILL, TIMARU

HERITAGE ASSESSMENT

Report Prepared by
SMART ALLIANCES LTD
for
TIMARU DISTRICT COUNCIL

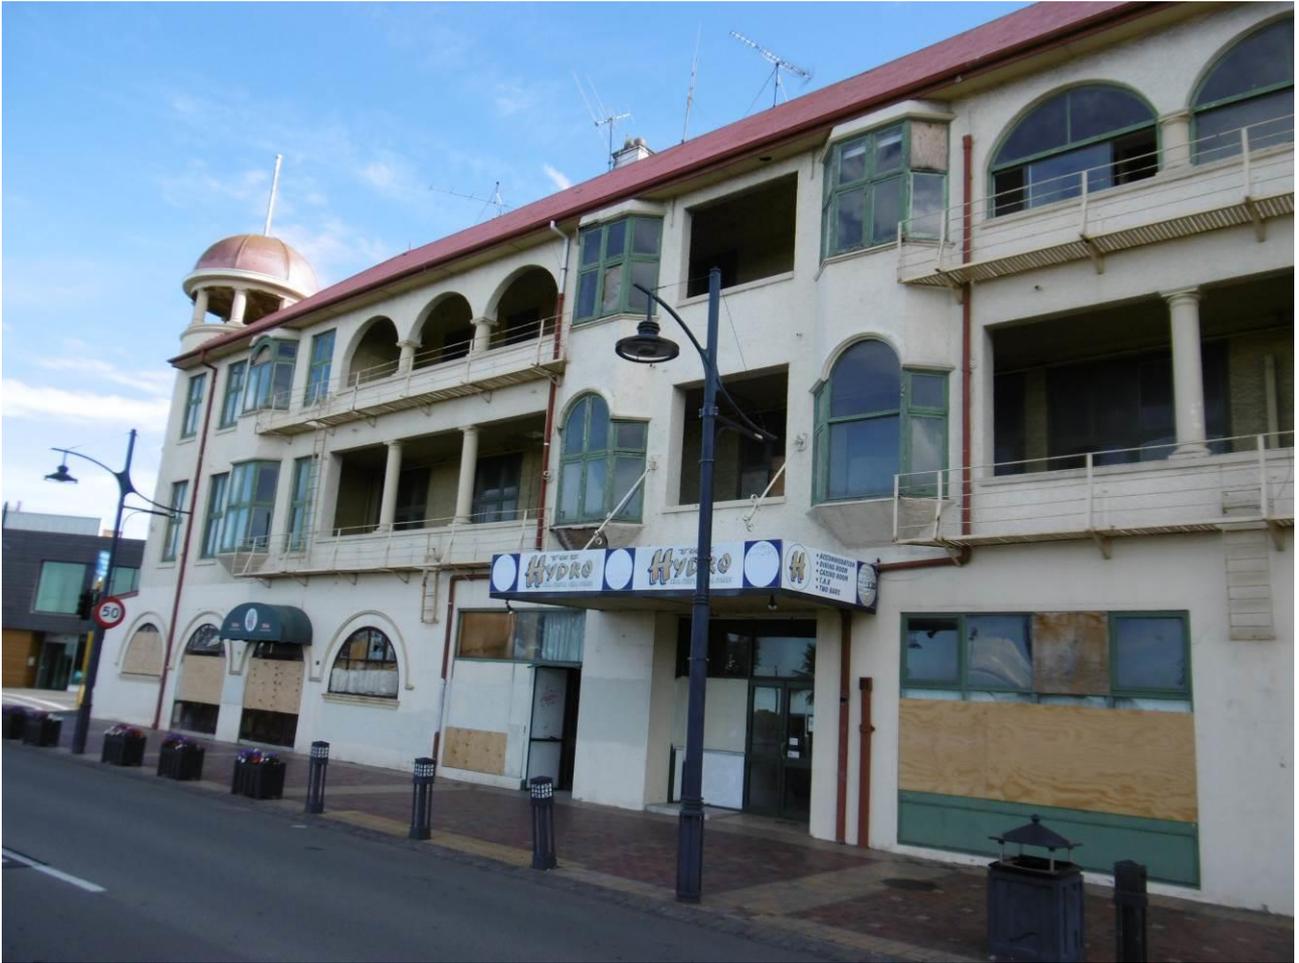
The façade is accentuated by three vertical banks of glazed timber oriel windows which look somewhat out of place today. These originally marked the centre point of each of the three gable roof structures which were removed following extreme wind damage on the 1st August 1975, much to the detriment of the overall building appearance and significance.

DETAIL OF THE ORIEL WINDOWS AND BALCONY COLLANAIDES, EAST ELEVATION

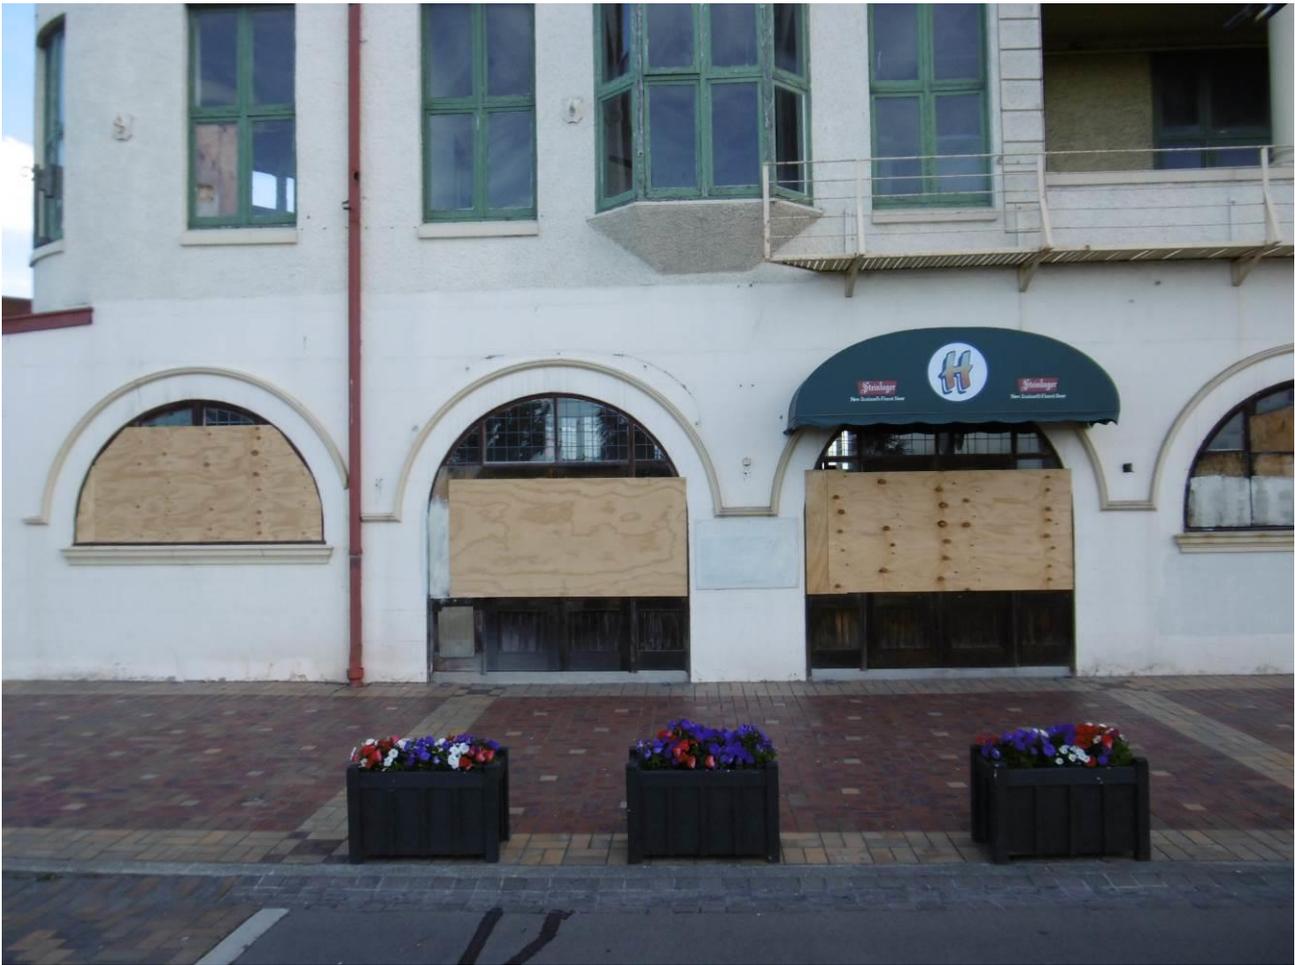
Around 1914 it was decided to extend the bar and restaurant areas and the shops were subsequently converted to such use and the corner dining room windows were replaced by masonry walls with the present arched top window openings.

DETAIL OF ARCHED TOP WINDOWS AND DOORS GROUND FLOOR EAST ELEVATION

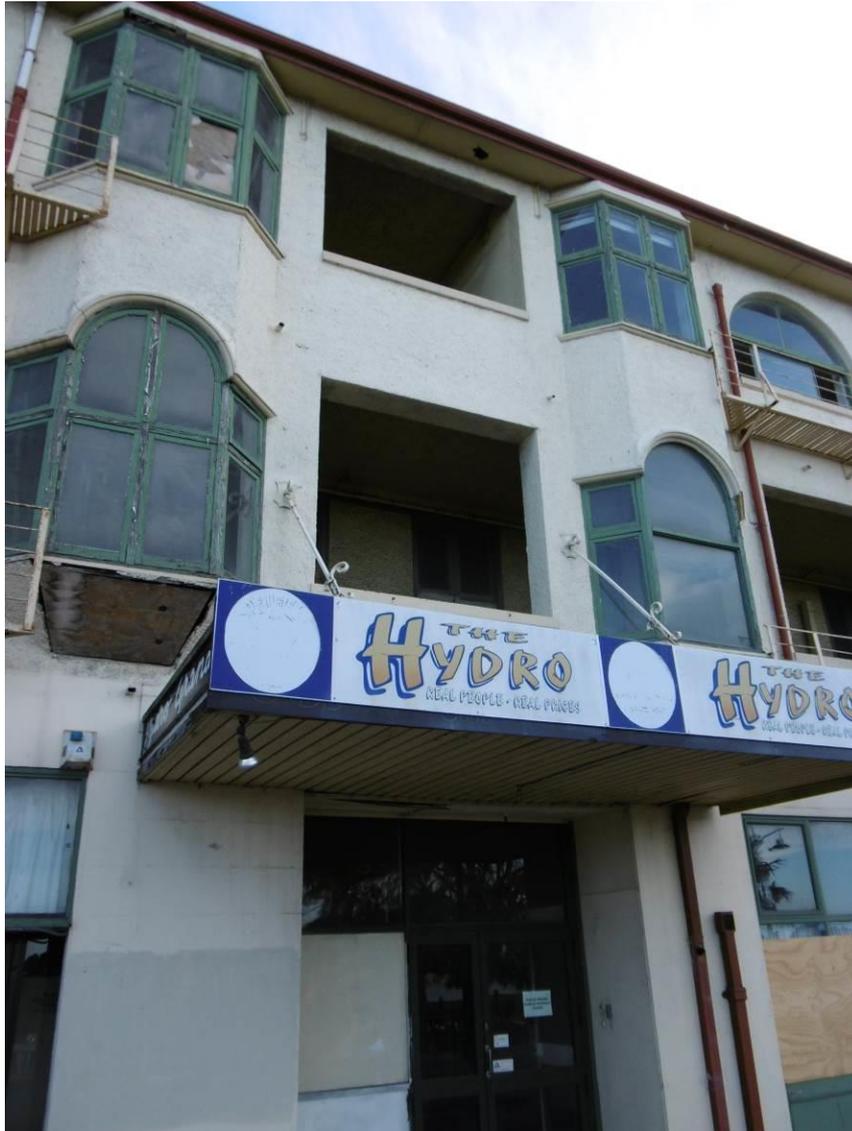
THE ONLY SECTION OF THE ORIGINAL VERANDAH WHICH REMAINS. NOTE THE ORIGINAL ORNATE SUSPENSION RODS AND BRACKETS AND DETAIL OF THE ORIGINAL ORIEL WINDOWS ABOVE. ALSO NOTE THE ROTTED BASE TO THE ORIEL WINDOW ABOVE THE VERANDAH WHICH HAS BEEN COVERED WITH PLYWOOD.

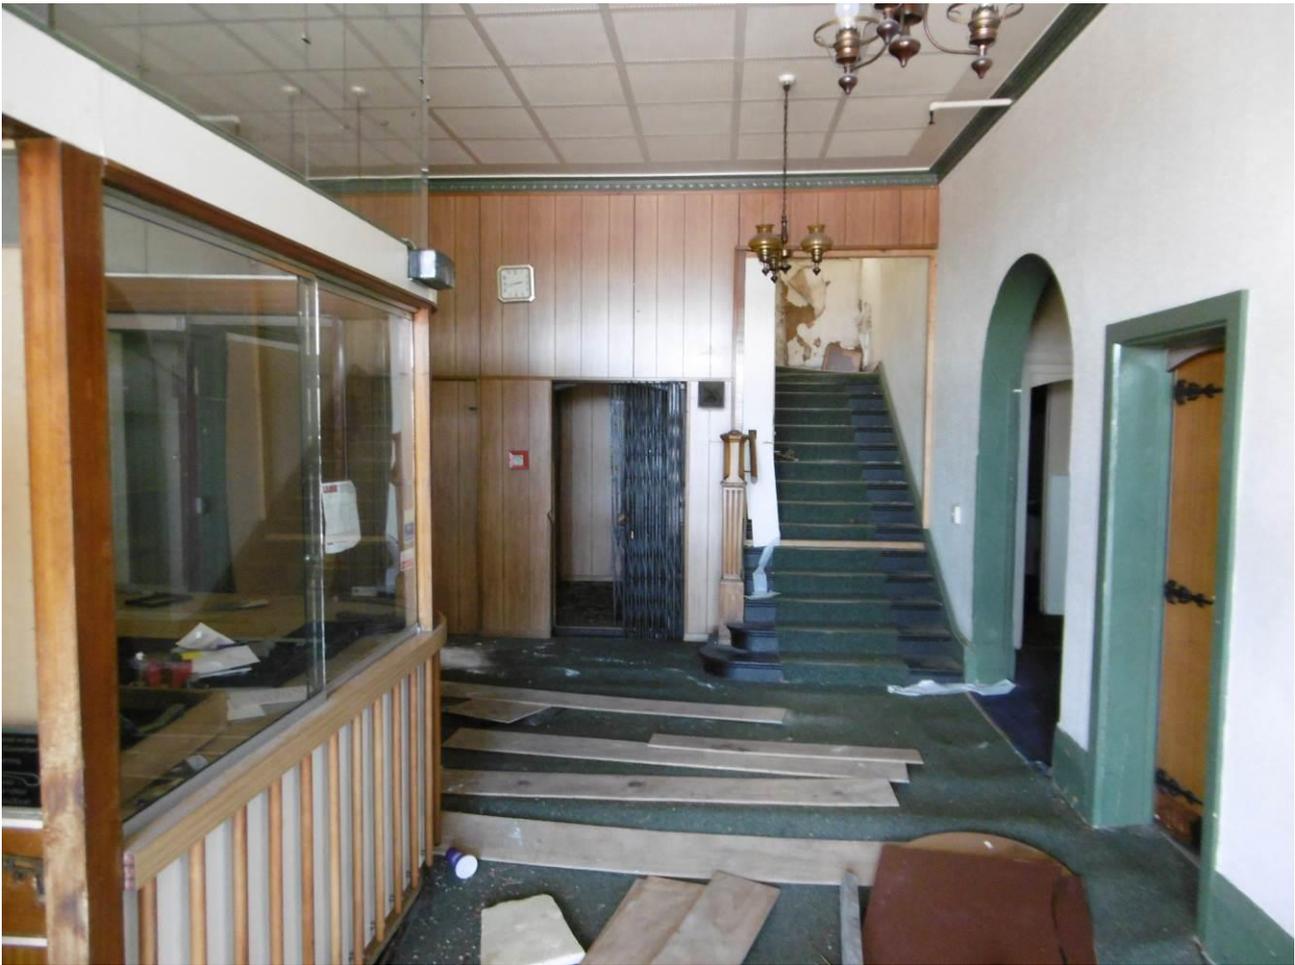
The main interior items of “considerable significance” or above are the two coloured stained glass windows in the central stairwell, the timber newel post at the bottom of the stair, the steel concertina lift doors, the original panelled bedroom doors, where these remain or are not smashed and a small area of painted timber panelling in the east corridor on the first floor.

VIEW OF MAIN ENTRANCE FROM THE FRONT DOOR. NOTE THE TIMBER NEWEL POST AND THE STEEL CONCERTINA LIFT DOOR

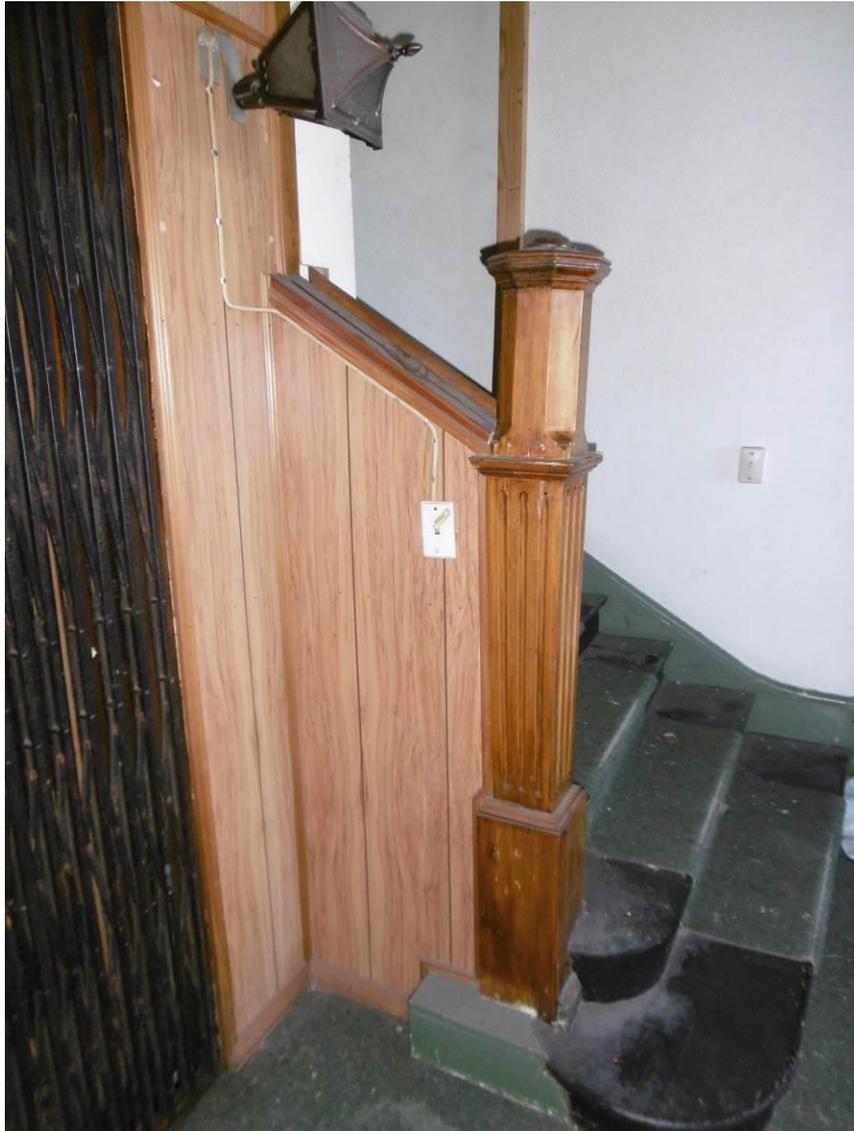
TIMBER NEWEL POST AT BOTTOM OF MAIN STAIR

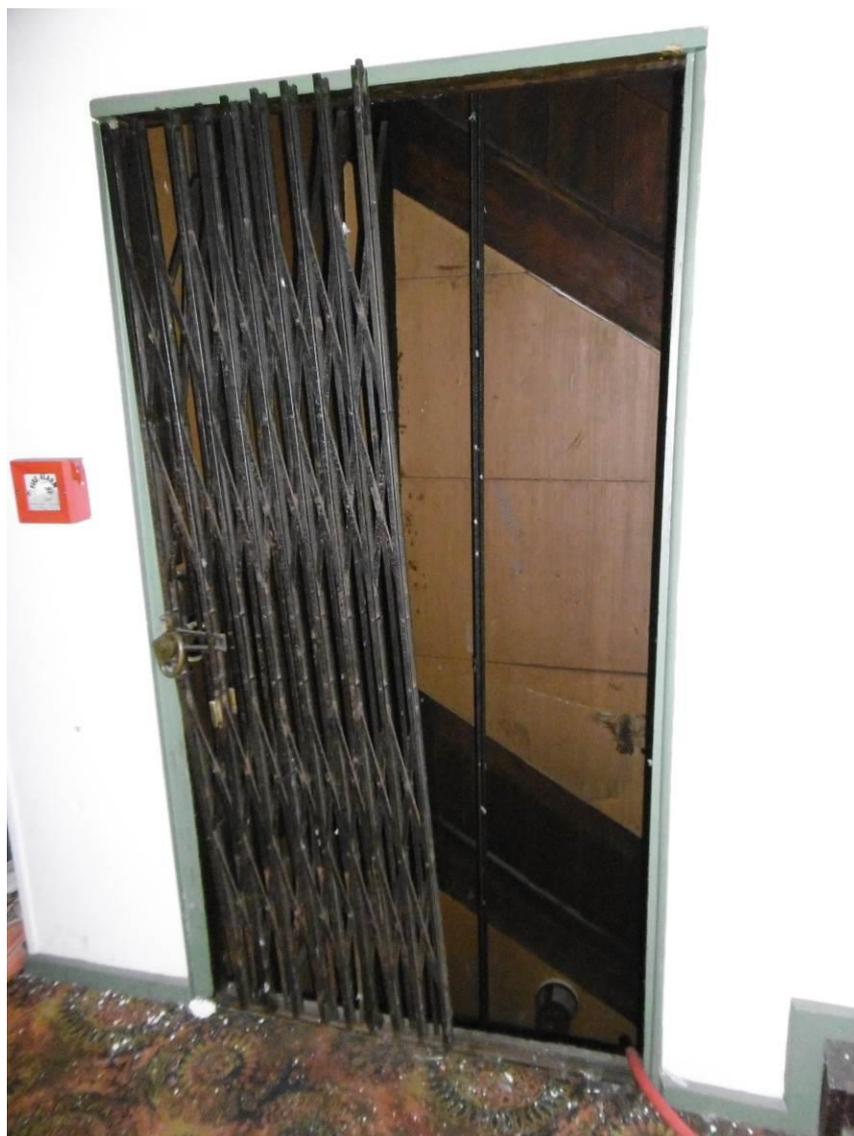
CONCERTINA STEEL LIFT DOORS ON EACH LEVEL

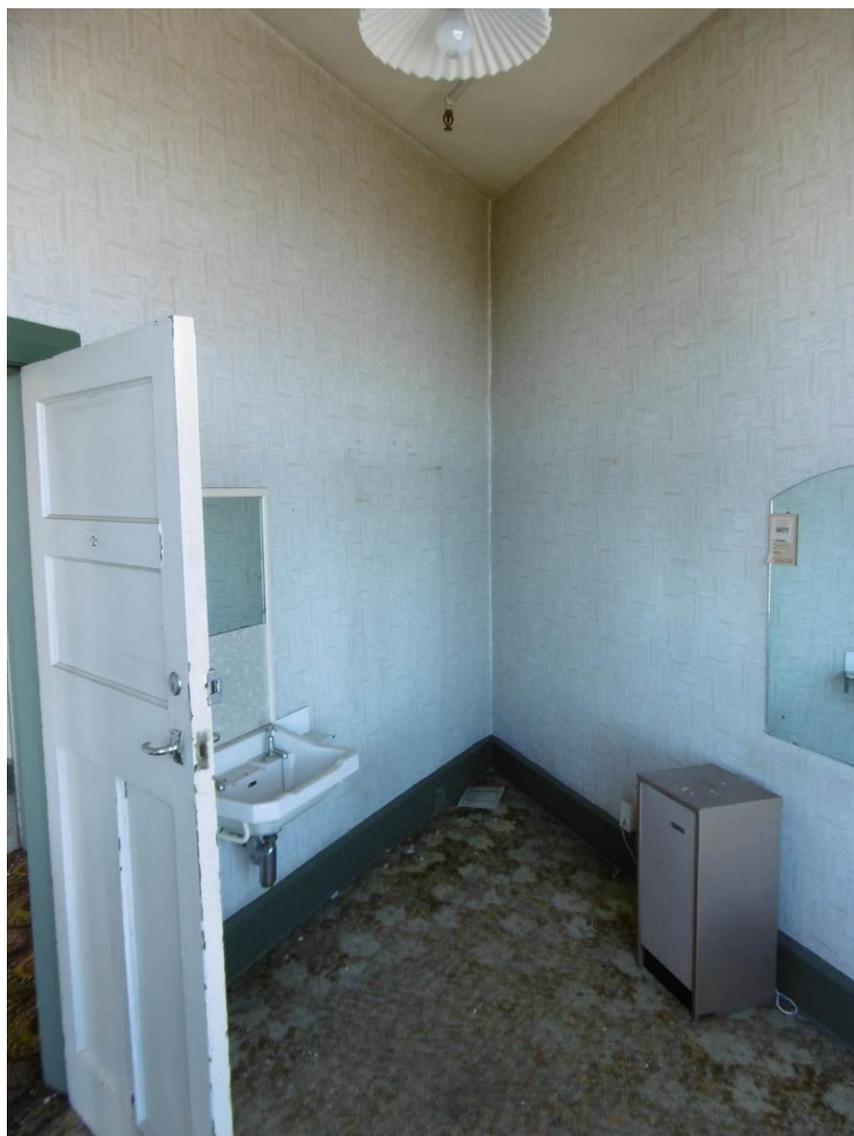
TYPICAL BEDROOM AMENITIES, FIRST FLOOR. THE PANELED DOOR IS THE ORIGINAL TYPE.

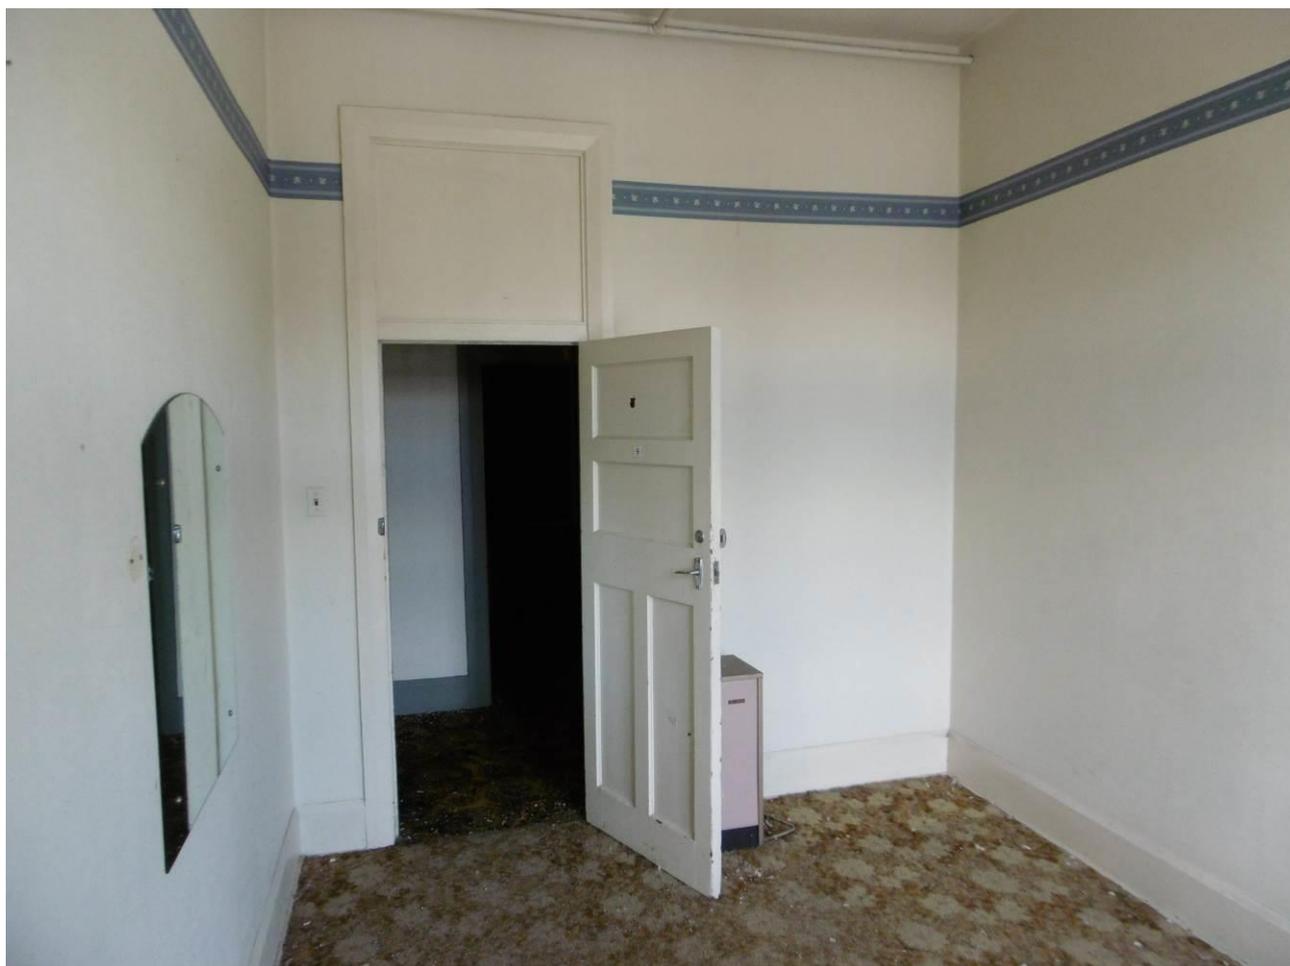
ANOTHER TYPICAL BEDROOM, LOOKING TOWARDS THE DOOR

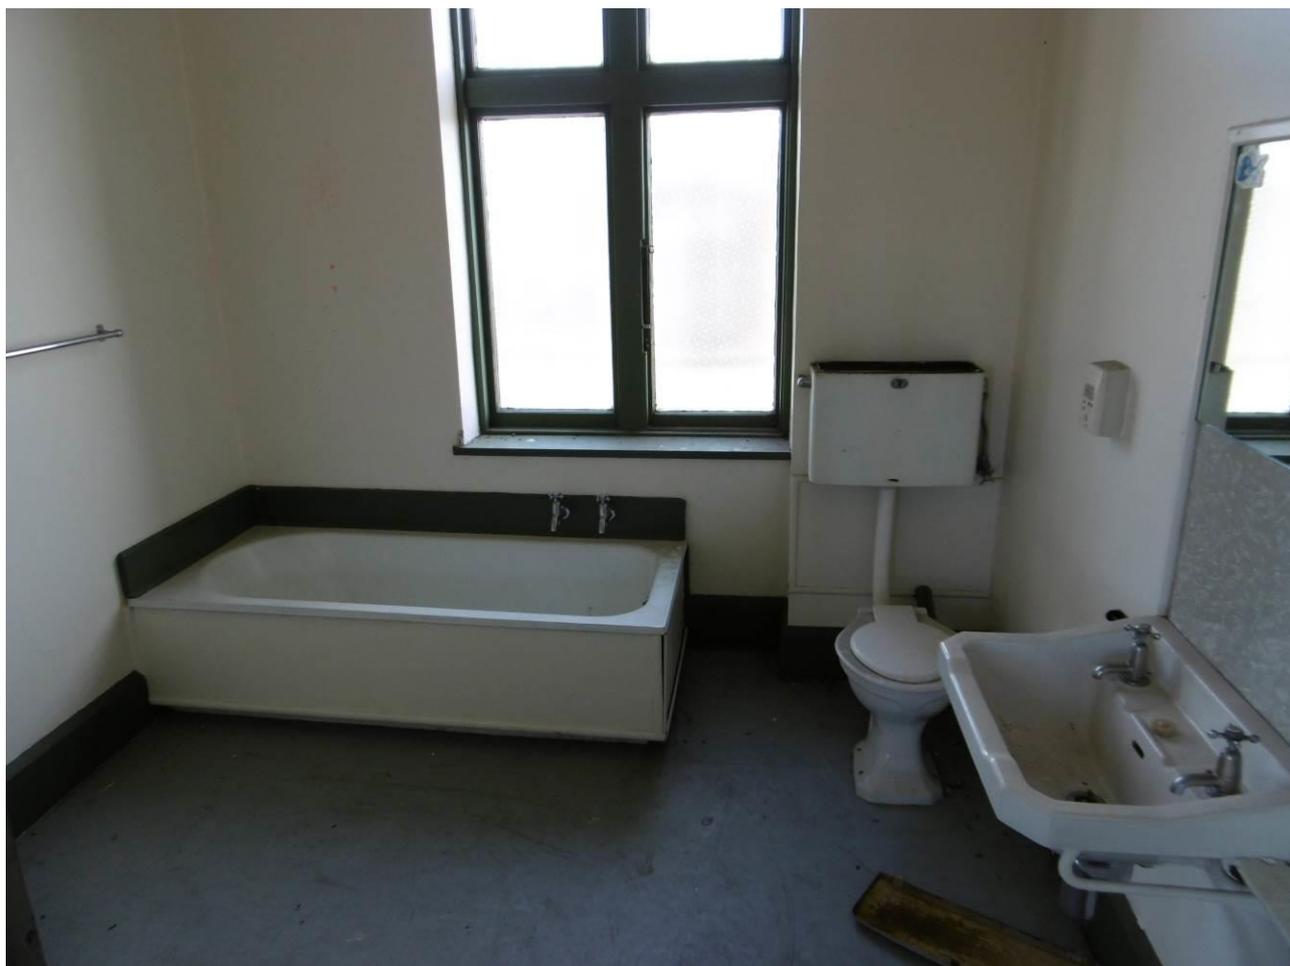
A BEDROOM WHICH HAS BEEN CONVERTED TO A BATHROOM

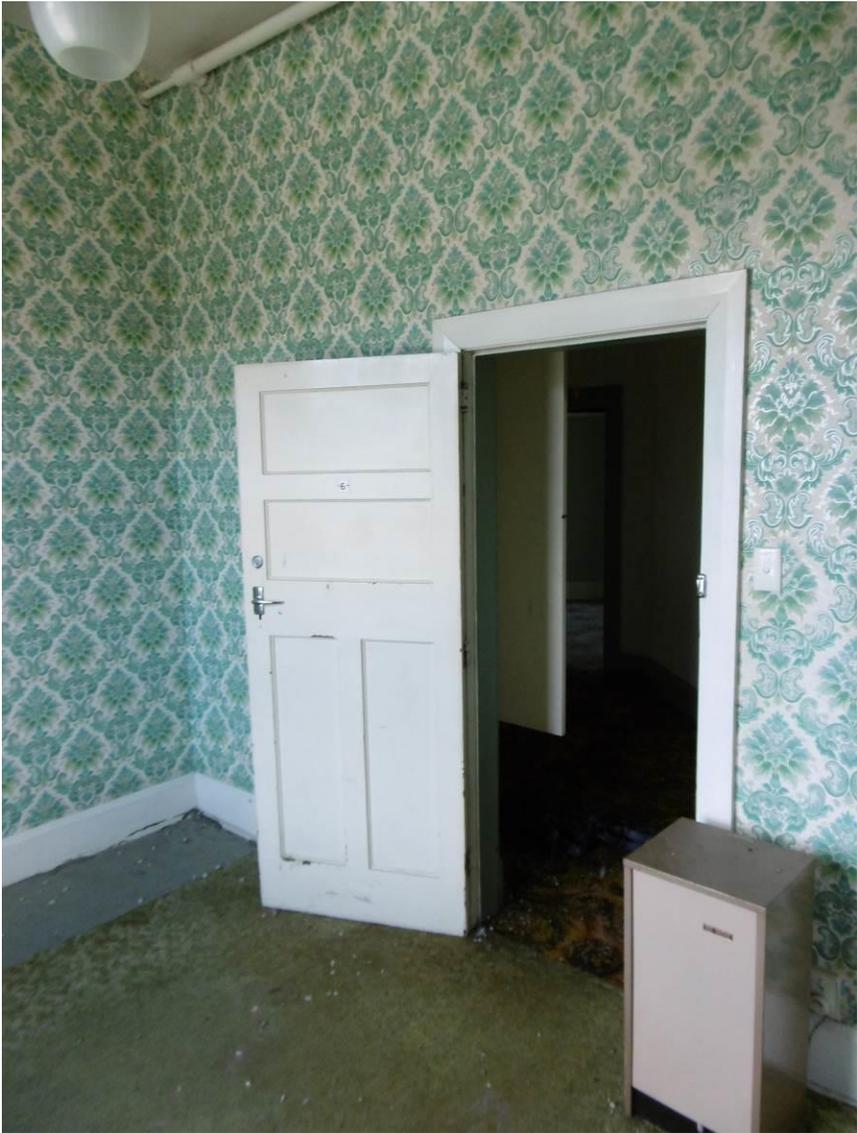
MOST BEDROOMS ARE DECORATED LIKE THIS.

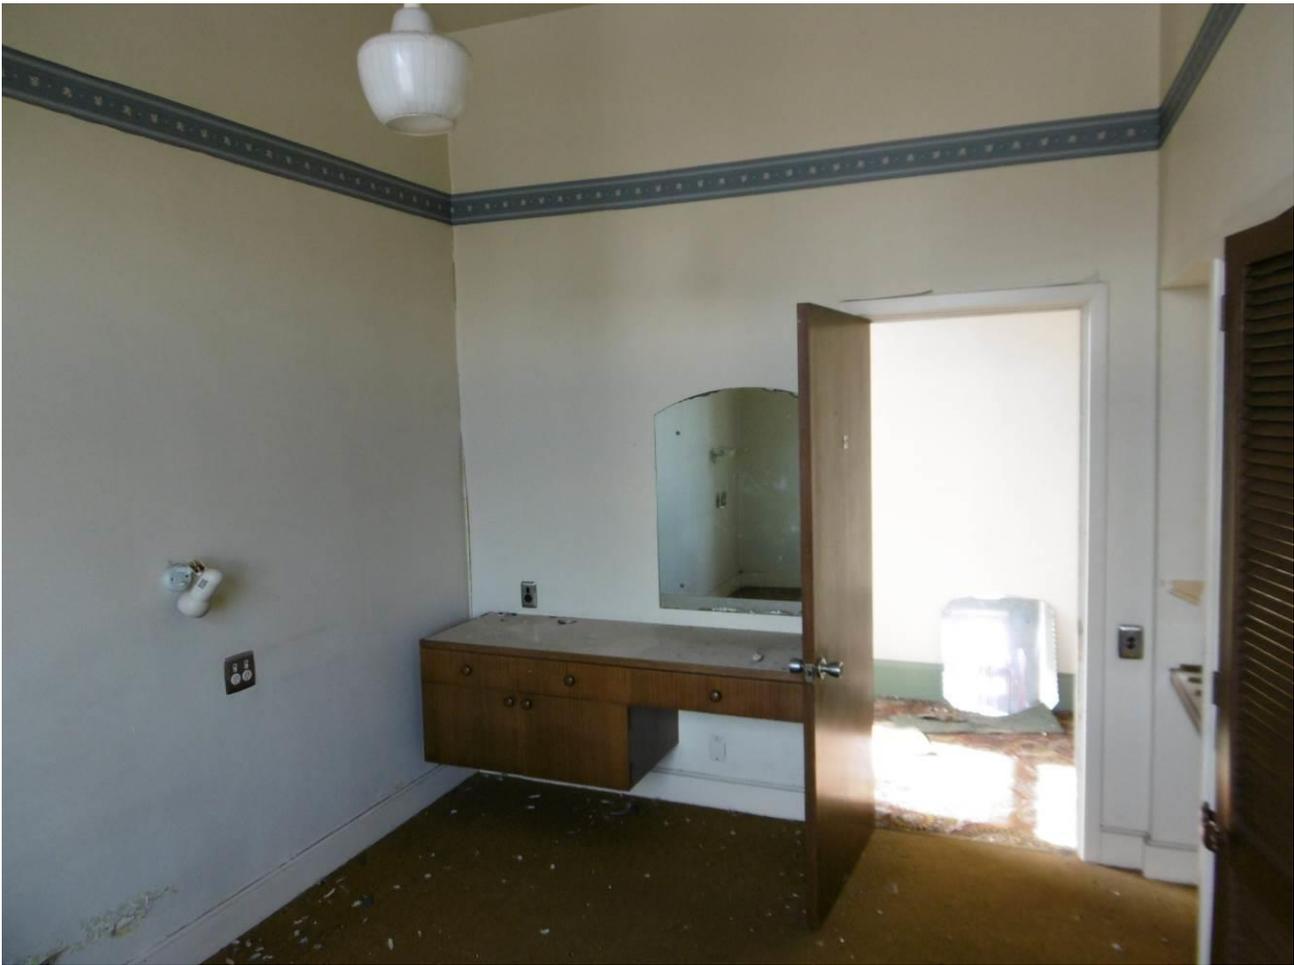
BEDROOM WITH BUILT IN FITTINGS

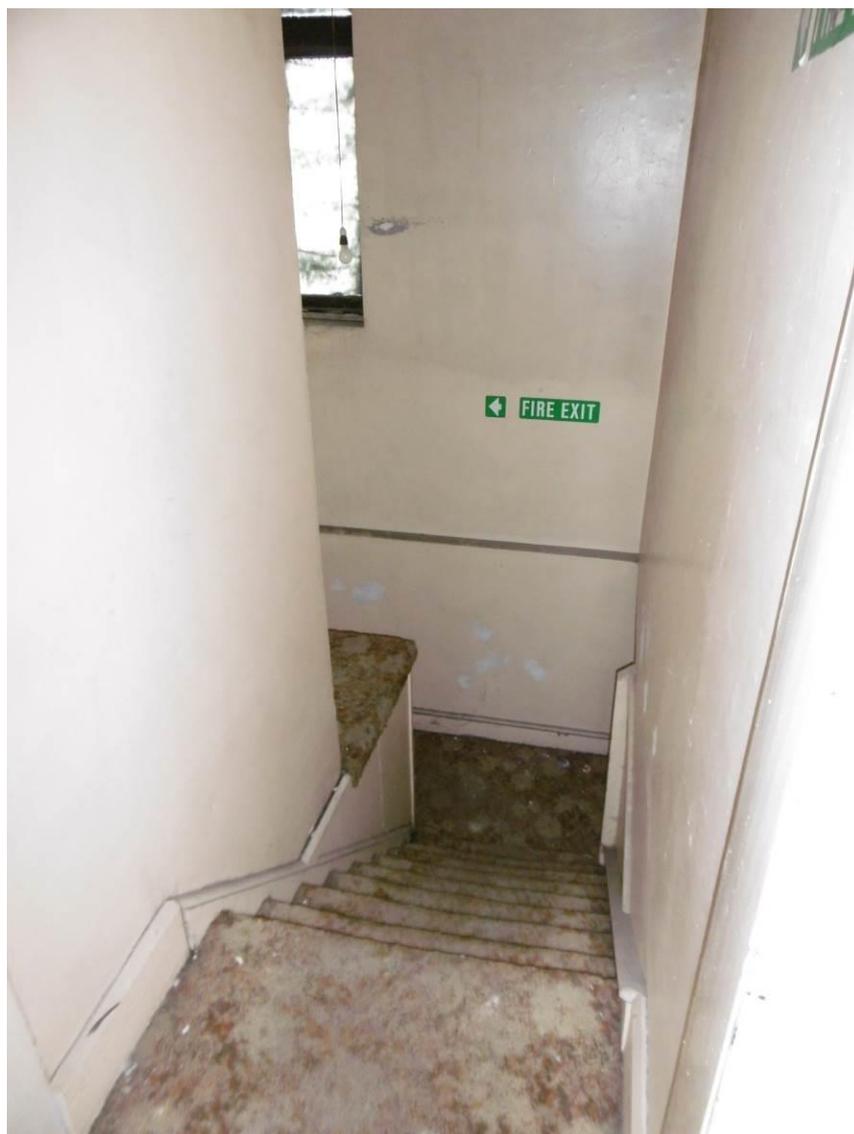
REAR EGRESS STAIRWELL

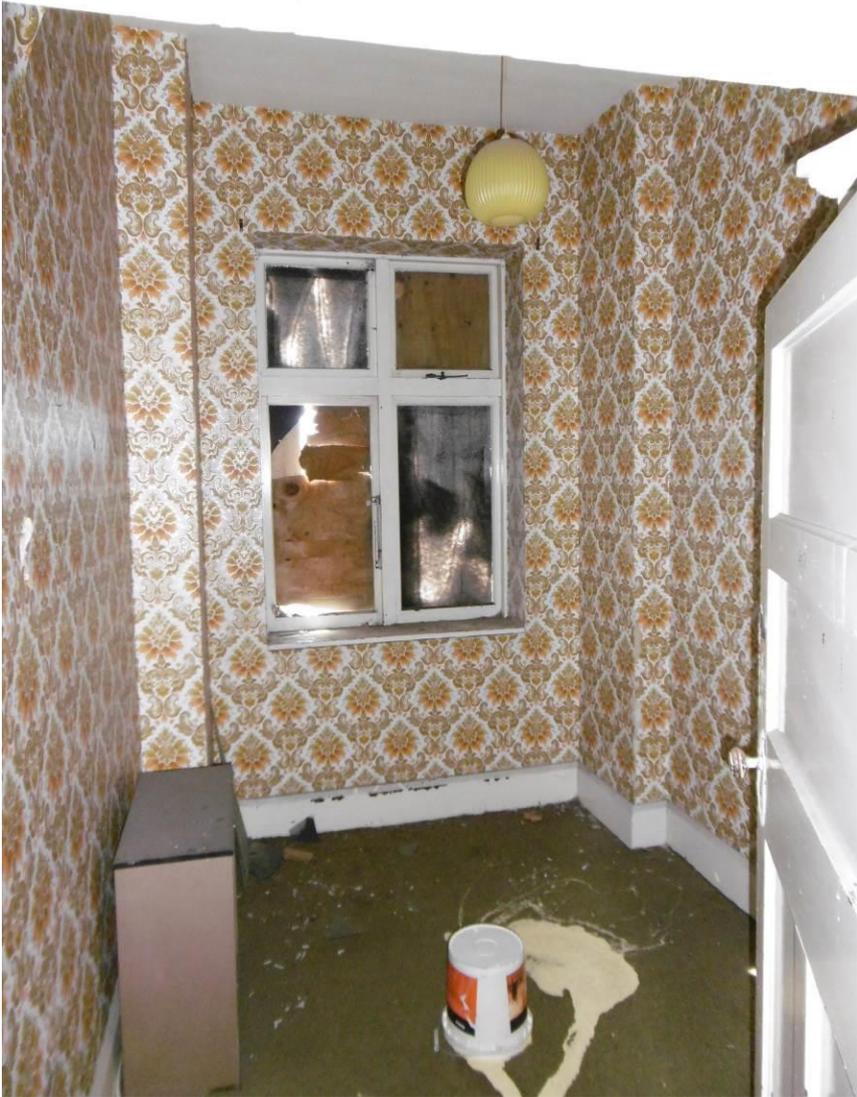
FORMER STAFF BEDROOM

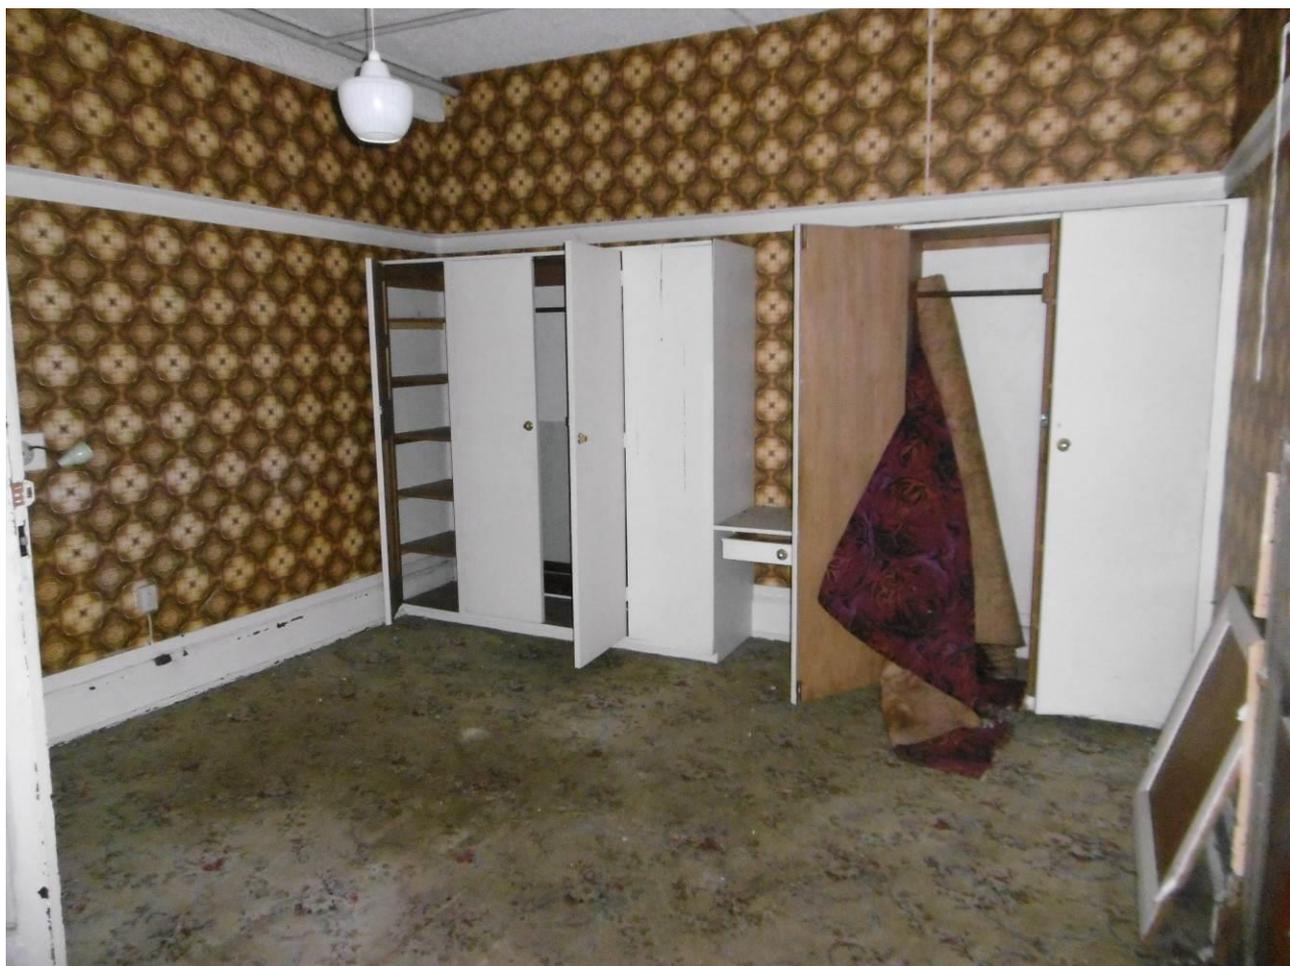
FORMER MANAGERS FLAT BEDROOM

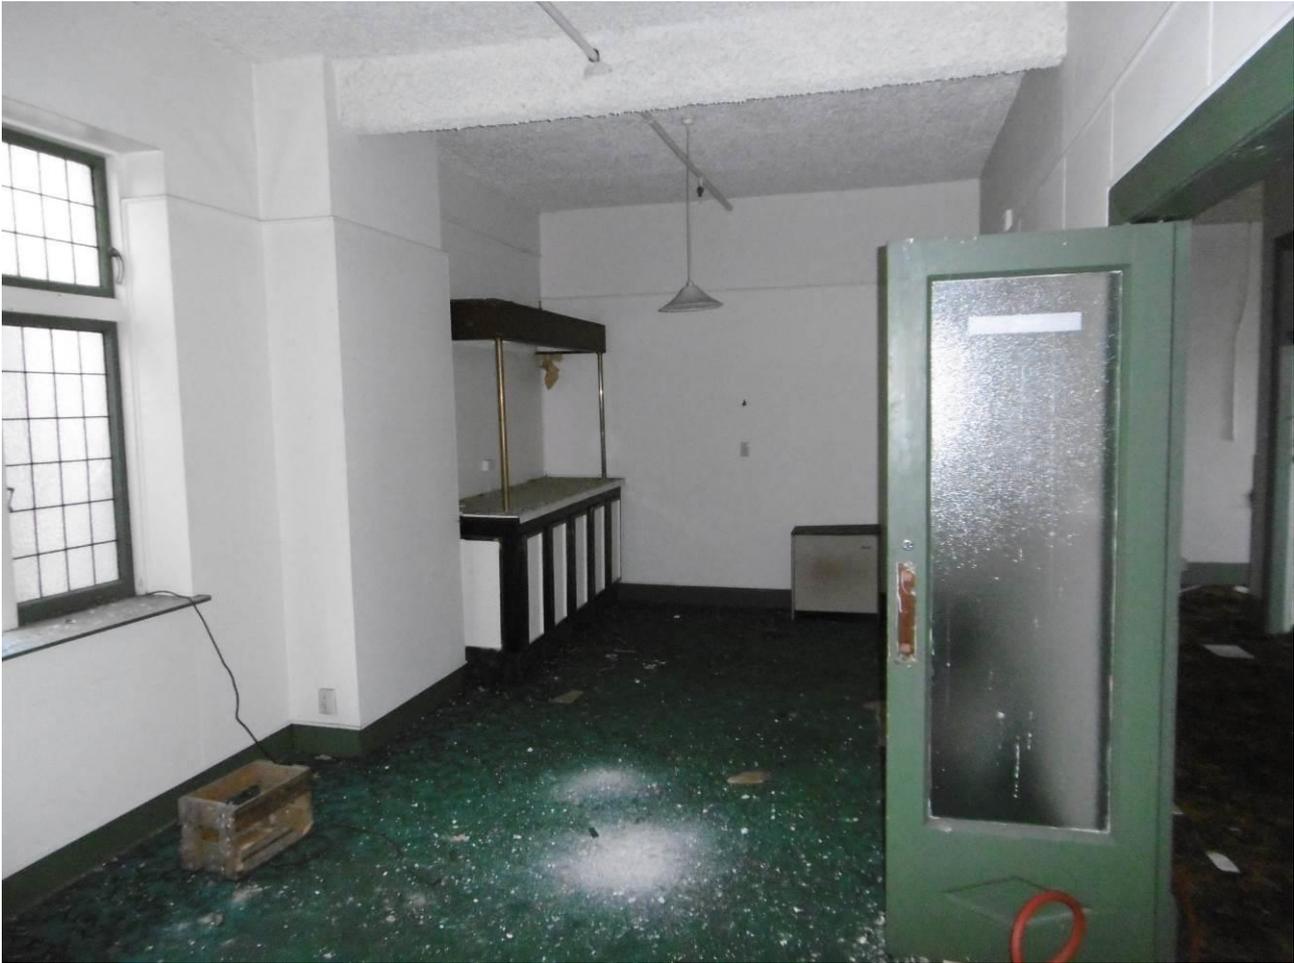
BREAKFAST/FUNCTIONS ROOM ON FIRST FLOOR

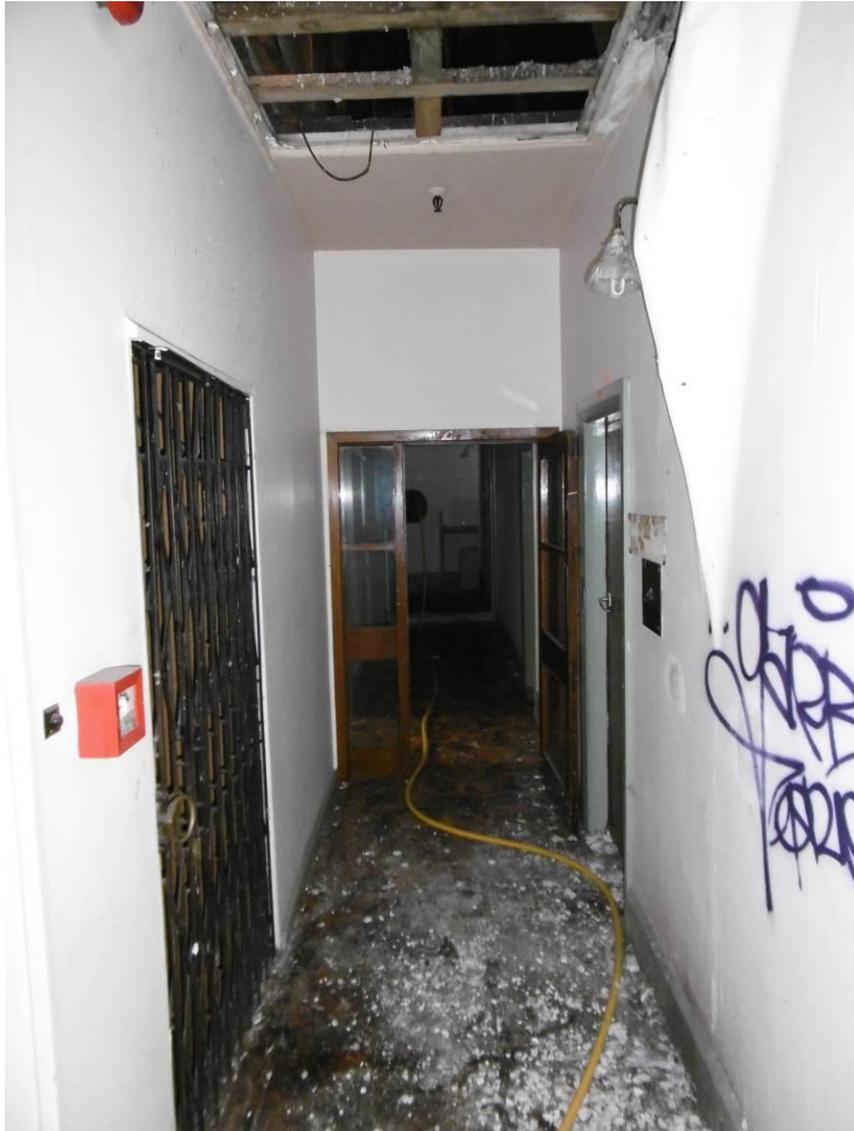
LIFT FOYER, UPPER FLOOR, WITH LIFT DOOR

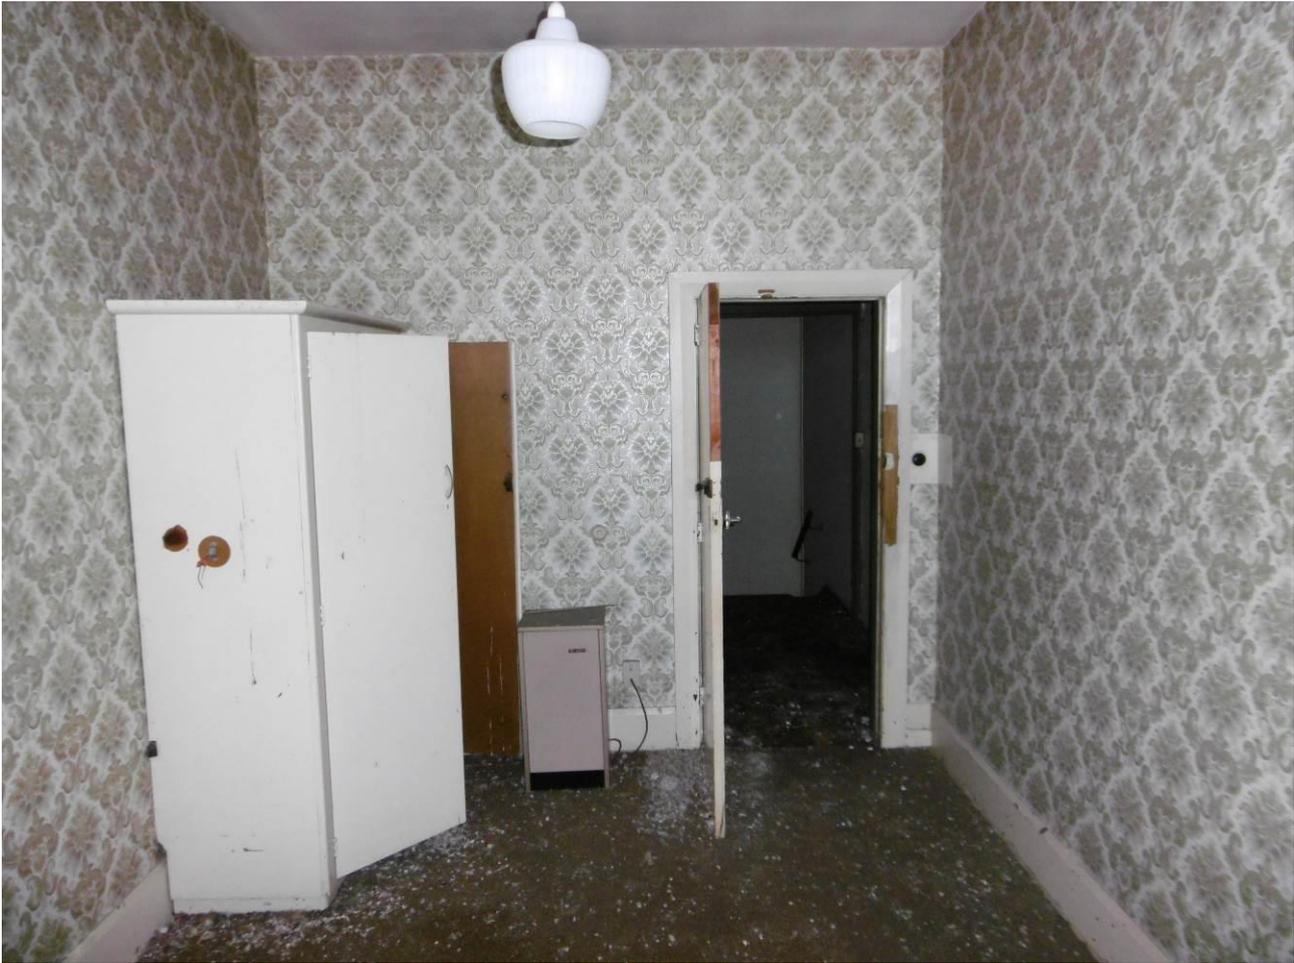
TYPICAL UPPER FLOOR BEDROOM

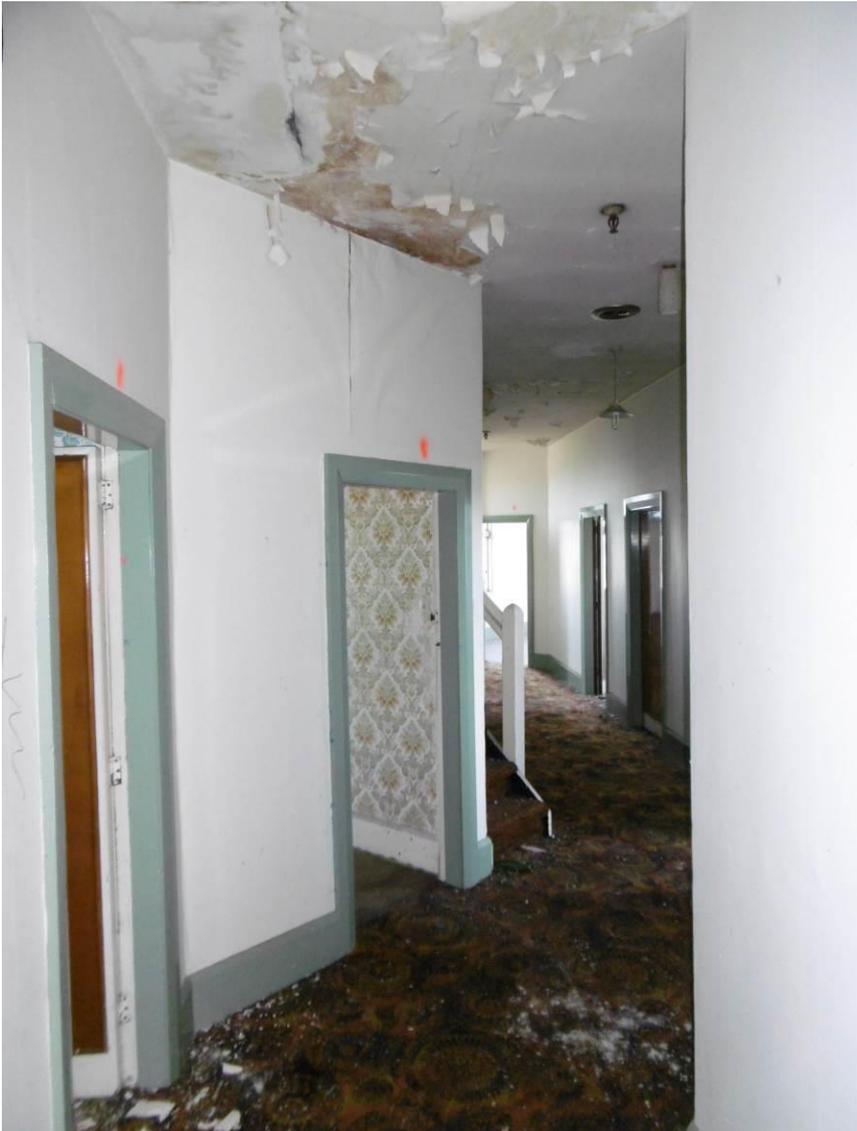
UPPER FLOOR CORRIDOR AREAS

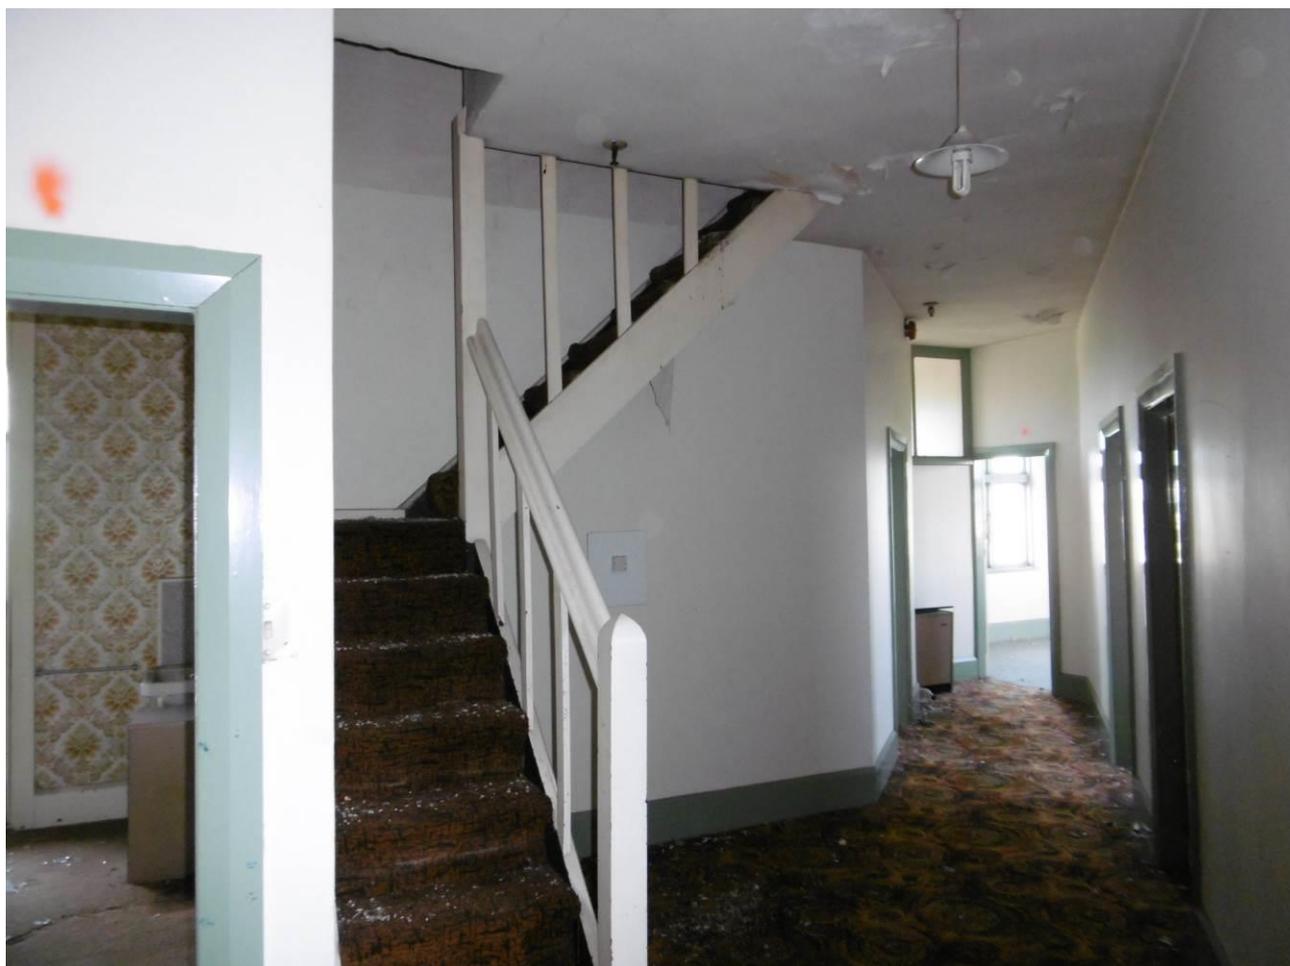
THE ACCESS STAIR TO THE CUPOLLA LOOKOUT.

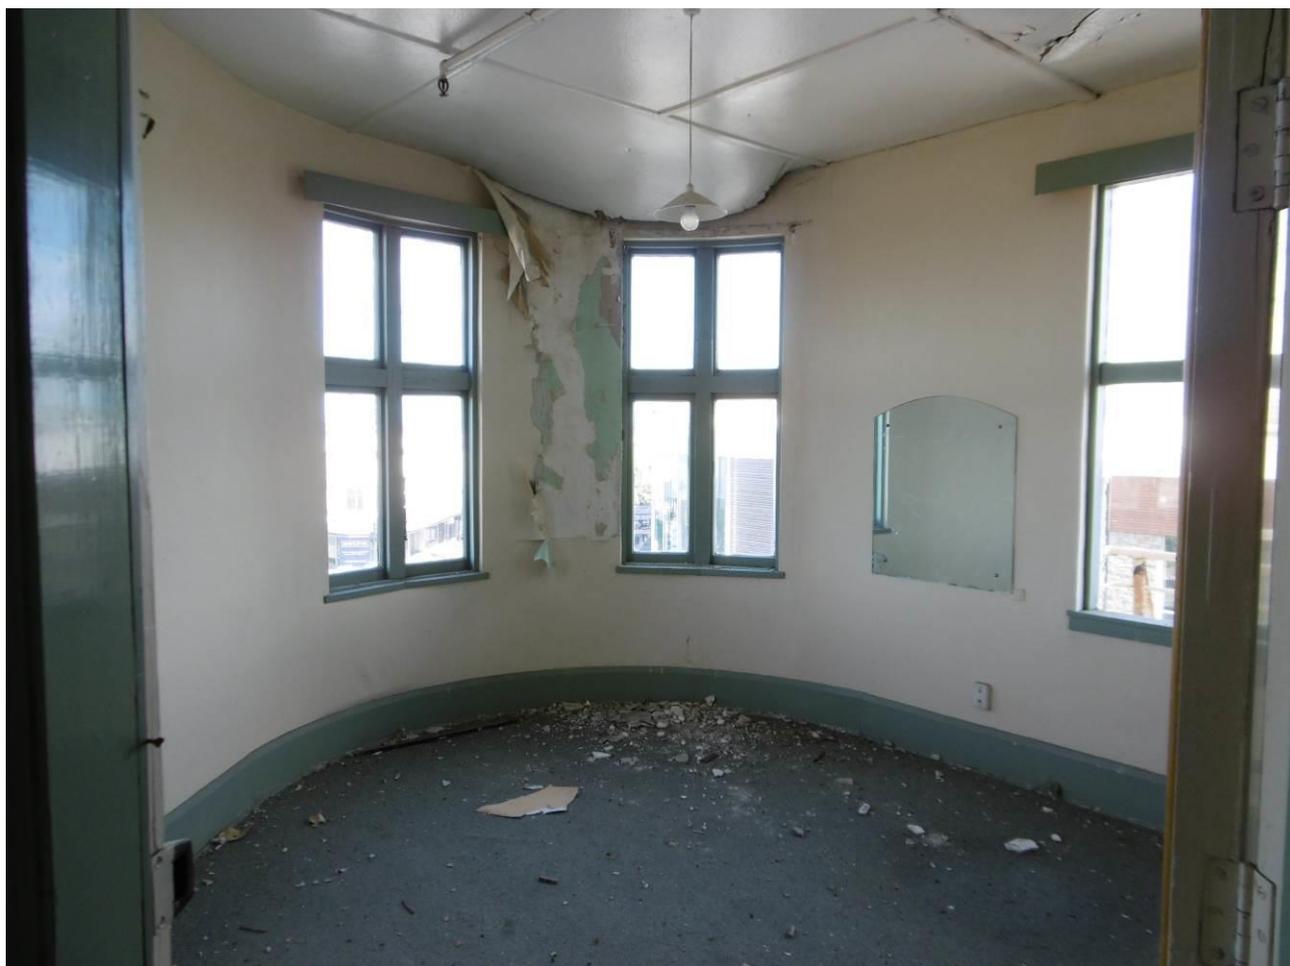
THE ROOM BELOW THE CORNER TOWER LOOKOUT
