HYDRO GRAND HOTEL

10 THE BAY HILL, TIMARU

HERITAGE ASSESSMENT

Report Prepared by
SMART ALLIANCES LTD
for
TIMARU DISTRICT COUNCIL

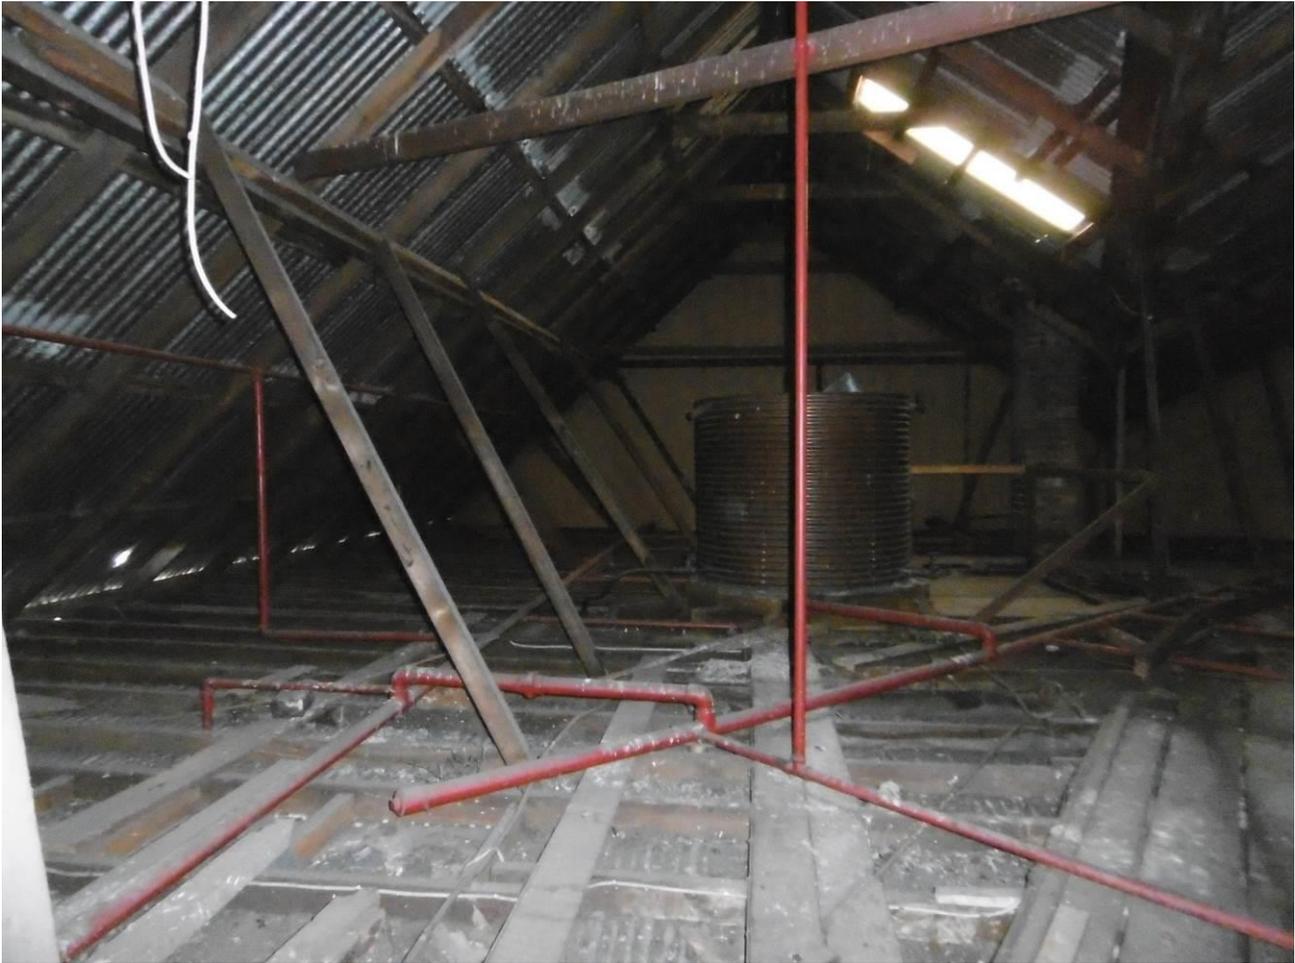
THE ROOF SPACE ADJACENT TO THE CUPOLLA, SHOWING FRAMING AND SPRINKLER PIPES.

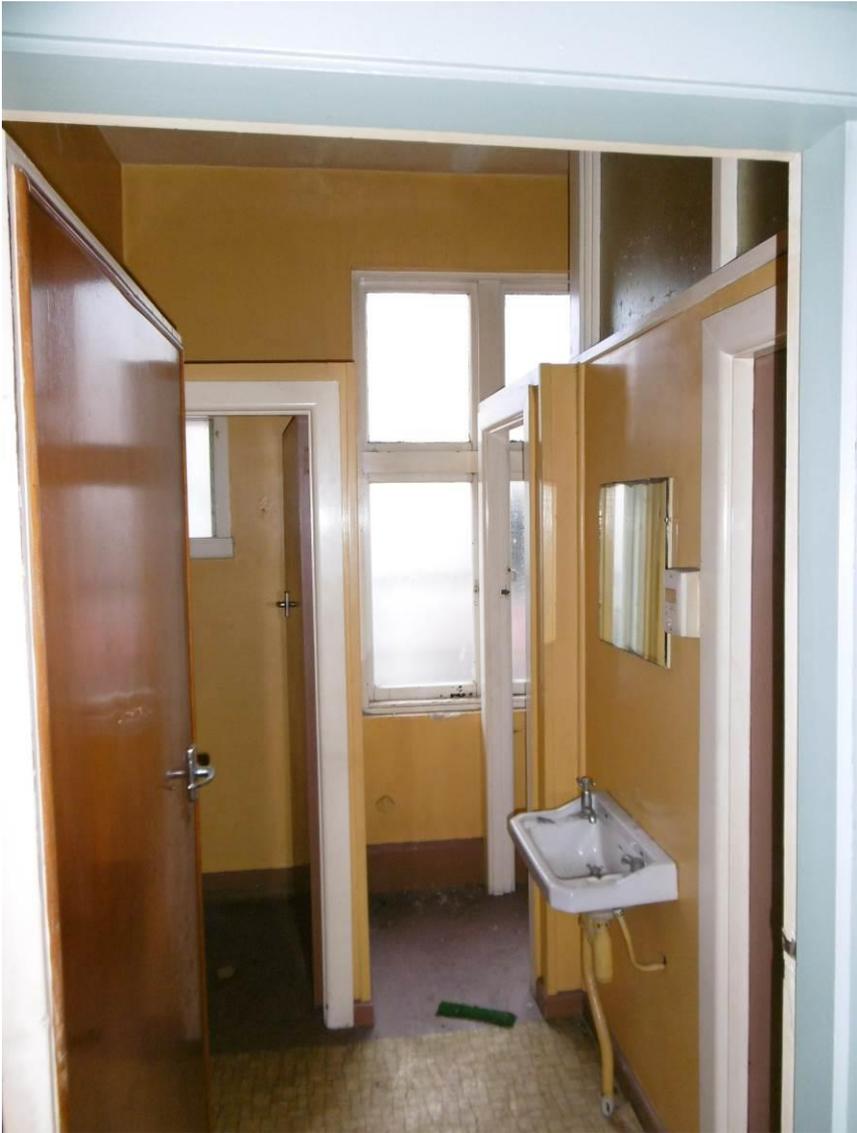
MENS COMMUNAL BATHROOM UPPER FLOOR.

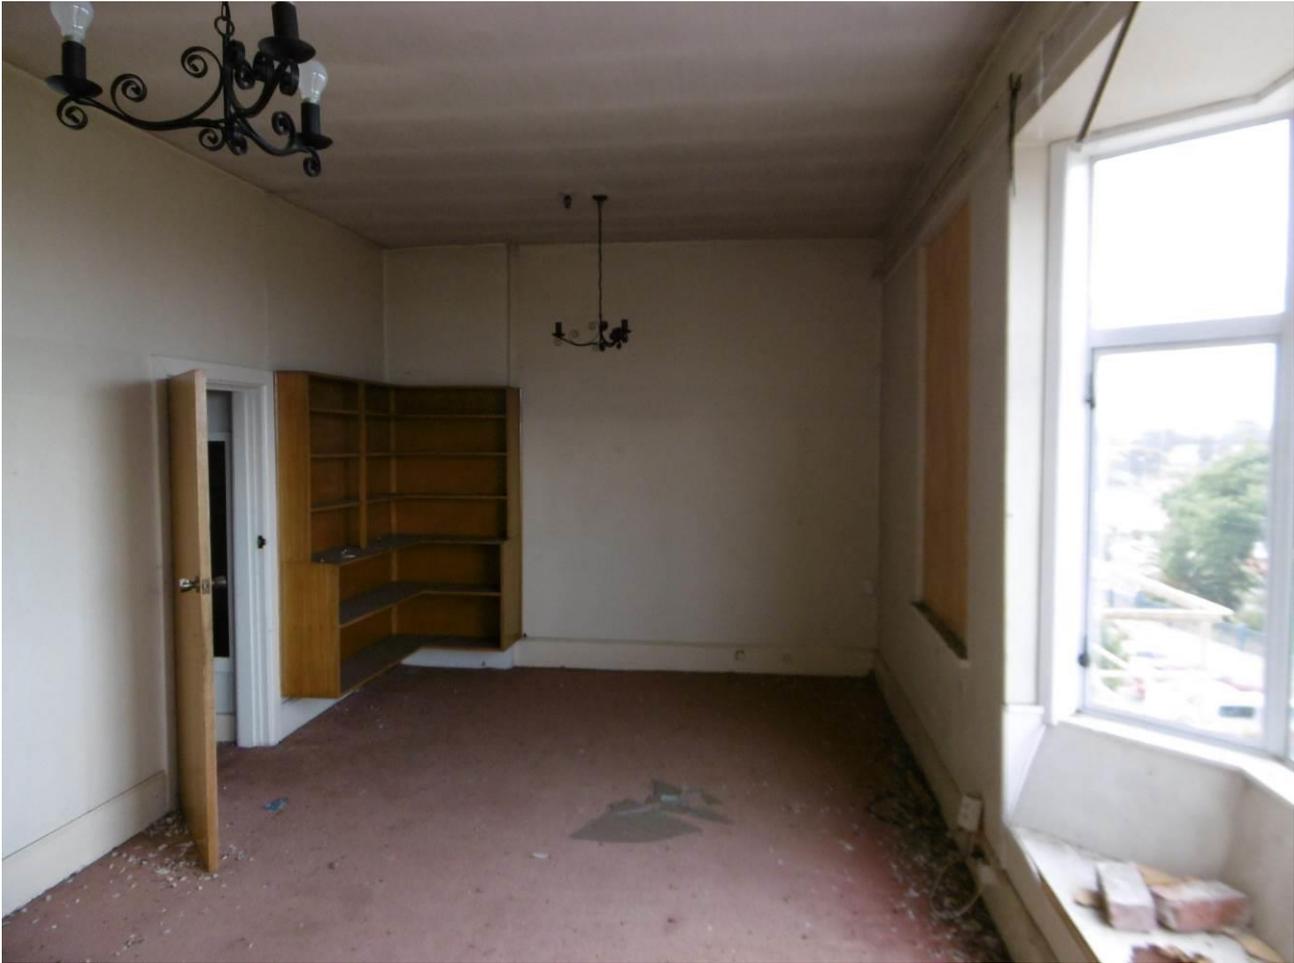
FRONT ROOM, MANAGERS FLAT, TOP FLOOR

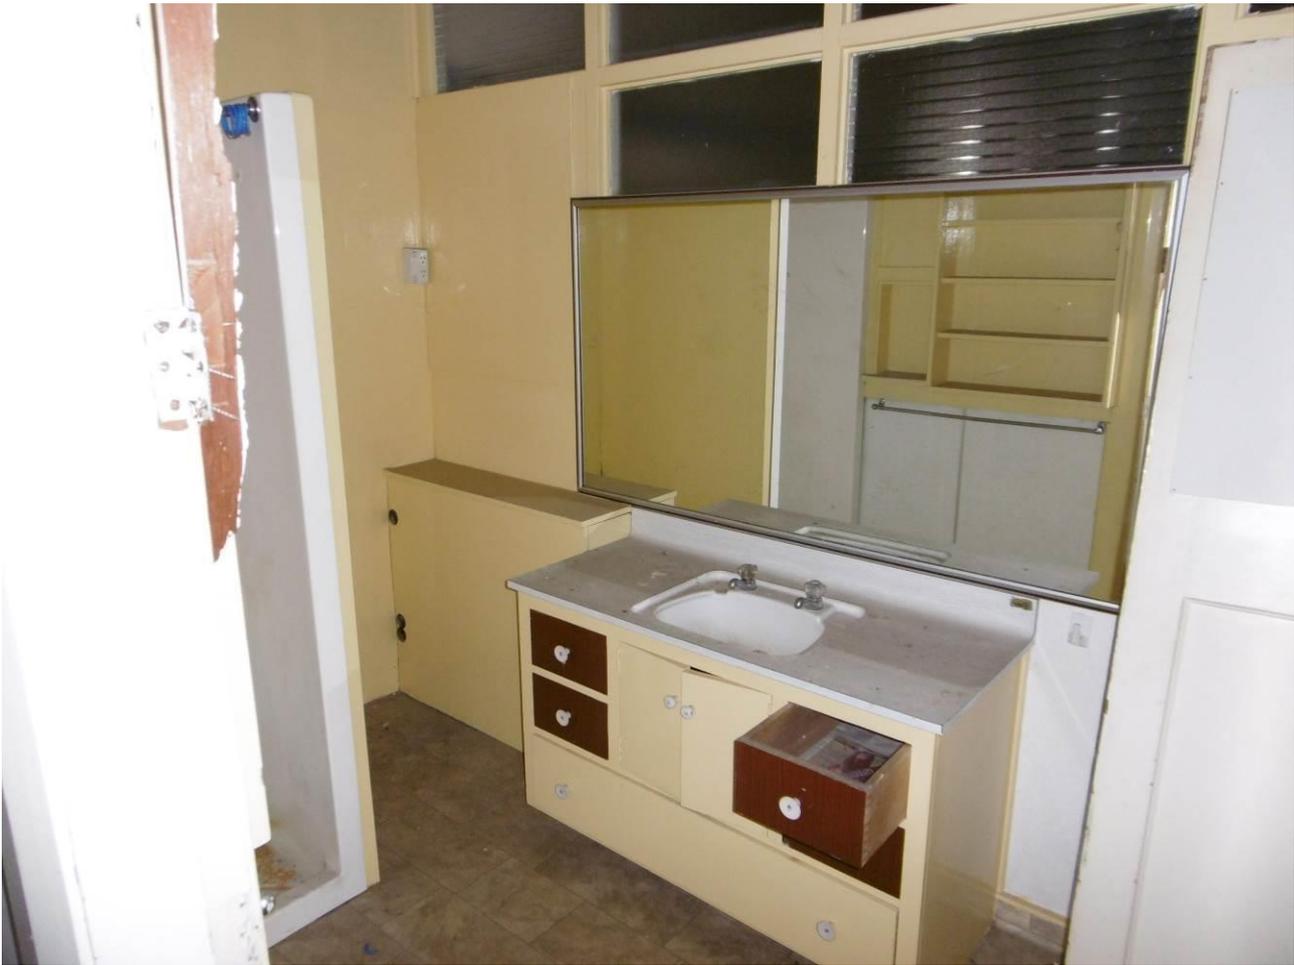
BATHROOM, MANAGERS FLAT

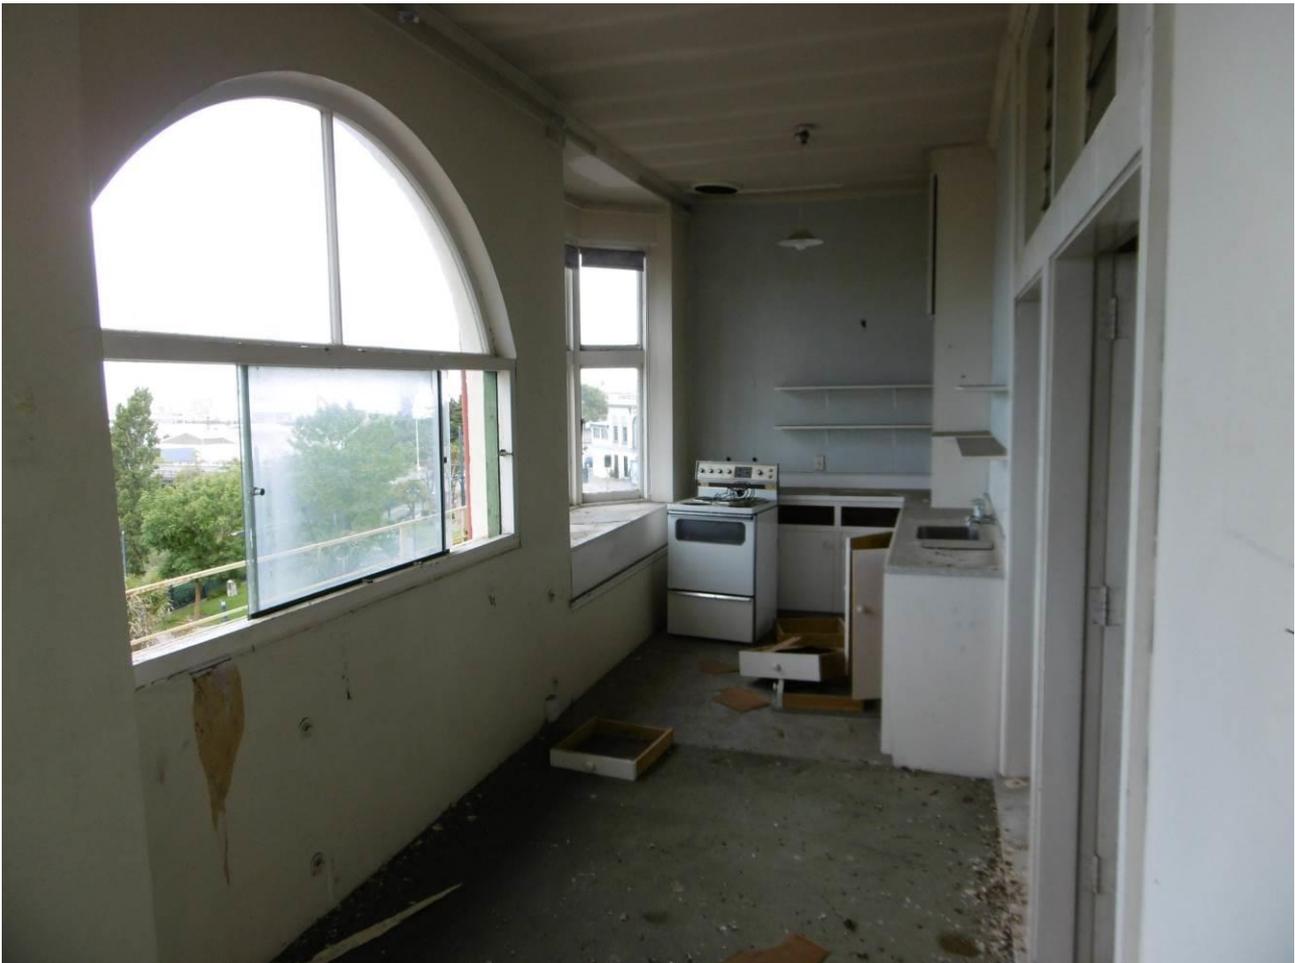
UPPER FLOOR BALCONY NORTH END, ENCLOSED AND CONVERTED TO THE MANAGERS FLAT KITCHEN

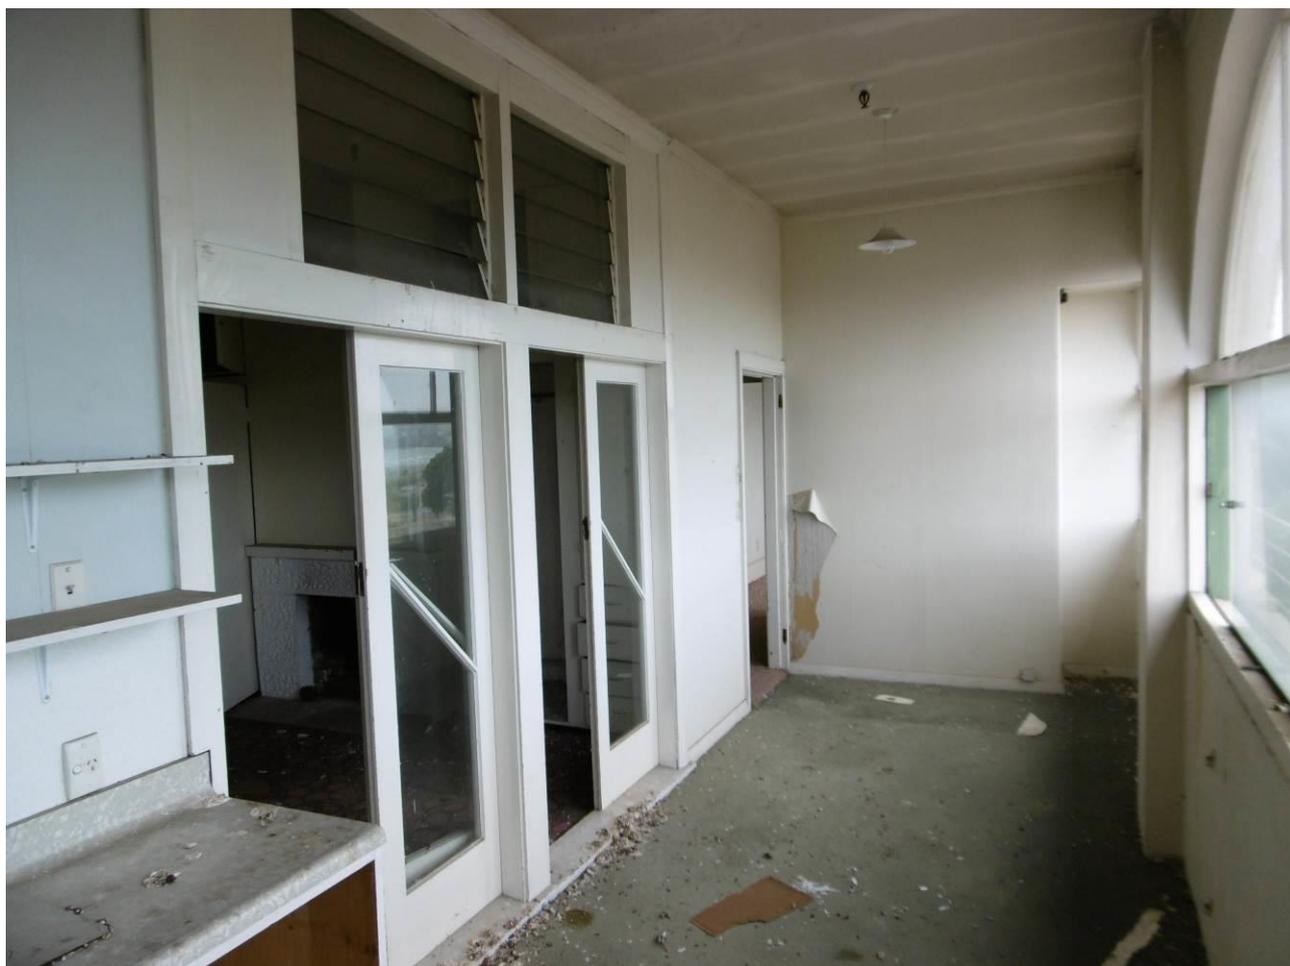
FURTHER VIEW OF THE CONVERTED BALCONY, WITH DOORS TO THE LIVING ROOM

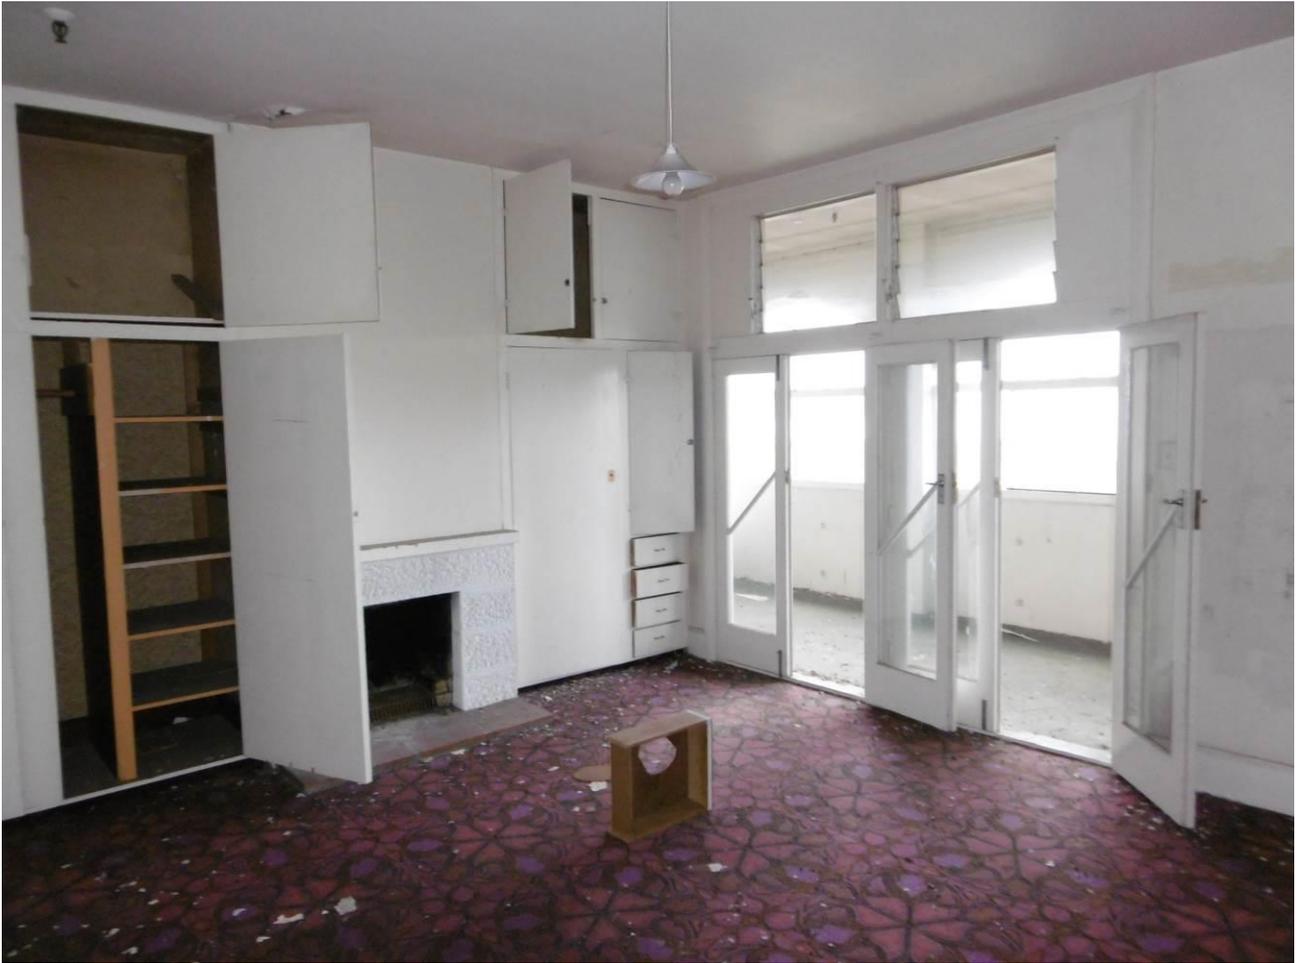
MANAGERS FLAT LIVING ROOM, LOOKING TOWARDS THE BALCONY

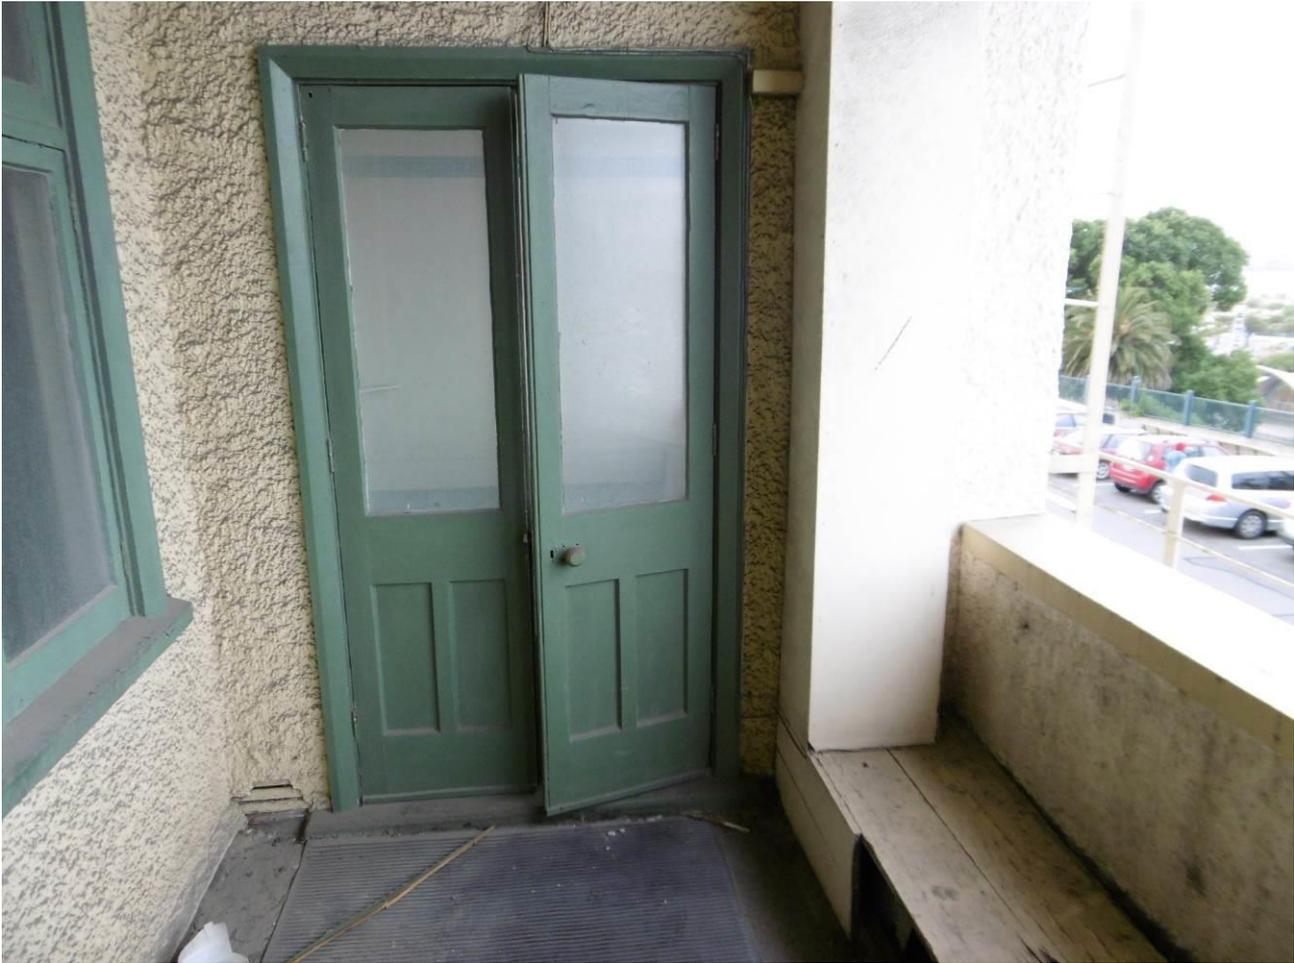
ACCESS DOORS FROM THE FIRST FLOOR CORRIDOR TO THE BALCONY
